East Lake Sammamish Trail Inglewood Hill Road Parking Lot Project

Tree Inventory/Assessment Report

**6/17/2017
Updated 7/7/17**

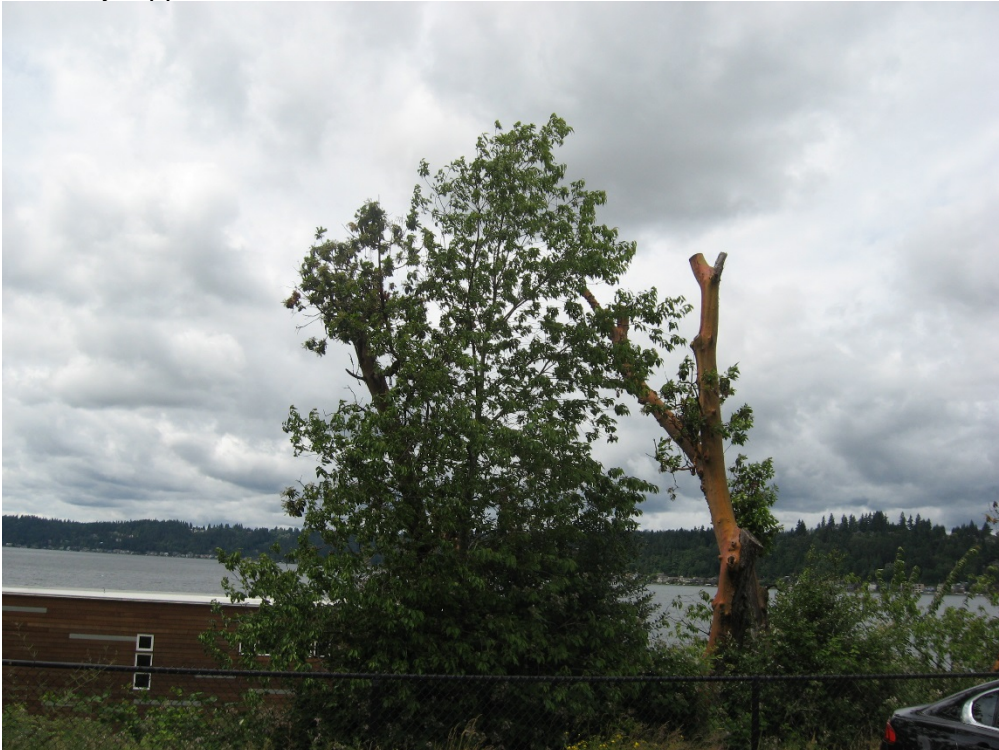
12 of the subject trees have been recently topped, likely to remove dead and or dying tops and to reduce hazard potential. These include #6000, #6001, #6002, #8035, #8036, #8037, #8038, #8039, #8040, #8041, #8042 and #8043. Topped heights range between 20’ and 40’. These will never develop a structurally sound form and are therefore rated as ‘poor’ condition

Recently topped trees #8042 and #8043
