CARRIER SUBDIVISION
 Roadway Cross Section Alternatives

SUBJECT: Preliminary Evaluation of a Row of Fir Trees Along SE 8th Street

Evaluation of Trees Across the Street from the Carrier Plat
On SE 8th Street east of 214th Ave SE, Sammamish, WA
Gilles Consulting
April 6, 2016
Page 9 of 13

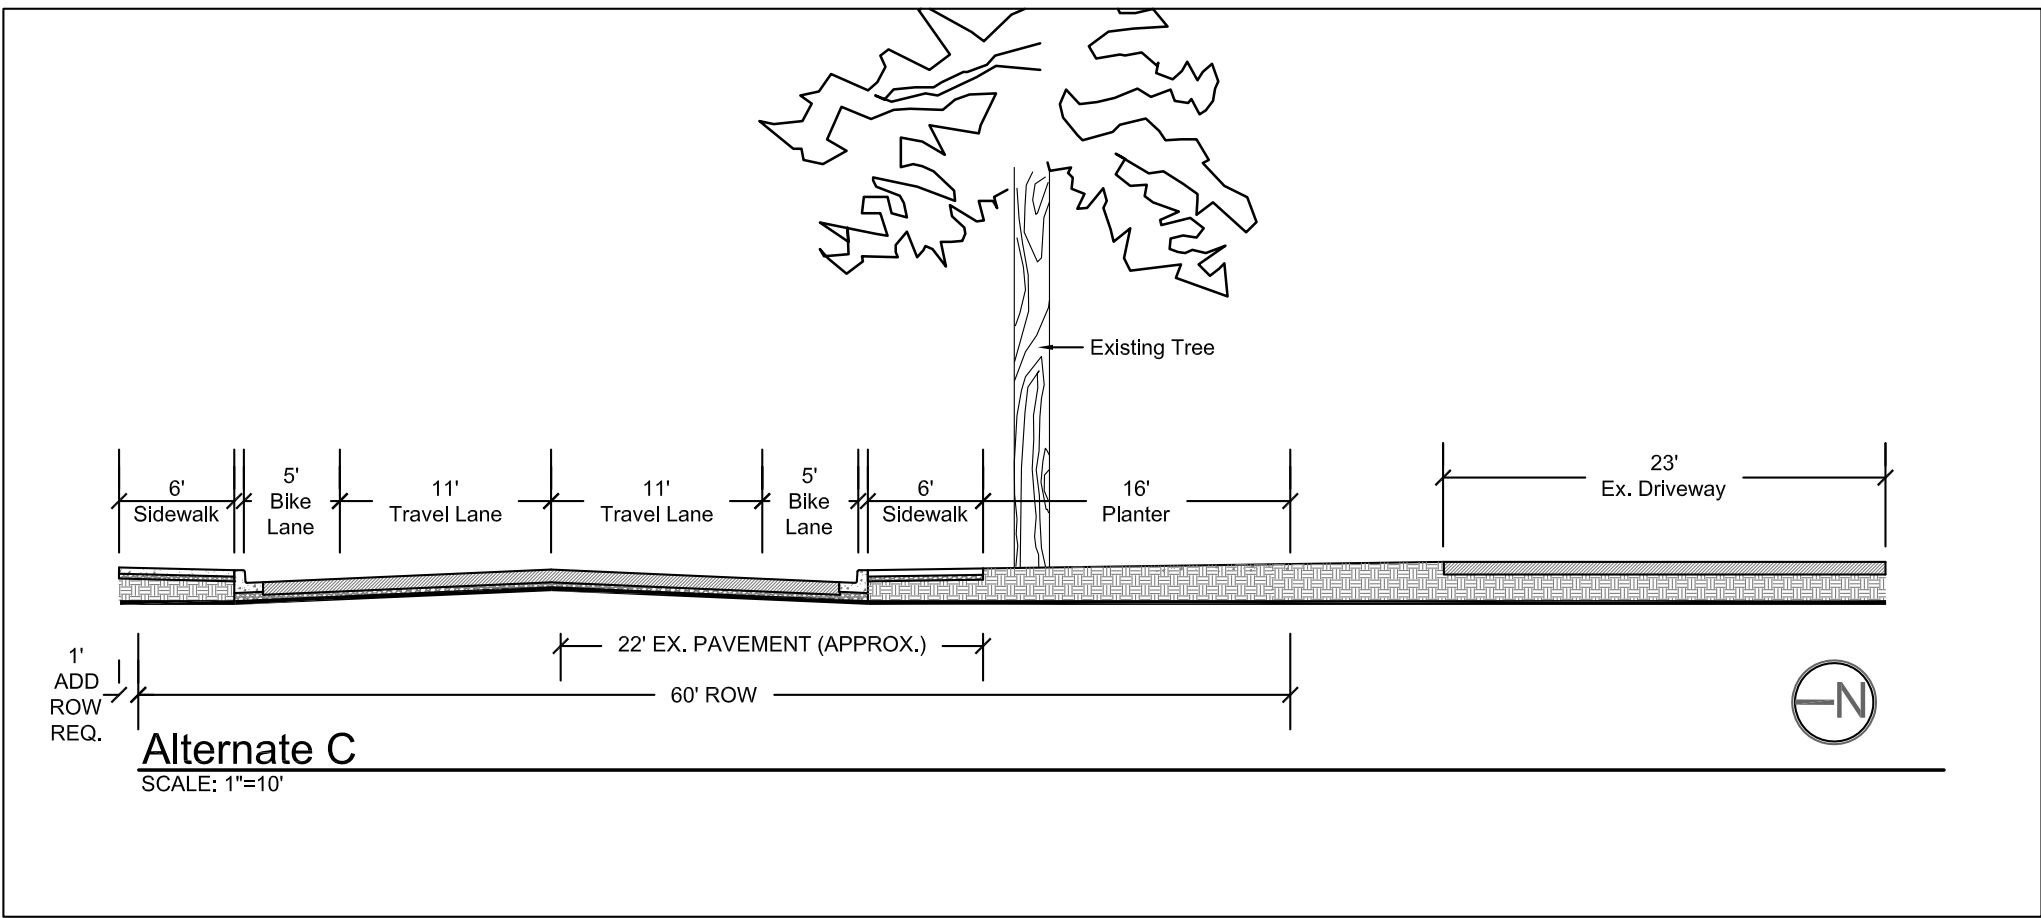
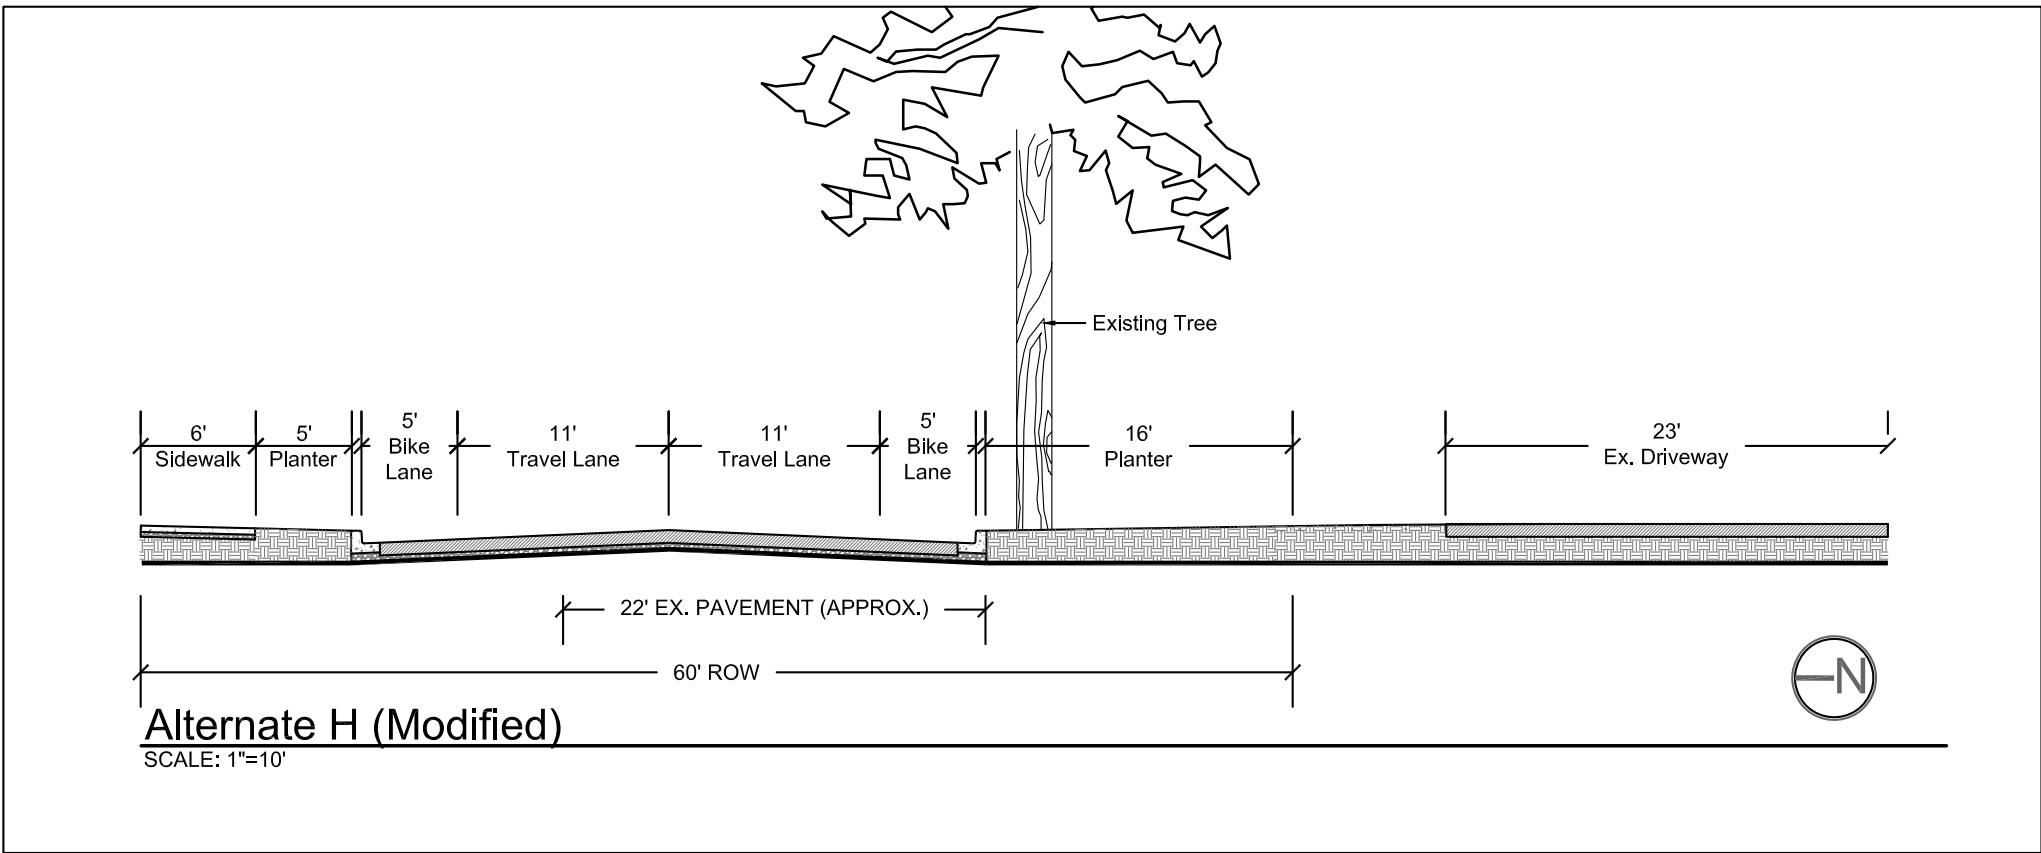
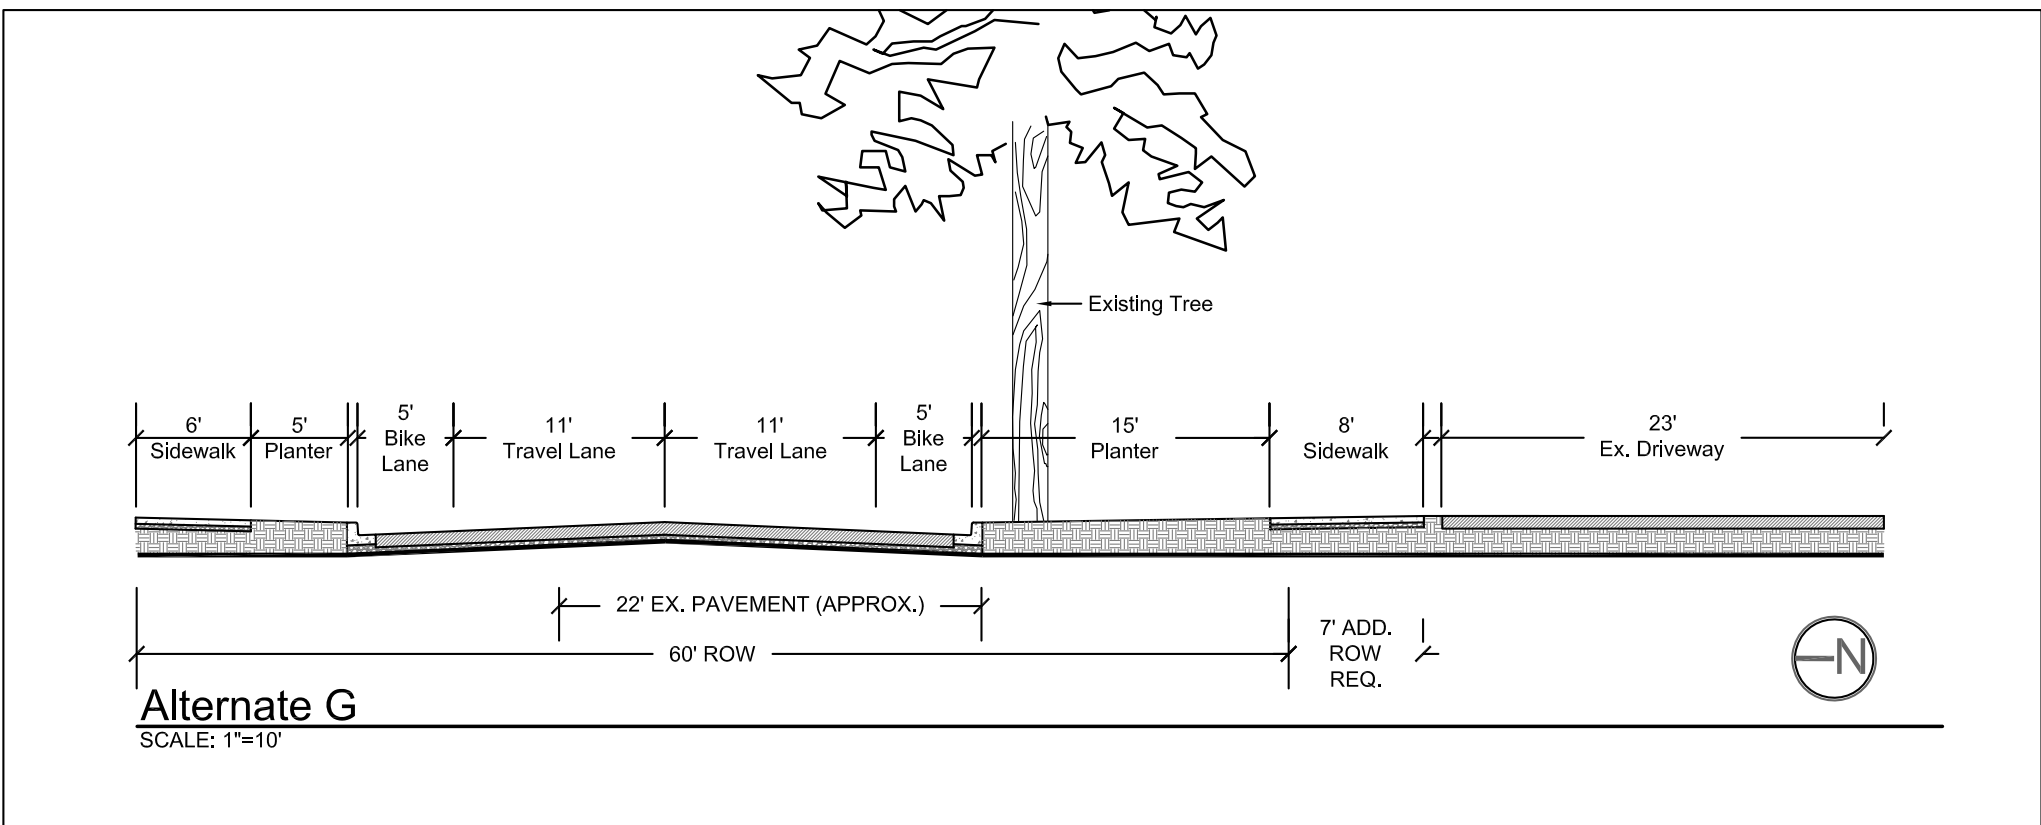
FYI, this is a follow-up to our meeting regarding this yesterday afternoon, according to my calculations, which are based on the survey work given to us by the applicant, in order to be able to construct cross section alternative "C" (with 6 foot sidewalks & 5 foot bike lanes on both sides of the road and an 11 foot travel lane in each direction, we need to get an additional 3 feet of ROW from the developer, which fits within the 3.5 feet required by our standard roadway cross section that you have already mentioned to the applicant that they would need to dedicate. My calculations assume that the back of walk on the south side of the street would be at the current edge of pavement location on the south side of the street and the cross section would go north from there. This would save any further encroachment into the unpaved area around the existing large trees on the south side of the street, which is what the arborist recommended that we do. This cross section is shown in yellow highlighting on the attached spreadsheet of possible roadway cross sections, as Cross Section Alternative "C". Thanks, John C.

After reviewing this report and per our discussion, I would recommend roadway cross section alternate C as shown on the attached drawing. This cross section allows for a sidewalk on both sides of SE 8th Street. It does eliminate the planter beds but with the heritage/landmark trees on the south side and wetlands on the north side I believe it's a reasonable compromise. This alternative does not propose additional impacts to the 27 trees and with the BMPS listed above they should continue to thrive after the improvements are complete.

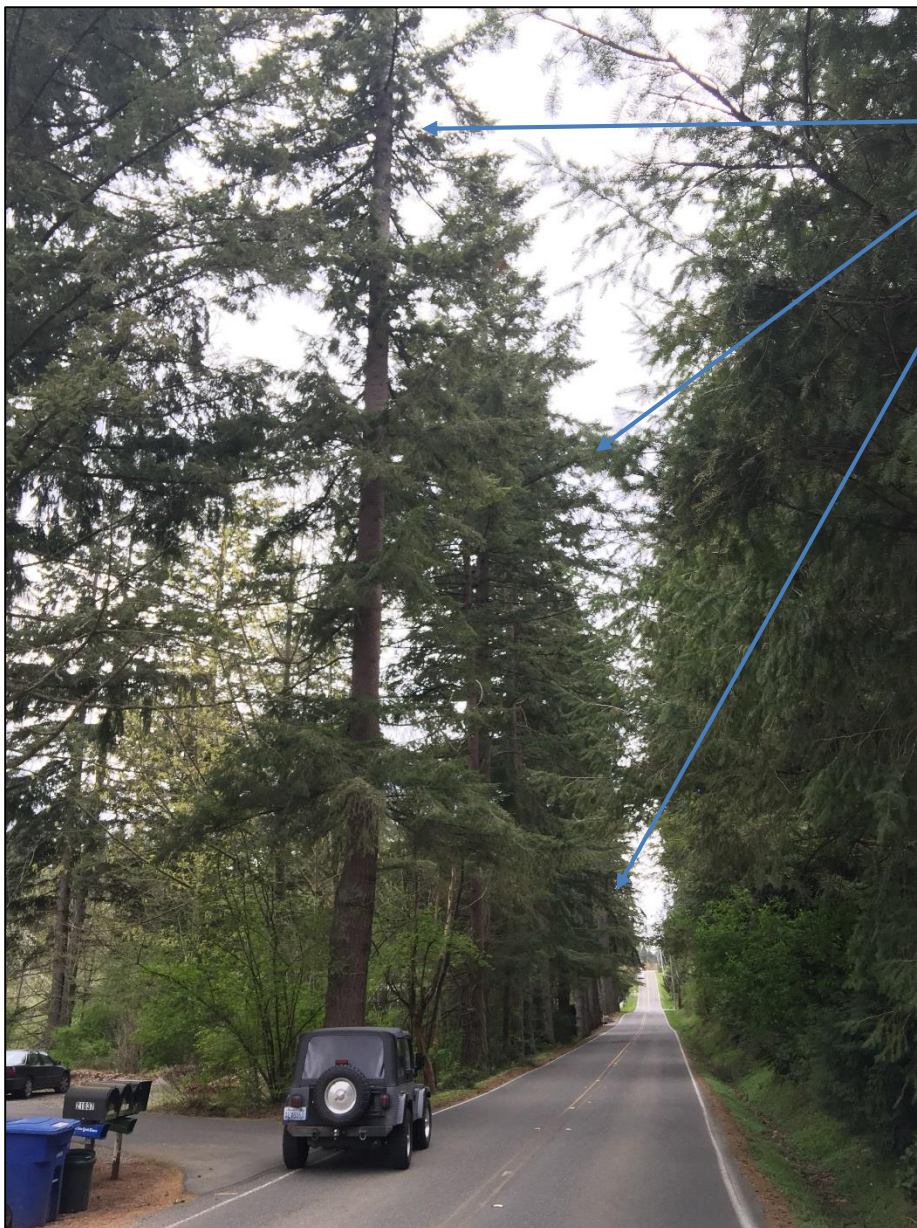
Photo # 1: Looking west along SE 8th Street at the row of Dir Trees.

Note the green canopy of the trees on both sides of the road at this point.

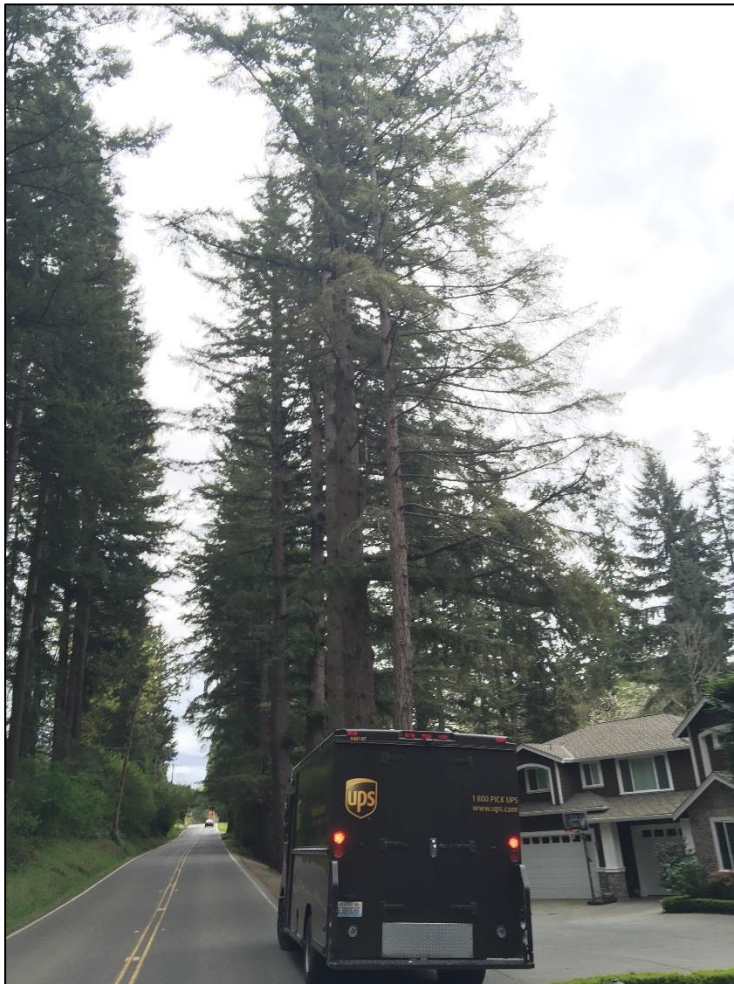
Photo # 2: Looking north from the driveway into 21415 SE 8th Street.

- There are several trees on either side of the driveway to 21415 SE 8th Street that appear to be in severe stress.
 - Their annual shoot elongation is very short for the species. Their foliage is chlorotic—pale yellowish in color. The foliage is thin or sparse. Their crowns are weak. These are all indications of decline.

Note the sparse and pale foliage on the first tree immediately north of the driveway. The tree is severely stressed and in decline. It may not be able to be saved.

I did not have enough time to perform any testing on the trees. However, as noted above, there are two trees that have signs and symptoms of root rot and internal trunk decay. Before a final determination is made on these two trees, should be tested. In addition, the trees on either side of the driveway to 21415 SE 8th Street, and the westernmost tree with the surface root that has some decay, should receive a Level Three Risk Assessment—that is they should all be tested to determine the extent of the decay. Once this is known, this will inform the decision to retain, shorten for safety, or remove completely for safety any of these few trees with indications of internal decay.

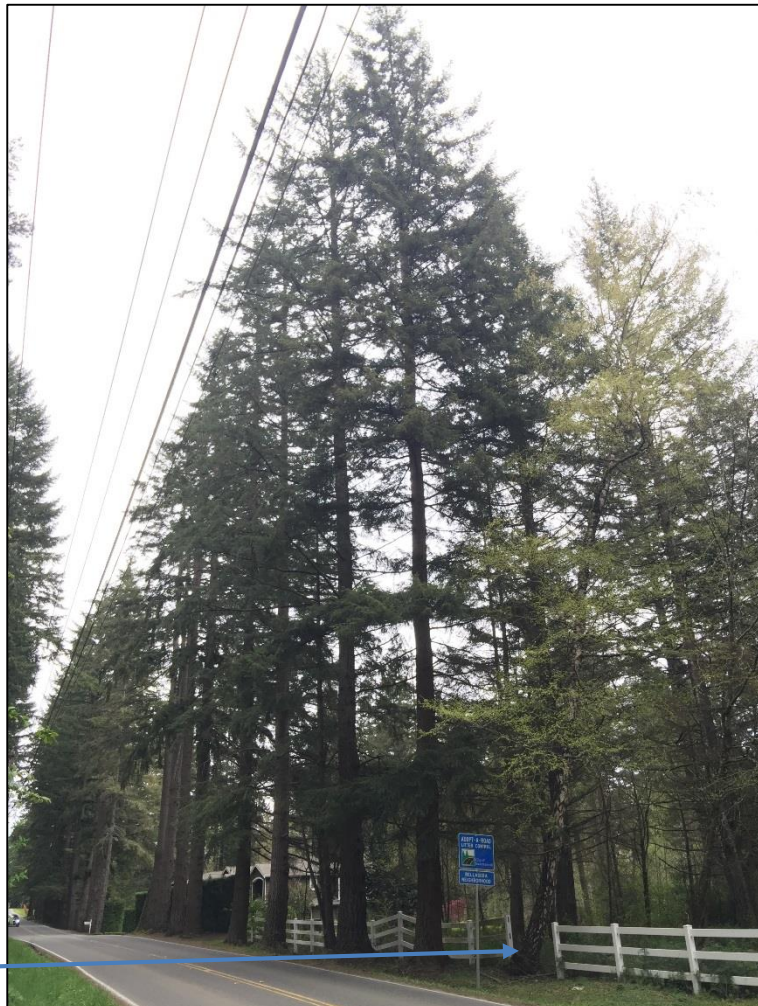
Photo # 3: Looking east from the westernmost tree—the Birch tree at the property line fence.

- The westernmost tree has one large buttress root growing to the west with damage to the top of the root.
 - There is some decay in the root.
- All of the trees are growing close to the edge of the pavement of the road.
 - This severely limits root growth to the north side of their trunks.
- Road Conditions:
 - The road asphalt of SE 8th Street is in rather good condition.
 - However, it is fairly oxidized.
 - This leads me to believe that the existing road conditions have been present for many years—possibly multiple decades.
 - This is important in that the latest road up-grade so close to the bases of such large trees is significant.
 - This indicates that the majority of the trees have adapted to the upgrade and are doing well.

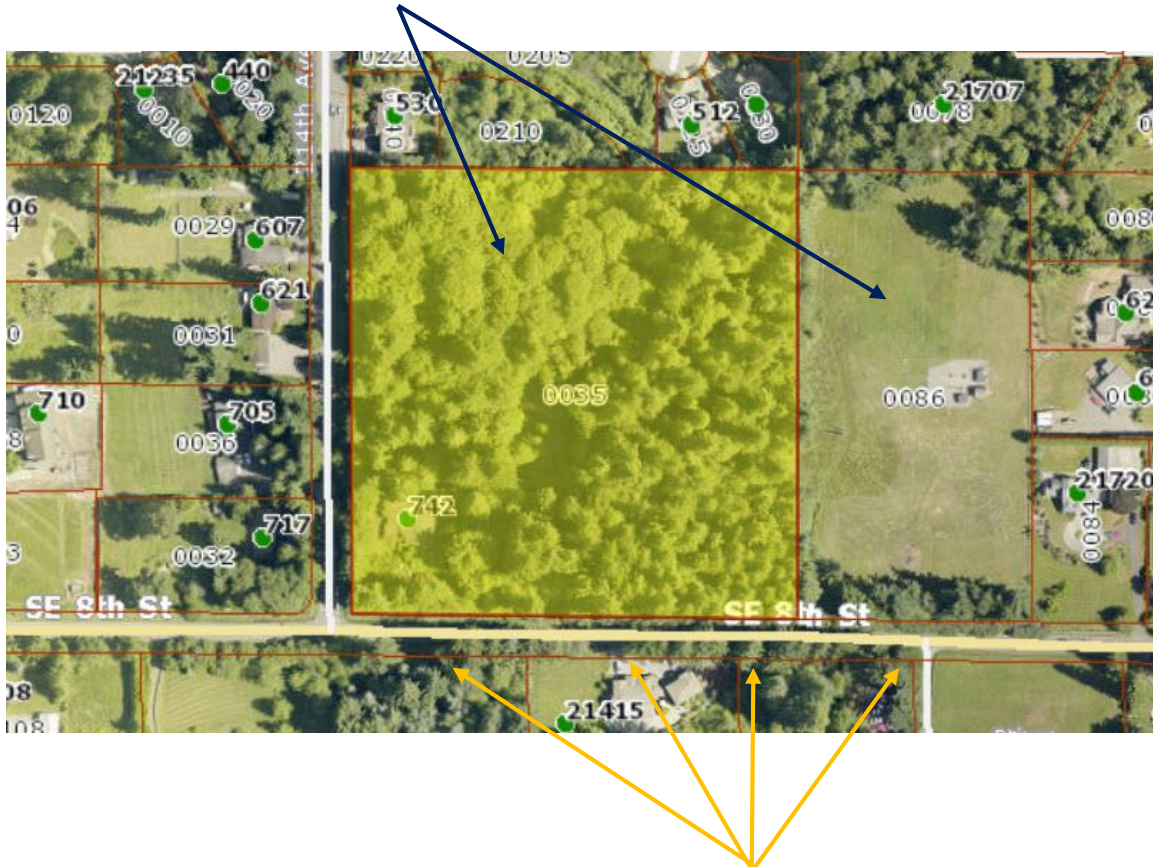
ATTACHMENT 1 - AERIAL PHOTO

Screen shot of an aerial photo showing the two properties that make up the Carrier Plat.
The project consists of these two properties.

The 27 trees evaluated are the row of right-of-way tree here between the south edge of the SE 8th Street pavement and the property lines of the adjacent properties.

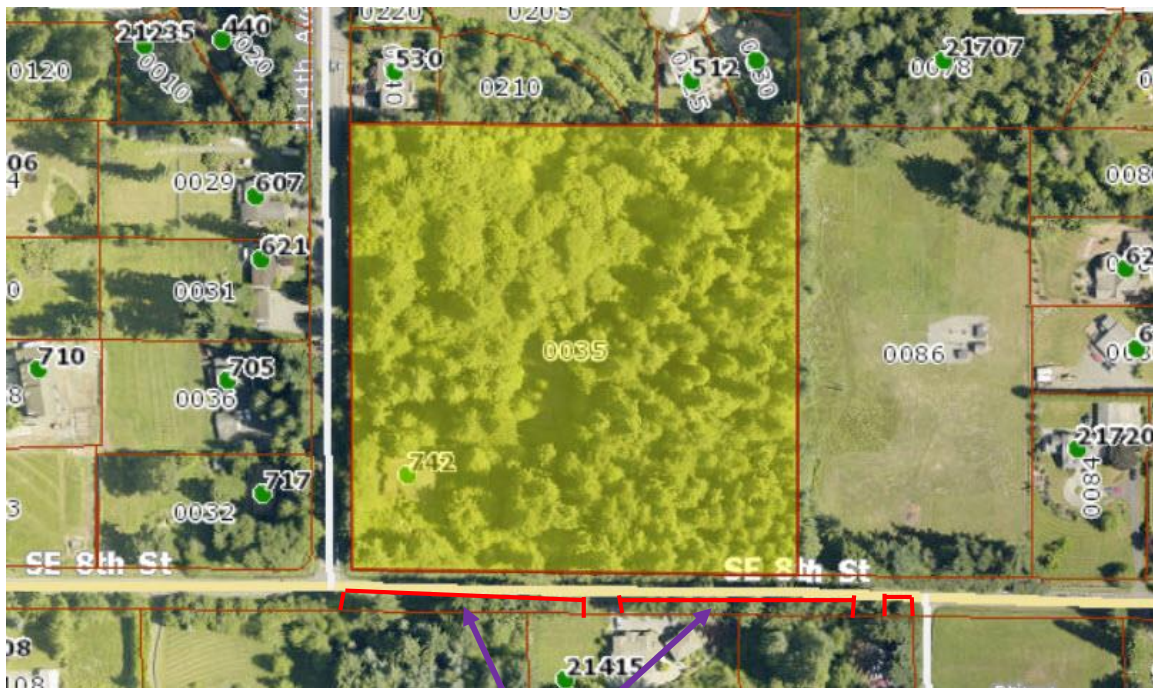
TREE PROTECTION FENCE LOCATIONS ———

Tree protection fences south of the south side of the road.

Tree protection in this case will consist mostly of placing *Tree Protection Fencing* immediately south of the south side of the existing pavement and protecting the trees from physical damage, root damage, and from cement trucks dumping waste on the critical root zones.
