Links to Documents related to East Lake Sammamish Trail, South Sammamish Segment B

TECHNICAL MEMORANDUM

DATE: February 26, 2015
TO: King County
FROM: Paul Fendt
SUBJECT: Evaluation of Existing Drainage Structures for Replacement in the South Sammamish Segment
CC: Craig Buitrago, Jenny Bailey
PROJECT NUMBER: 554-1521-075 (20/05)
PROJECT NAME: East Lake Sammamish Trail

DATE: May 18, 2015
TO: King County
FROM: Paul Fendt
SUBJECT: Evaluation of Existing Drainage Structures for Replacement in the South Sammamish Segment
CC: Craig Buitrago, Jenny Bailey
PROJECT NUMBER: 554-1521-075 (20/05)
PROJECT NAME: East Lake Sammamish Trail

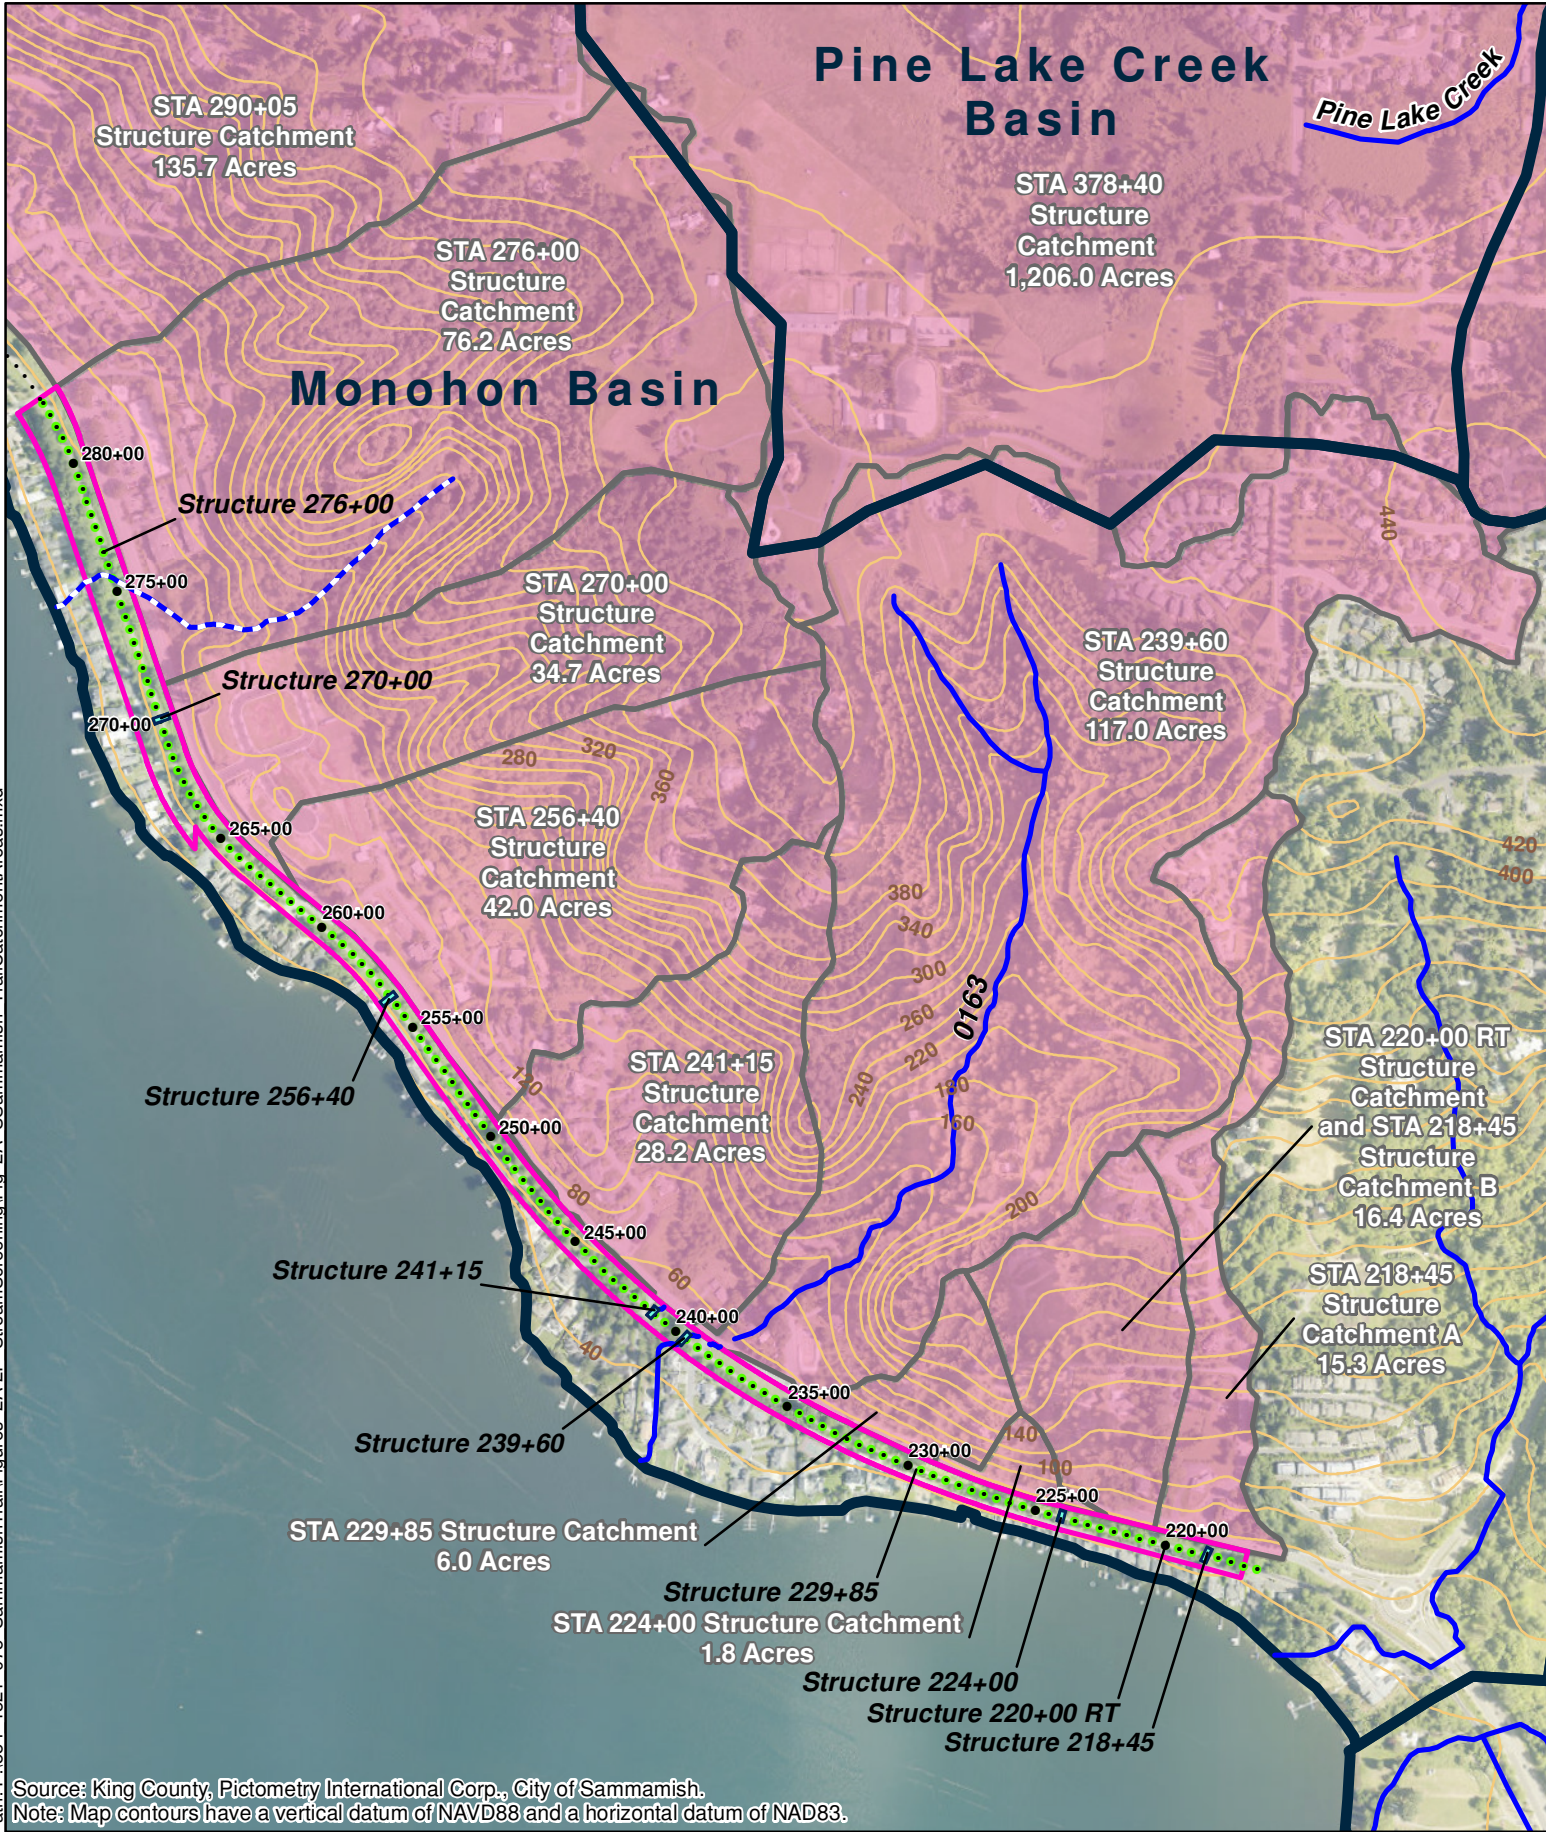
Figure 2A
Trail Drainage Structure
Catchment Areas

The primary indicator of a natural drainage basin used in the desk-top screen is the presence or absence of natural contours that would indicate a stream or drainage channel. The size of the drainage basins not meeting this screen is less than 32 acres for all but one structure; there are, however, some smaller basins showing contours indicating historic drainage. This initial screen includes no evaluation of annual flow regimes for small catchments, although very small and modified basins would be expected to have minimal flow, if any, during the dry season. Only those structures with no apparent historic streams or basins were screened out of further consideration for replacement; the basin size is used as an additional line of evidence that supports the exclusion. Table 1 lists the structures and the presence or absence of natural drainage basin characteristics along with the approximate drainage catchment area to each structure. Structures with no natural drainage basin are shown in red and will be removed from consideration for replacement. Figures 2A-2F show the approximate catchment areas to the trail structures.
