# LAUGHING JACOBS BASIN PLAN

**City of Sammamish**  
801 228th Ave. SE  
Sammamish, Washington 98075

Geosyntec Consultants, Inc  
520 Pike Street, Suite 2600  
Seattle, Washington 98101

May 10, 2022

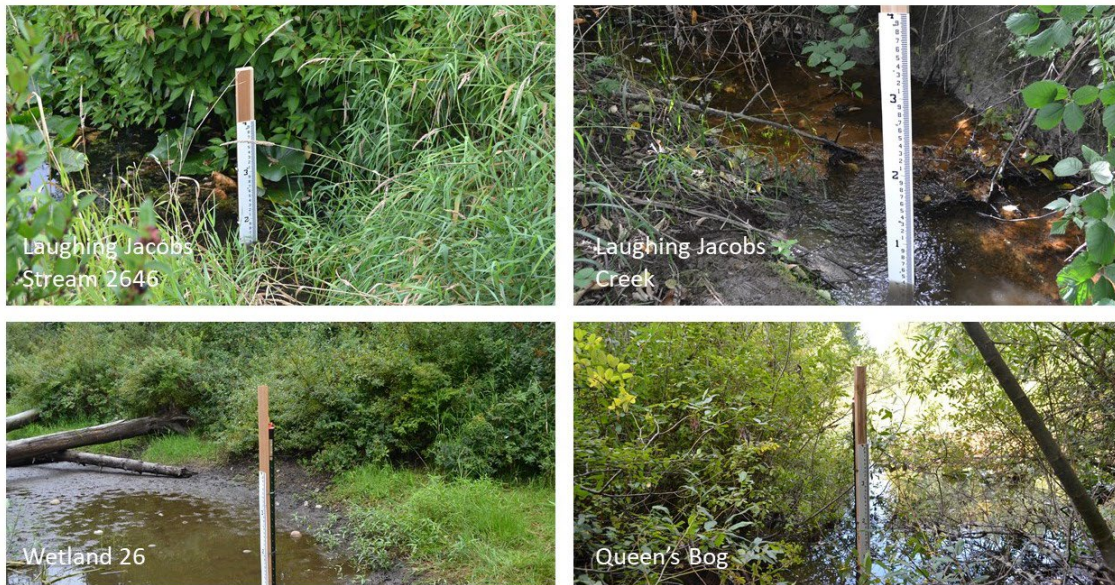
Figure 4-2. Monitoring Stations

Each of the four monitoring stations included a rigid wood and metal frame with a locked stilling well to house monitoring equipment, a staff plate for manual water level

measurements, and a forked structure to insert into the ground for stability. Photographs of each location are provided in Figure 4-2.

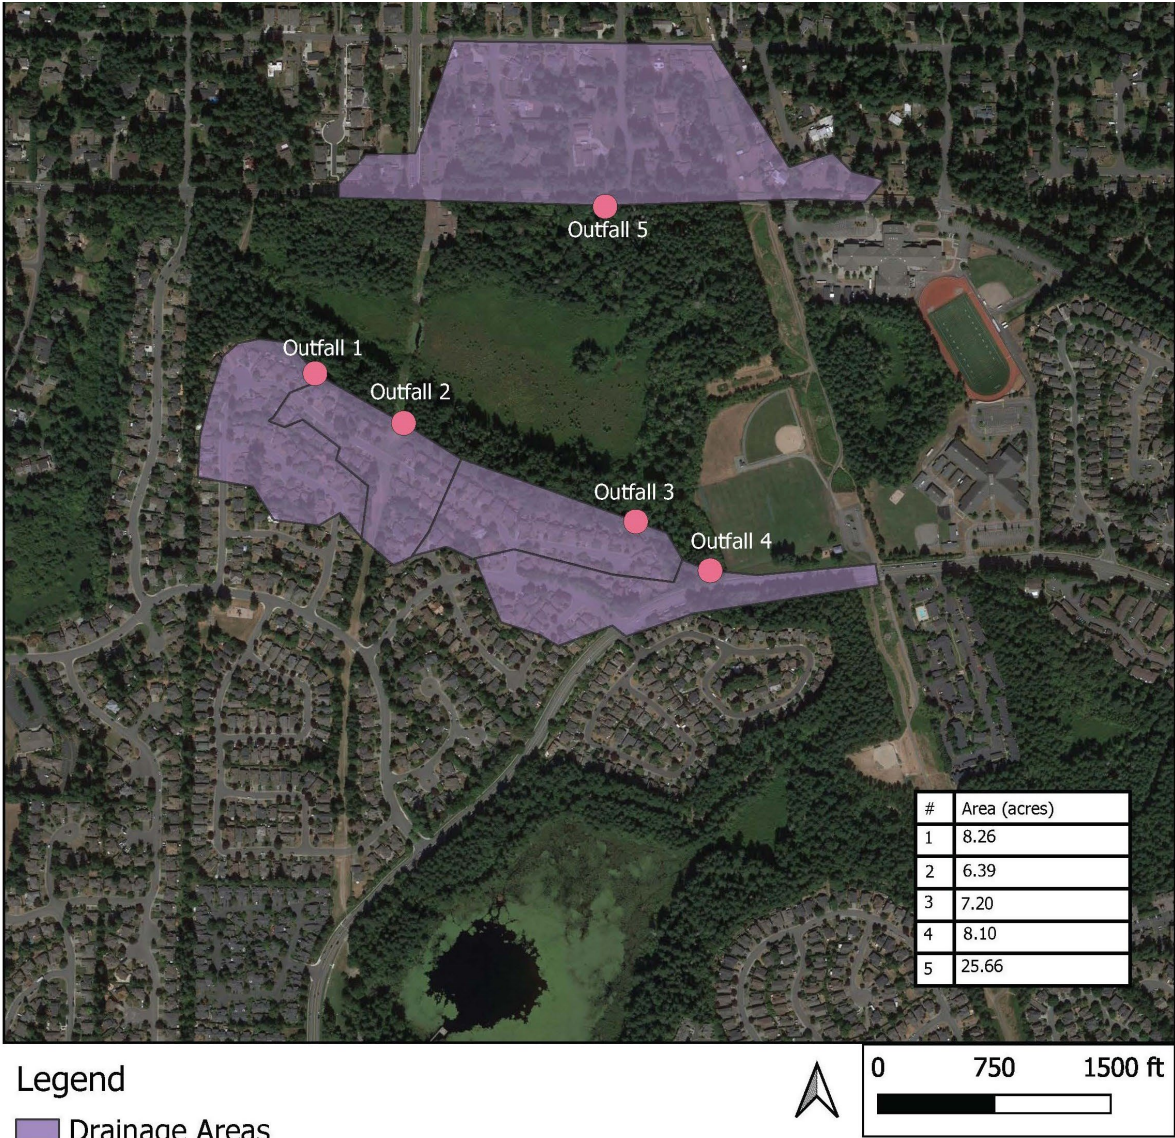
Figure 6-1. Queen’s Bog Drainage Areas

some level of stormwater treatment and are excluded from the bioretention sizing analysis (Outfalls 2 and 4 in Figure 6-2).

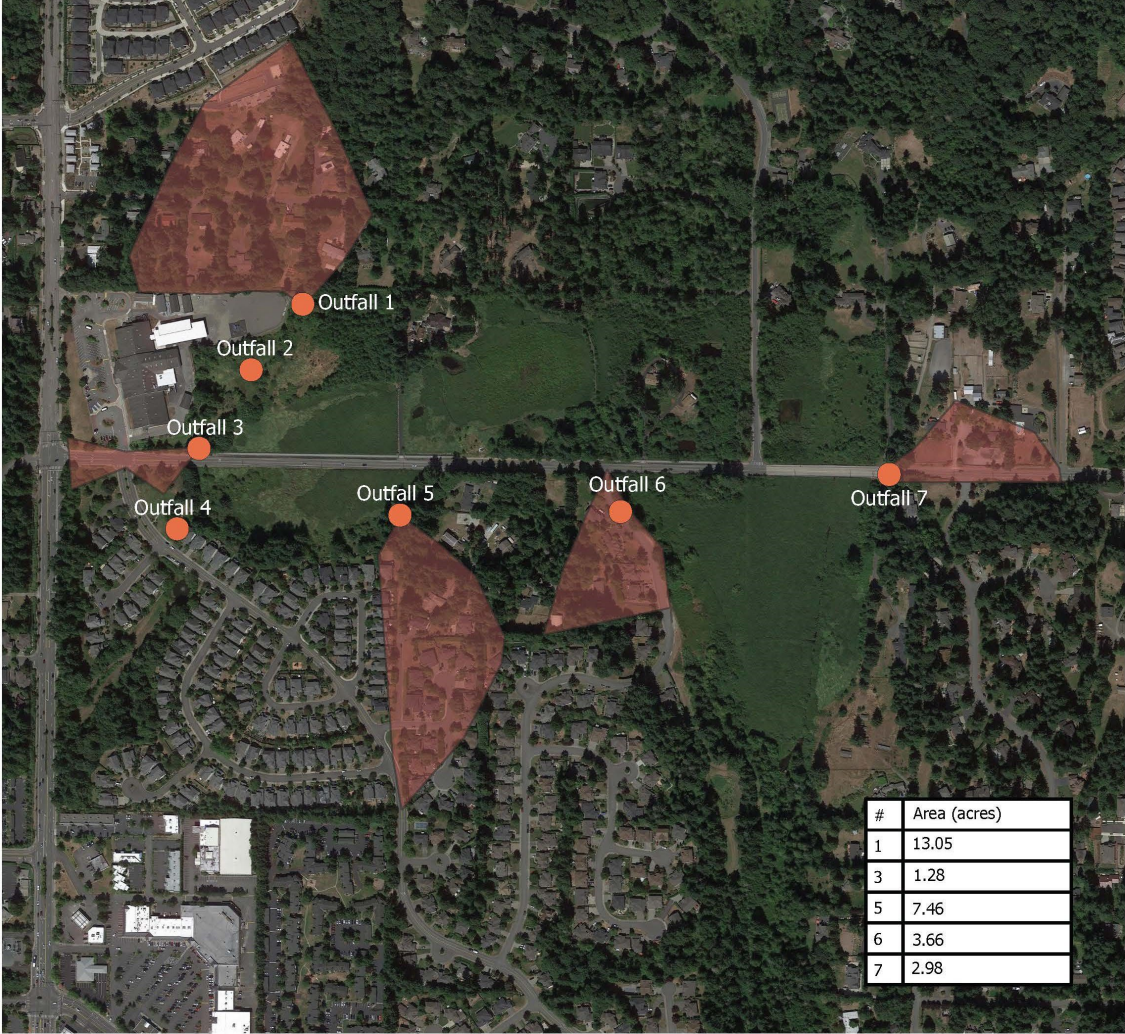
Bioretention areas were sized to treat the drainage area tributary to the discharge location indicated in Figure 6-1. Placement upgradient of the discharge location was not considered for modeling; however, bioretention area footprints may be optimized if not placed at the discharge location.

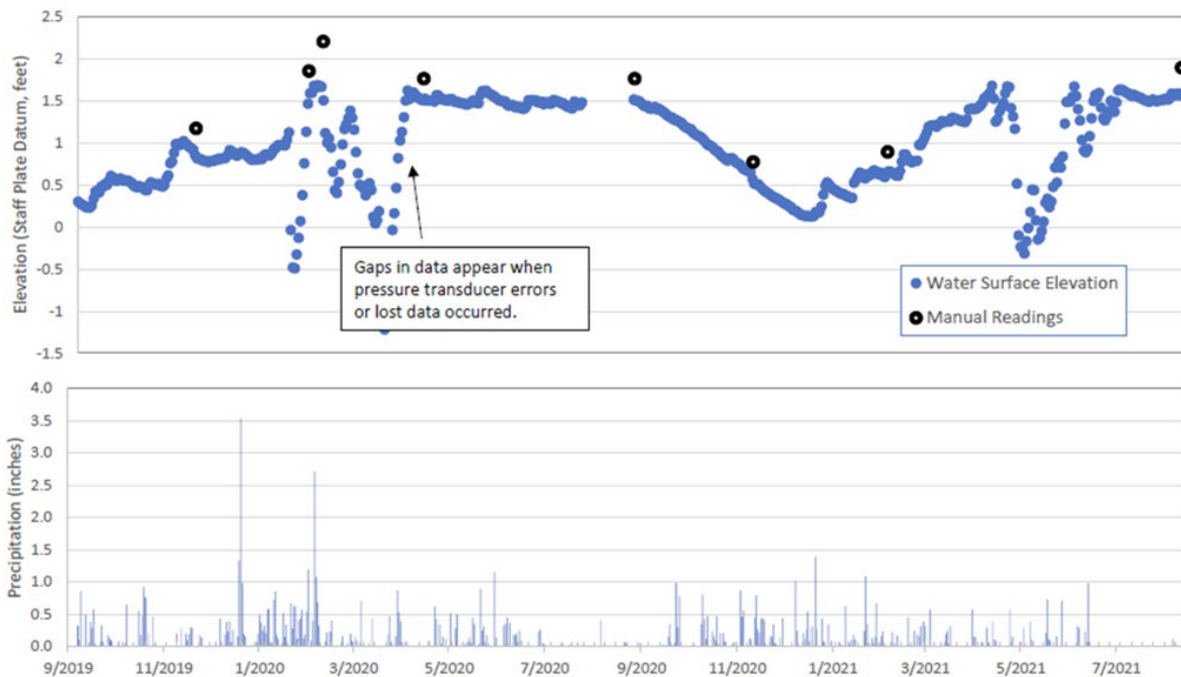
Figure 6-4. Measured Water Surface at Queen’s Bog

Manual readings were used to correct monitoring data to provide a continuous record of water surface elevations in Queen’s Bog. This record is shown in Figure 6-4.

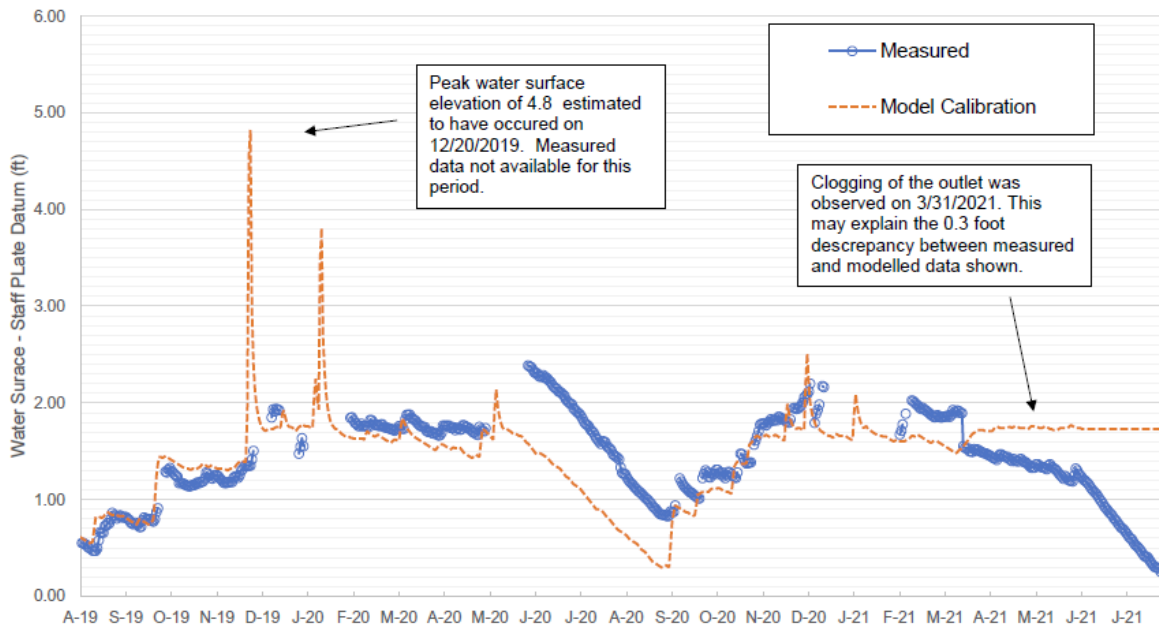
Figure 6-5. Water Balance Calibration

rainfall in the previous 5 days. The calibration results, which were completed in March 2021, are shown in Figure 6-5.

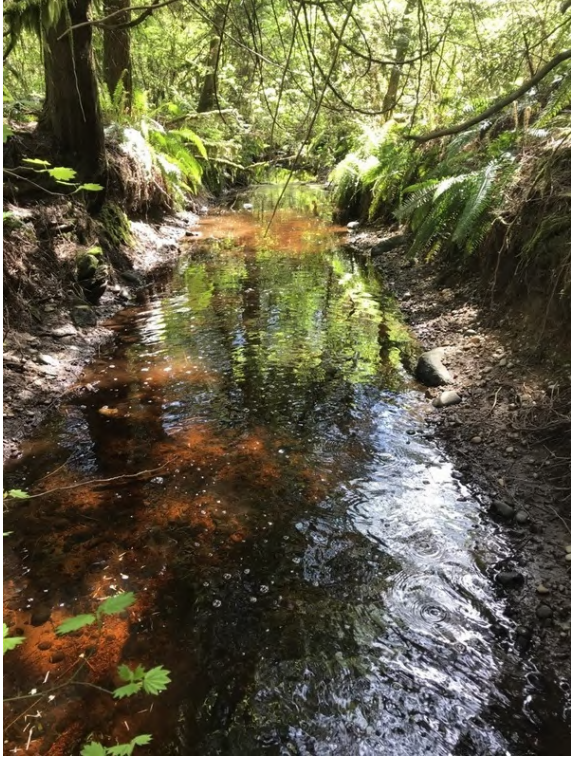
*Photo 5. The creek upstream of SE 32<sup>nd</sup> Way has been artificially straightened and is confined due to three to four feet of channel incision which severely limits floodplain connectivity.*

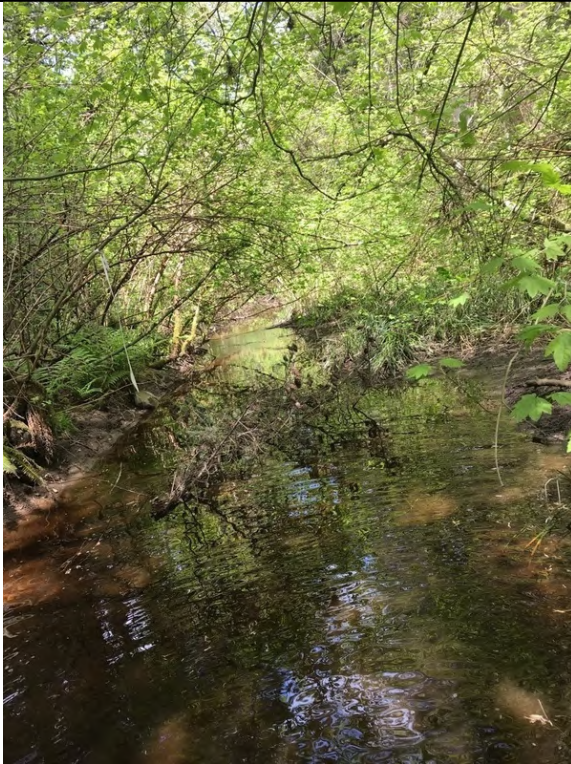
*Photo 6. Downstream of SE 32<sup>nd</sup> Way, the creek widens and shallows and has low, gradual banks with good floodplain access.*

The stream crosses under SE 32<sup>nd</sup> Way in 6.5-foot by 5.-foot corrugated aluminum squash culvert (WDFW Site ID 920029, see Appendix C for details) that is 100 percent passable (WDFW, 2019c). Downstream of SE 32<sup>nd</sup> Way, the stream has a bankfull width of approximately 26 feet (Photo 6). The stream appears to be stable and bank erosion was not observed. Morphology downstream is primarily a glide, although some riffles and pools are present. Small stream-side riparian wetlands are present downstream of the culvert. Low, gradual banks provide floodplain access, and there are some high flow channels. Stream substrate is generally silt and sand with a few gravels smaller than three-quarters of an inch in diameter, with a median grain size of sand. Riparian habitat for

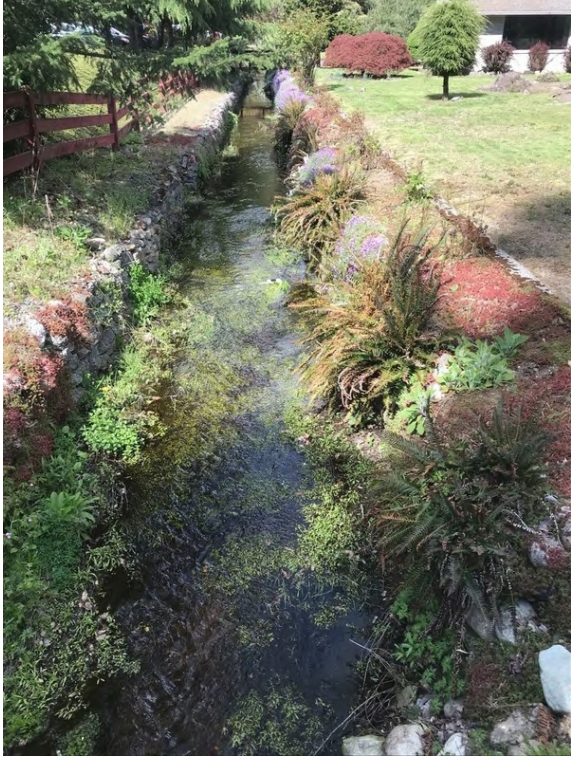
*Photo 7. Immediately upstream of the Issaquah-Pine Lake Road SE culvert, the creek is channelized and has armored banks between a residence and the Lakeside Montessori School.*

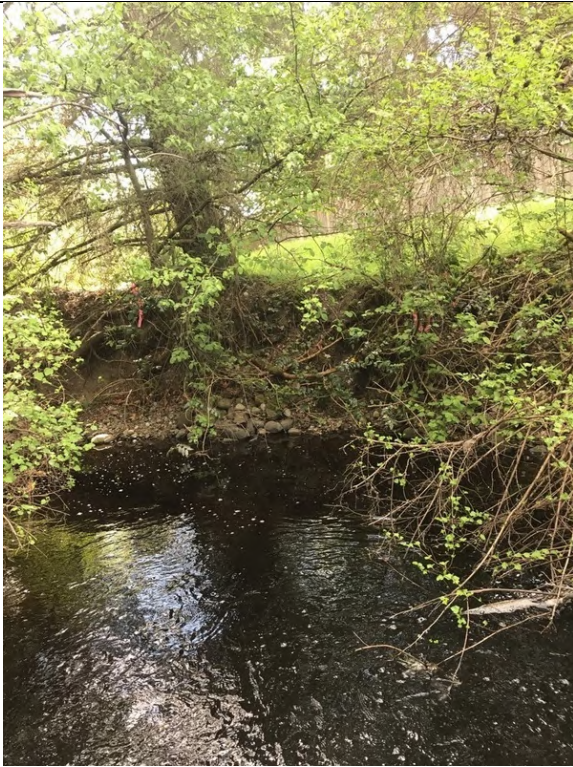
*Photo 10. Immediately downstream of the Issaquah-Pine Lake Road SE culvert, the creek is incised with tall, steep banks and erosion has undercut tree roots.*

Downstream of the Issaquah-Pine Lake Road SE culvert, bankfull widths are on the order of 10.5 to 12 feet. Some bank erosion occurs immediately downstream of the culvert, where there are incised, steep banks and erosion has undercut tree roots (Photo 10). Morphology downstream of the culvert is pool-riffle and only small amounts of large wood are present. Once outside of the culvert influence, streambanks are approximately 2 feet tall and provide some floodplain connectivity (Photo 11). Stream substrate is generally pebble to up to 6-inch cobbles with a median diameter of about 1 inch. Embeddedness is generally low. A second culvert conveys the creek downstream of the Issaquah-Pine Lake Road SE culvert. Substrate below this lower culvert is generally sand to three-quarter-inch gravel, with low to moderate embeddedness. Prior to entering Laughing Jacobs Lake, the stream flows through a large wetland complex on the northeast side of the lake.

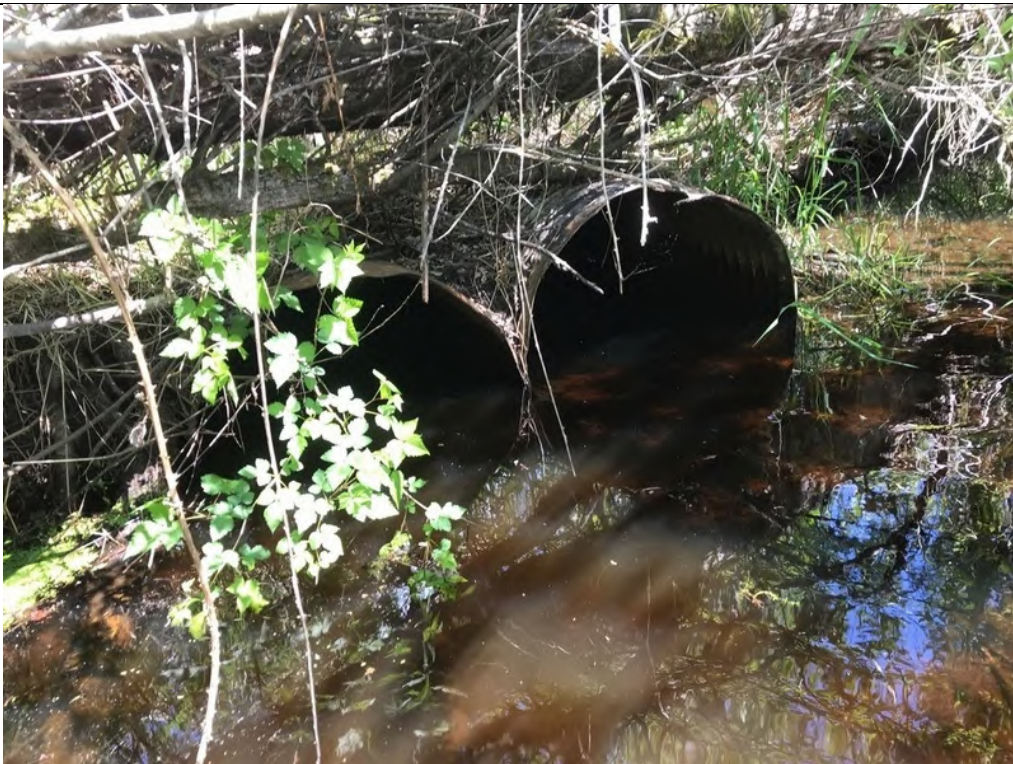
*Photo 12. View of downstream side of culverts under SE 42<sup>nd</sup> Street.*

The stream crossing under SE 42<sup>nd</sup> Street (WDFW Site ID 920026, see Appendix C for details) consists of twin round metal pipes and has been assessed by WDFW as having unknown barrier status (WDFW, 2019c) (Photo 12). In the vicinity of the crossing, the stream typically has a bankfull width on the order of approximately 12 to 13 feet, but was approximately 17 feet downstream of the SE 42<sup>nd</sup> Street culvert. The creek has a gentle gradient in this reach, typically less than 1 percent, and is generally a slow-moving glide or run (Photo 13). Upstream of the SE 42<sup>nd</sup> Street culvert, the reach is incised with a poor connection to its floodplain due to channelization. The connection to the floodplain is generally better downstream of the SE 42<sup>nd</sup> Street culvert. Large wood is present in minor amounts and is typically less than 4 inches in diameter. One small wetland was observed near the pedestrian bridge next to the road.

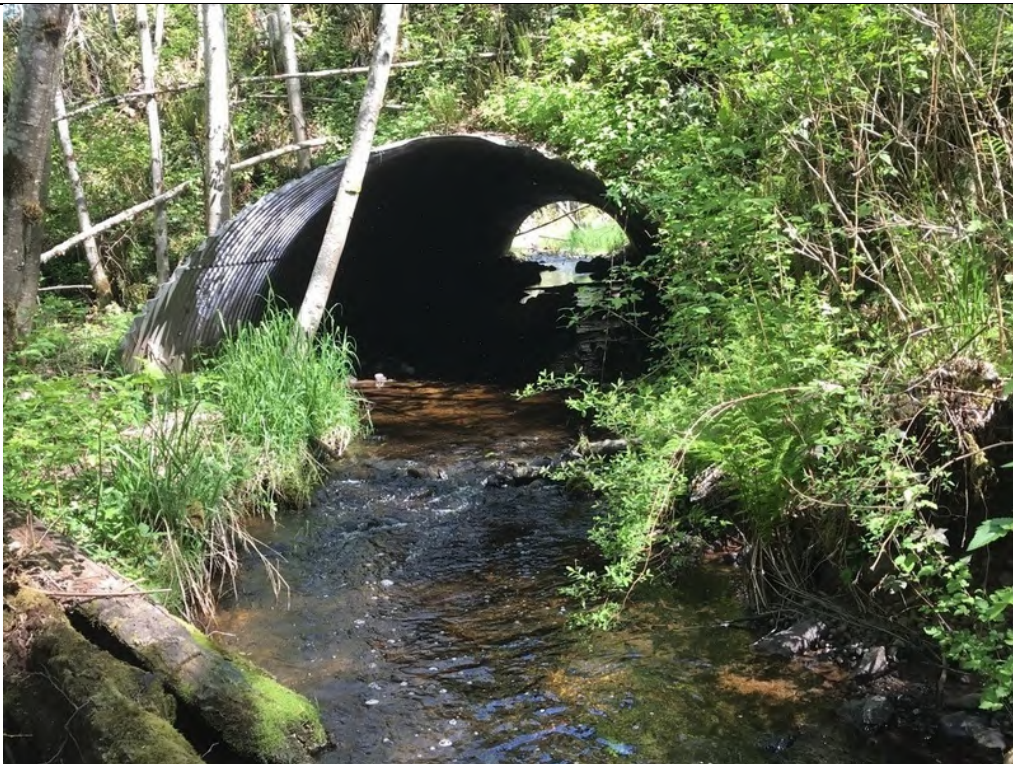
*Photo 14. 230<sup>th</sup> Way SE culvert crossing, looking upstream.*

The lower portion of the middle mainstem, in the vicinity of 230<sup>th</sup> Way SE, has a bankfull width on the order of approximately 15 feet and a gentle gradient typically less than 1 percent. The culvert crossing (WDFW Site ID 920025, see Appendix C for details) is a large bottomless half pipe, which is fully fish passable (WDFW, 2019c) (Photo 14). Two years ago, there was a beaver dam on the upstream side of the 230<sup>th</sup> Way SE culvert, although it is no longer present (personal communication, Danika Globokar, City of Lake Sammamish, April 29, 2019). This reach appears to be stable and only minor erosion of the natural streambanks was observed. Upstream of the crossing, the stream flows through a broad (50-foot-wide) valley bottom reed canarygrass wetland that extends several hundred feet upstream of the crossing (Photo 15). The valley bottom wetland shows signs (dead trees and wrack) indicating at least somewhat frequent overbank inundation.

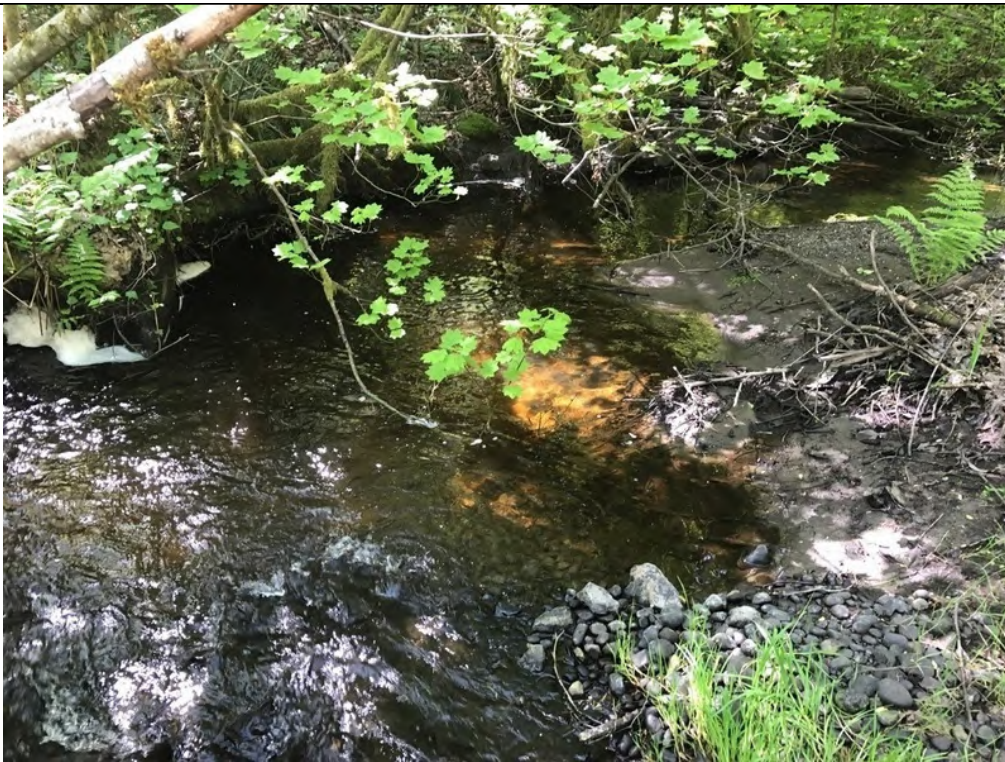
*Photo 16. Laughing Jacobs Creek downstream of 230<sup>th</sup> Way SE culvert.*

There is pool-riffle morphology immediately downstream of the SE 230<sup>th</sup> Way SE culvert, with high quality spawning habitat, but it transitions back to glide morphology shortly downstream (Photo 16). There is very little wood, and it is generally small wood less than 2 inches in diameter. In this area, the stream is well connected to its floodplain; banks are generally 1 to 2 feet high. There are two minor high water channels shortly downstream of the 230<sup>th</sup> Way SE culvert. Bed material generally ranges from sand to small gravels up to approximately three-quarters of an inch in diameter. Gravels are approximately 50 percent embedded in sand. An exception to this is that coarser cobbles up to 8 inches in diameter are present immediately downstream of the 230<sup>th</sup> Way SE culvert.

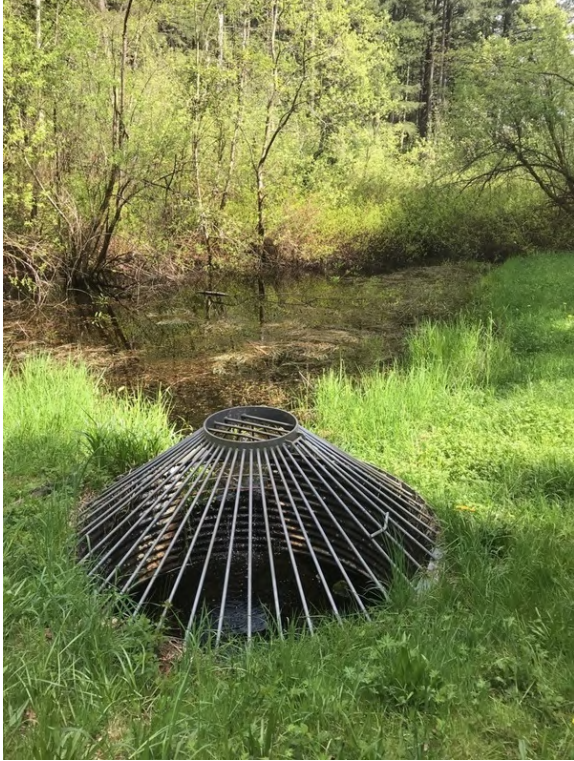
*Photo 19. An eight-foot-diameter standpipe with a debris rack (birds nest) controls the flow of water from Queens Bog west into the upper reaches of the stream.*

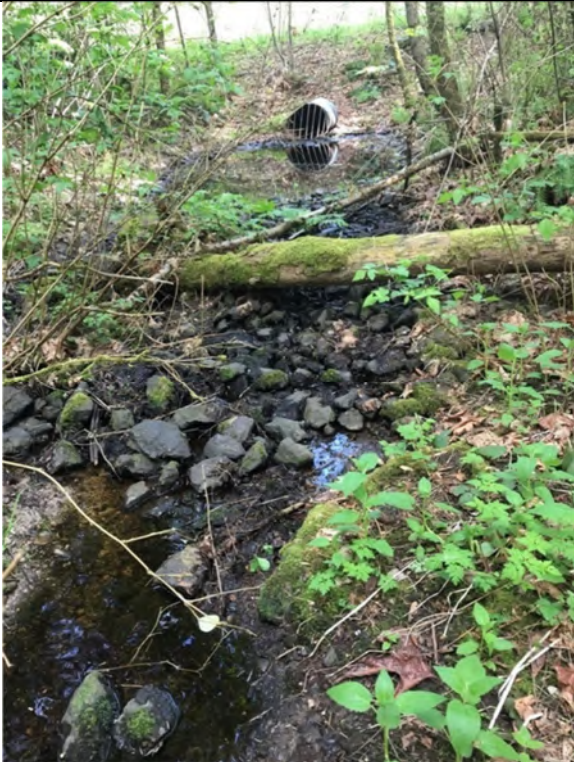
*Photo 20. Headwaters of East Tributary at Klahanie Park wetlands; trail crossing is a fish passage barrier.*

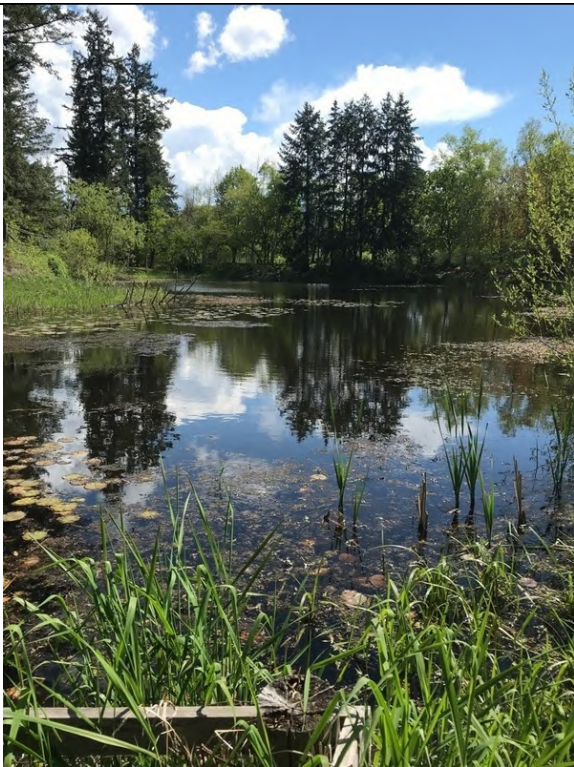
*Photo 22. Upstream of Issaquah-Pine Lake Road SE, the South Tributary headwaters are a series of three open-water wetlands/stormwater ponds connected by culverts and water control structures.*

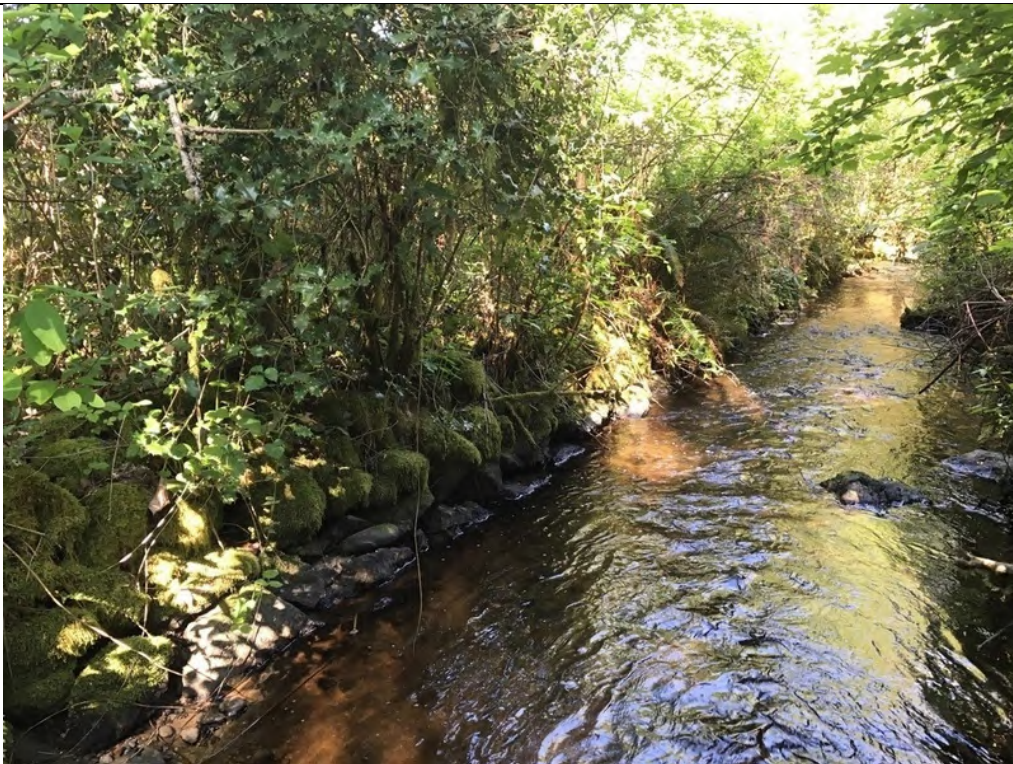
*Photo 30. The channel in this reach has been straightened and approximately fifty percent of the banks in this reach have riprap armoring.*

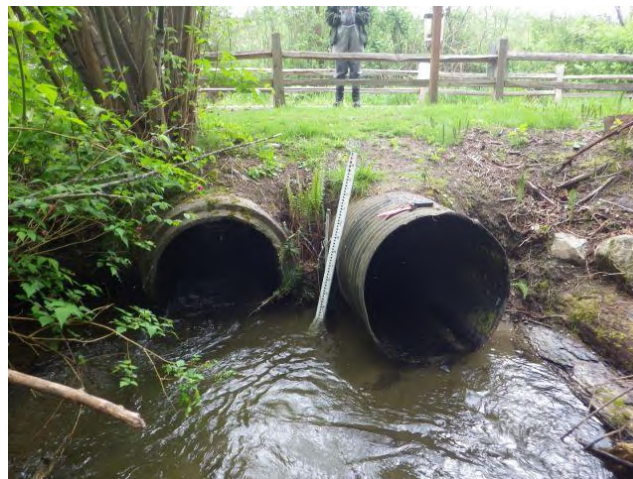
<b>Assessment Results</b>			
Barrier:	<input type="text" value="Yes"/>	Passability (%):	<input type="text" value="33"/>
Reason:	<input type="text" value="Other"/>	Fishway Present:	<input type="text" value="No"/>
		Method:	<input type="text" value="Other"/>
		Recheck:	<input type="text"/>

<b>Comments</b>
Last segment of 2.2 detached - grade break. Culvert 1.2 33% passable depth barrier at time of assessment - likely 0% passable during low flow. Culvert 2.2 33% passable slope barrier.

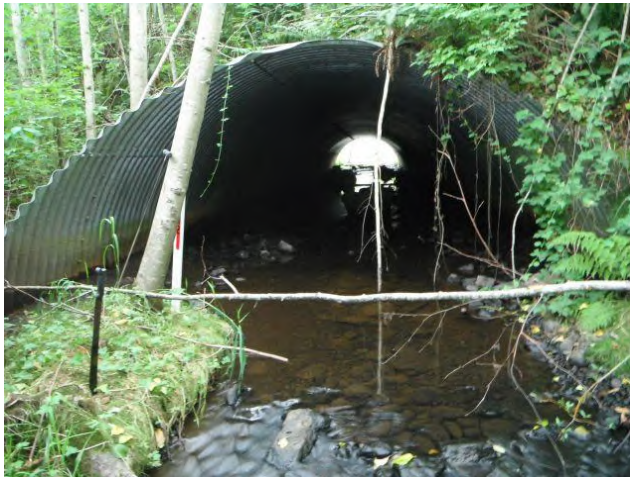
<b>Channel Description</b>	
Toe Width (m):	<input type="text"/>
Average Width (m):	<input type="text" value="5.54"/>
Culvert/Stream Width Ratio:	<input type="text" value="1.03"/>
<b>Plunge Pool</b>	
Length (m):	<input type="text" value="-999.99"/>
Max Depth (m):	<input type="text" value="-99.99"/>
OHW Width (m):	<input type="text" value="-999.99"/>
<b>Road</b>	
Fill Depth (m):	<input type="text" value="10.00"/>

<b>Assessment Results</b>			
Barrier:	<input type="text" value="No"/>	Passability (%):	<input type="text" value="100"/>
Reason:	<input type="text" value="N/A"/>	Fishway Present:	<input type="text" value="No"/>
		Method:	<input type="text" value="Level A"/>
		Recheck:	<input type="text"/>

<b>Comments</b>
Large woody debris anchored inside of pipe with rebar. Pipe beveled at both ends.

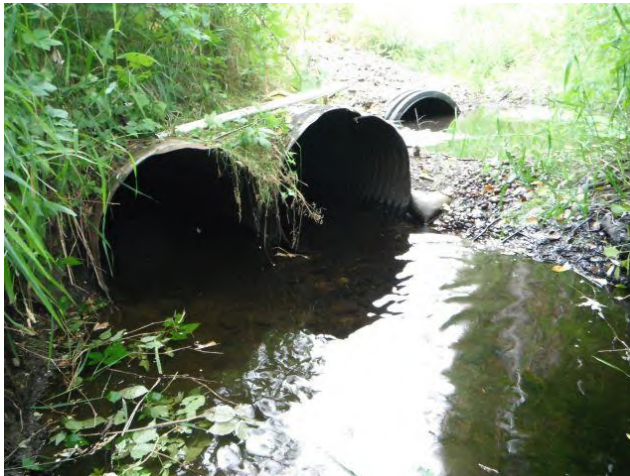
<b>Channel Description</b>	
Toe Width (m):	<input type="text"/>
Average Width (m):	<input type="text" value="4.58"/>
Culvert/Stream Width Ratio:	<input type="text" value="0.40"/>
<b>Plunge Pool</b>	
Length (m):	<input type="text" value="-999.99"/>
Max Depth (m):	<input type="text" value="-99.99"/>
OHW Width (m):	<input type="text" value="-999.99"/>
<b>Road</b>	
Fill Depth (m):	<input type="text" value="2.50"/>

<b>Assessment Results</b>			
Barrier:	<input type="text" value="Unknown"/>	Passability (%):	<input type="text" value="Unknown"/>
Reason:	<input type="text" value="Level B Required"/>	Fishway Present:	<input type="text" value="No"/>
		Method:	<input type="text" value="Level A"/>
		Recheck:	<input type="text"/>

<b>Comments</b>
Boulder headwall at upstream end. Some sandbagging along channel at downstream end. Level B recheck required to assess passability.

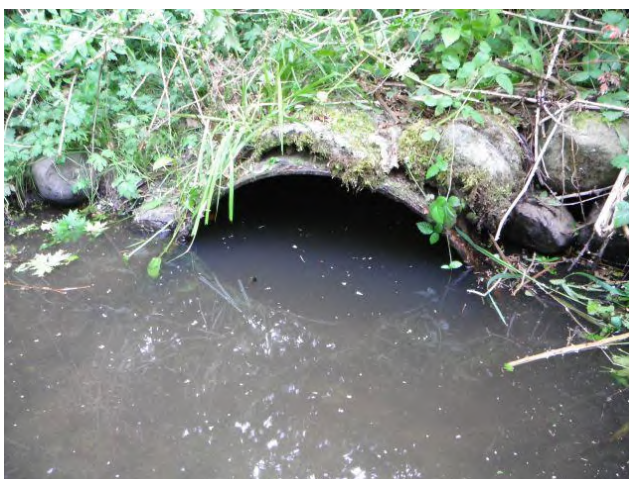
<b>Channel Description</b>	
Toe Width (m):	<input type="text"/>
Average Width (m):	<input type="text" value="3.92"/>
Culvert/Stream Width Ratio:	<input type="text" value="0.21"/>
<b>Plunge Pool</b>	
Length (m):	<input type="text" value="-999.99"/>
Max Depth (m):	<input type="text" value="-99.99"/>
OHW Width (m):	<input type="text" value="-999.99"/>
<b>Road</b>	
Fill Depth (m):	<input type="text" value="4.50"/>

<b>Assessment Results</b>			
Barrier:	<input type="text" value="Yes"/>	Passability (%):	<input type="text" value="33"/>
Reason:	<input type="text" value="Undersized"/>	Fishway Present:	<input type="text" value="No"/>
		Method:	<input type="text" value="Professional Judgment"/>
		Recheck:	<input type="text"/>

<b>Comments</b>
0.84m SST at downstream end, 0.46m PCC at upstream end. Several generations of overflow pipes found draining pond into stormwater management systems. Boulder headwall at downstream end. Beaver deciever device at upstream end (pond).

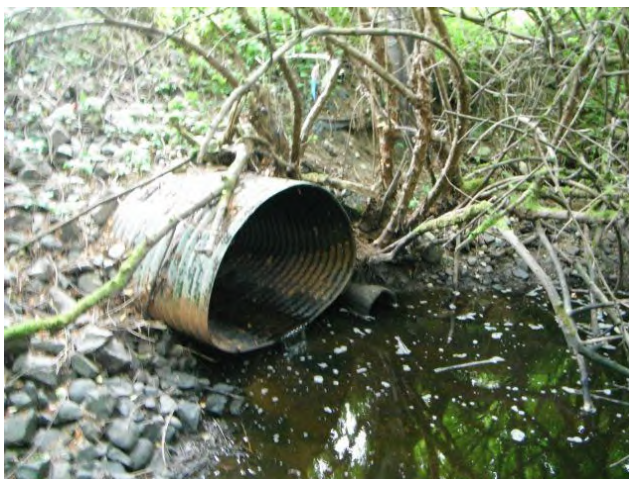
<b>Channel Description</b>	
Toe Width (m):	<input type="text"/>
Average Width (m):	<input type="text" value="3.82"/>
Culvert/Stream Width Ratio:	<input type="text" value="0.37"/>
<b>Plunge Pool</b>	
Length (m):	<input type="text" value="-999.99"/>
Max Depth (m):	<input type="text" value="-99.99"/>
OHW Width (m):	<input type="text" value="-999.99"/>
<b>Road</b>	
Fill Depth (m):	<input type="text" value="3.00"/>

<b>Assessment Results</b>			
Barrier:	<input type="text" value="Yes"/>	Passability (%):	<input type="text" value="0"/>
Reason:	<input type="text" value="Slope"/>	Fishway Present:	<input type="text" value="No"/>
		Method:	<input type="text" value="Level A"/>
		Recheck:	<input type="text"/>

<b>Comments</b>
Stacked stone headwall at upstream end of pipe. Small pond at downstream end of pipe, no plunge pool.

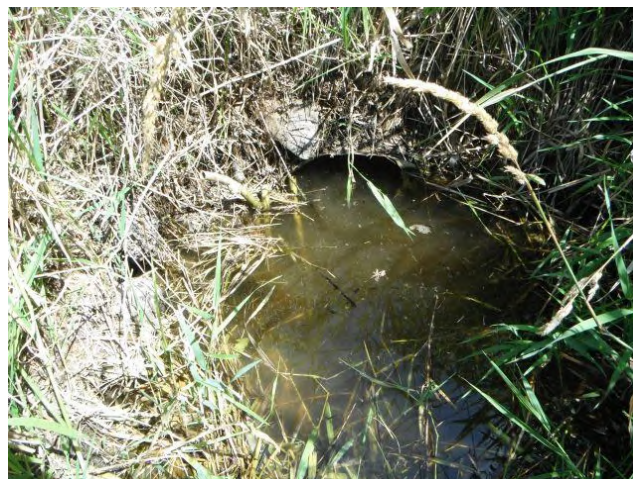
<b>Channel Description</b>	
Toe Width (m):	<input type="text"/>
Average Width (m):	<input type="text" value="-99.99"/>
Culvert/Stream Width Ratio:	<input type="text" value="-99.99"/>
<b>Plunge Pool</b>	
Length (m):	<input type="text" value="-999.99"/>
Max Depth (m):	<input type="text" value="-99.99"/>
OHW Width (m):	<input type="text" value="-999.99"/>
<b>Road</b>	
Fill Depth (m):	<input type="text" value="1.00"/>

<b>Assessment Results</b>			
Barrier:	<input type="text" value="Unknown"/>	Passability (%):	<input type="text" value="Unknown"/>
Reason:	<input type="text" value="Insufficient Data"/>	Fishway Present:	<input type="text" value="No"/>
		Method:	<input type="text" value="Level A"/>
		Recheck:	<input type="text"/>

<b>Comments</b>
Crosses the street to a collection box, 90 degree turn. Ties in with storm management system. Downstream end has a mangled trash rack. Unable to shoot due to change in material and connection with city storm water system. Upstream is PCC, downstream CAL.

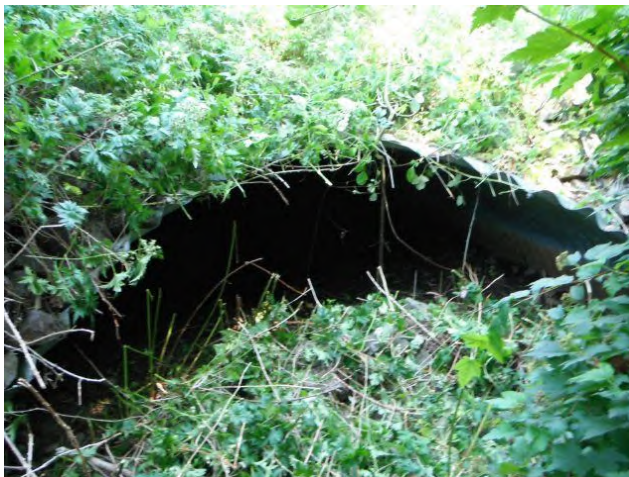
<b>Channel Description</b>	
Toe Width (m):	<input type="text"/>
Average Width (m):	<input type="text" value="3.96"/>
Culvert/Stream Width Ratio:	<input type="text" value="-99.99"/>
<b>Plunge Pool</b>	
Length (m):	<input type="text" value="-999.99"/>
Max Depth (m):	<input type="text" value="-99.99"/>
OHW Width (m):	<input type="text" value="-999.99"/>
<b>Road</b>	
Fill Depth (m):	<input type="text" value="5.00"/>

<b>Assessment Results</b>			
Barrier:	<input type="text" value="No"/>	Passability (%):	<input type="text" value="100"/>
Reason:	<input type="text" value="N/A"/>	Fishway Present:	<input type="text" value="No"/>
		Method:	<input type="text" value="Level A"/>
		Recheck:	<input type="text"/>

<b>Comments</b>
Believed to be a SQSH over 5m wide, but unable to verify due to the amount and type of bedload material inside pipe. 2/3 filled in with artificial boulders. Heavily overgrown with blackberries and other shrubs growing mid channel.

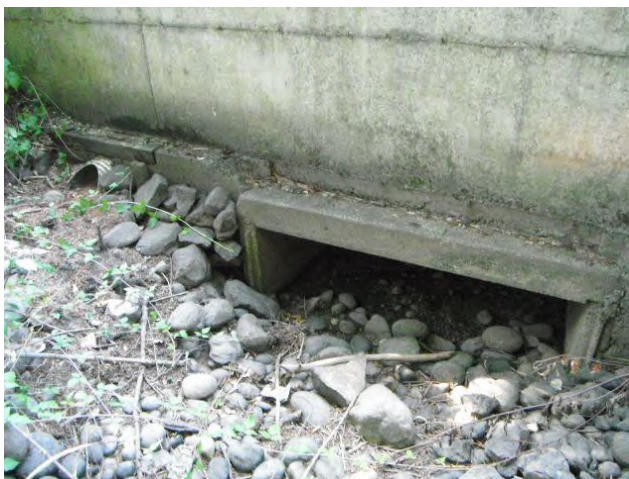
<b>Channel Description</b>	
Toe Width (m):	<input type="text"/>
Average Width (m):	<input type="text" value="3.96"/>
Culvert/Stream Width Ratio:	<input type="text" value="0.38"/>
<b>Plunge Pool</b>	
Length (m):	<input type="text" value="-999.99"/>
Max Depth (m):	<input type="text" value="-99.99"/>
OHW Width (m):	<input type="text" value="-999.99"/>
<b>Road</b>	
Fill Depth (m):	<input type="text" value="2.50"/>

<b>Assessment Results</b>			
Barrier:	<input type="text" value="Unknown"/>	Passability (%):	<input type="text" value="Unknown"/>
Reason:	<input type="text" value="Level B Required"/>	Fishway Present:	<input type="text" value="No"/>
		Method:	<input type="text" value="Level A"/>
		Recheck:	<input type="text"/>

<b>Comments</b>
Level B required during flows. Level B is not in project scope due to only resident fish use. Roadside surface water management drains entering at downstream end of pipe. Cement retaining wall with cyclone fencing on top defining sidewalk elevation.

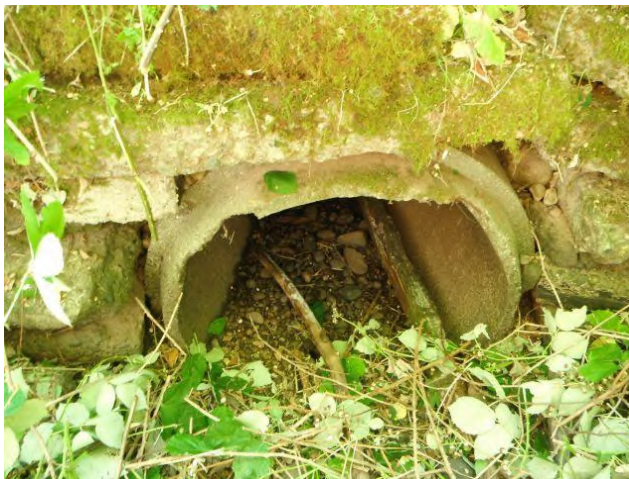
<b>Channel Description</b>	
Toe Width (m):	<input type="text"/>
Average Width (m):	<input type="text" value="3.90"/>
Culvert/Stream Width Ratio:	<input type="text" value="0.23"/>
<b>Plunge Pool</b>	
Length (m):	<input type="text" value="-999.99"/>
Max Depth (m):	<input type="text" value="-99.99"/>
OHW Width (m):	<input type="text" value="-999.99"/>
<b>Road</b>	
Fill Depth (m):	<input type="text" value="2.00"/>

<b>Assessment Results</b>			
Barrier:	<input type="text" value="Unknown"/>	Passability (%):	<input type="text" value="Unknown"/>
Reason:	<input type="text" value="Level B Required"/>	Fishway Present:	<input type="text" value="No"/>
		Method:	<input type="text" value="Level A"/>
		Recheck:	<input type="text"/>

<b>Comments</b>
Determined that Level B analysis is required during time of flows, but out of scope of project due to resident only fish use. Stacked stone and concrete headwall at upstream and downstream end of pipe.

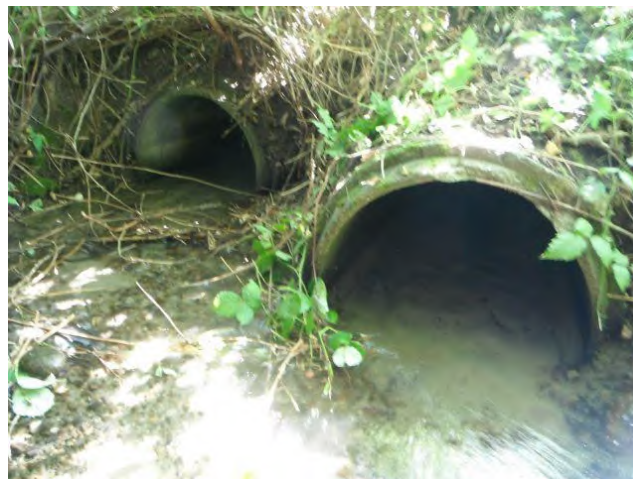
<b>Channel Description</b>	
Toe Width (m):	<input type="text"/>
Average Width (m):	<input type="text" value="5.20"/>
Culvert/Stream Width Ratio:	<input type="text" value="0.29"/>
<b>Plunge Pool</b>	
Length (m):	<input type="text" value="-999.99"/>
Max Depth (m):	<input type="text" value="-99.99"/>
OHW Width (m):	<input type="text" value="-999.99"/>
<b>Road</b>	
Fill Depth (m):	<input type="text" value="2.50"/>

<b>Assessment Results</b>			
Barrier:	<input type="text" value="Yes"/>	Passability (%):	<input type="text" value="67"/>
Reason:	<input type="text" value="Slope"/>	Fishway Present:	<input type="text" value="No"/>
		Method:	<input type="text" value="Level A"/>
		Recheck:	<input type="text"/>

<b>Comments</b>
Left bank pipe receiving majority of flows at 4/12/2016 visit. 0.41 cms.

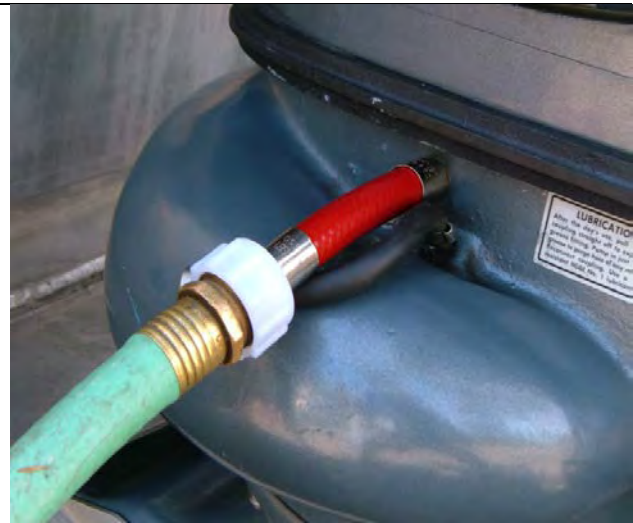
**2B.** Water intake bolt has been removed, and outboard flushing adapter has been attached.

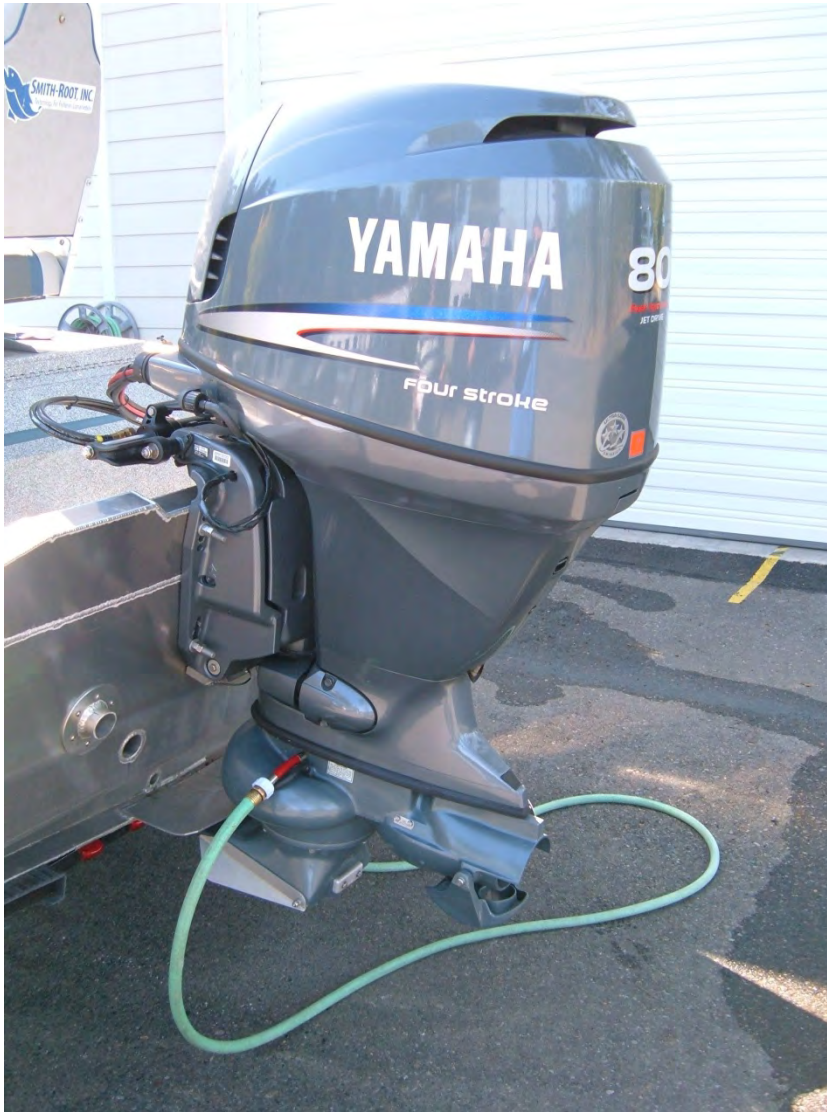
**2C.** Outboard flushing adapter attached to lower jet unit. Ready to turn on water supply and flush outboard system.

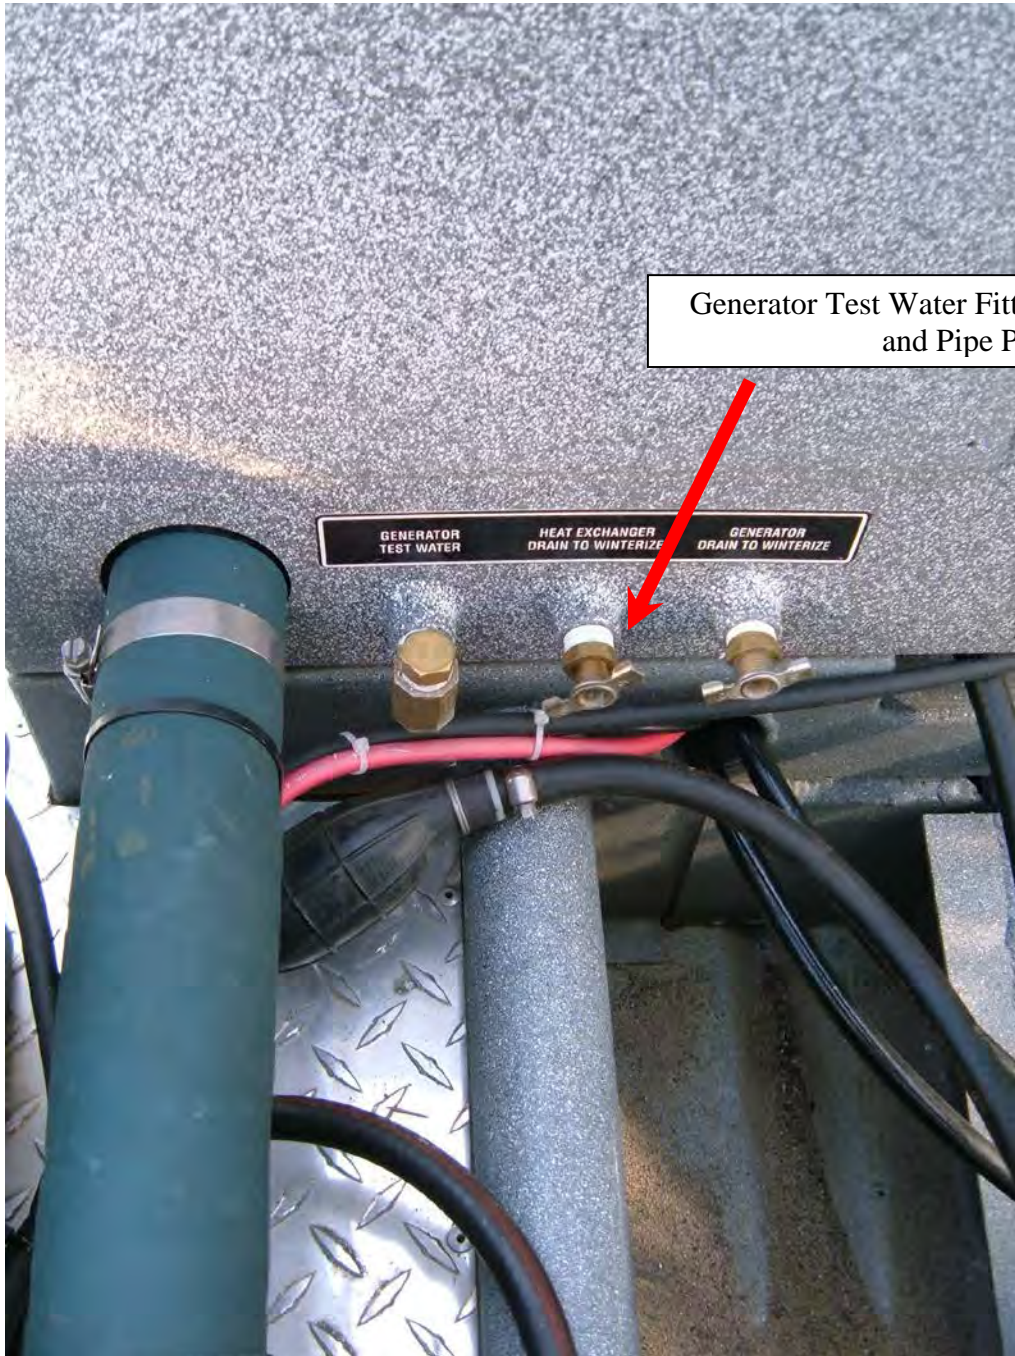
Generator Test Water Fitting  
and Pipe Plug

**3B.** Generator raw water flushing connection (i.e. Generator Test Water Fitting). Located on the base of generator cover, port side aft.

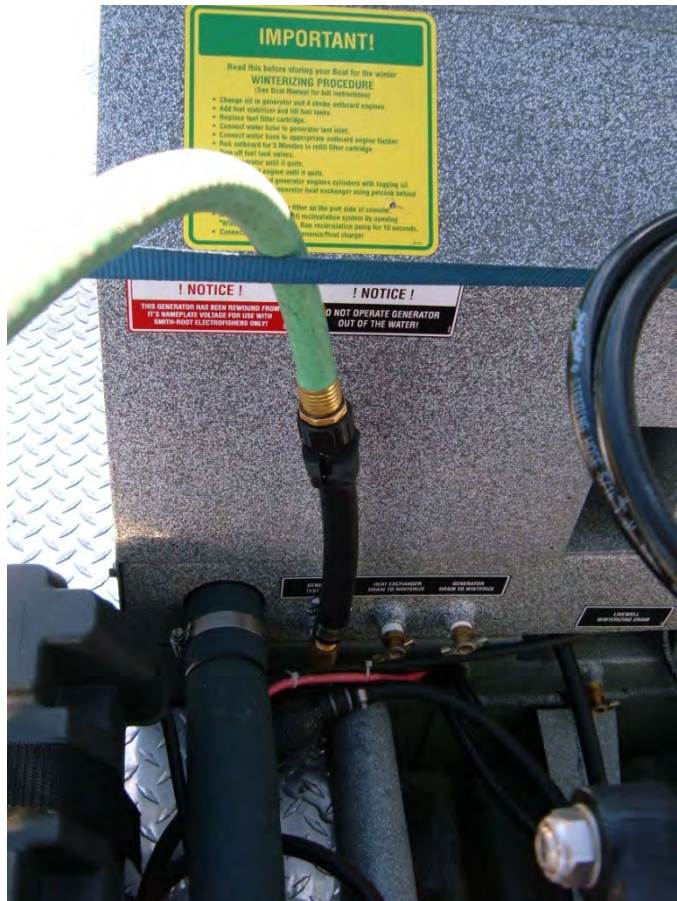
3C. Pipe plug has been removed, and generator flushing adapter has been attached.

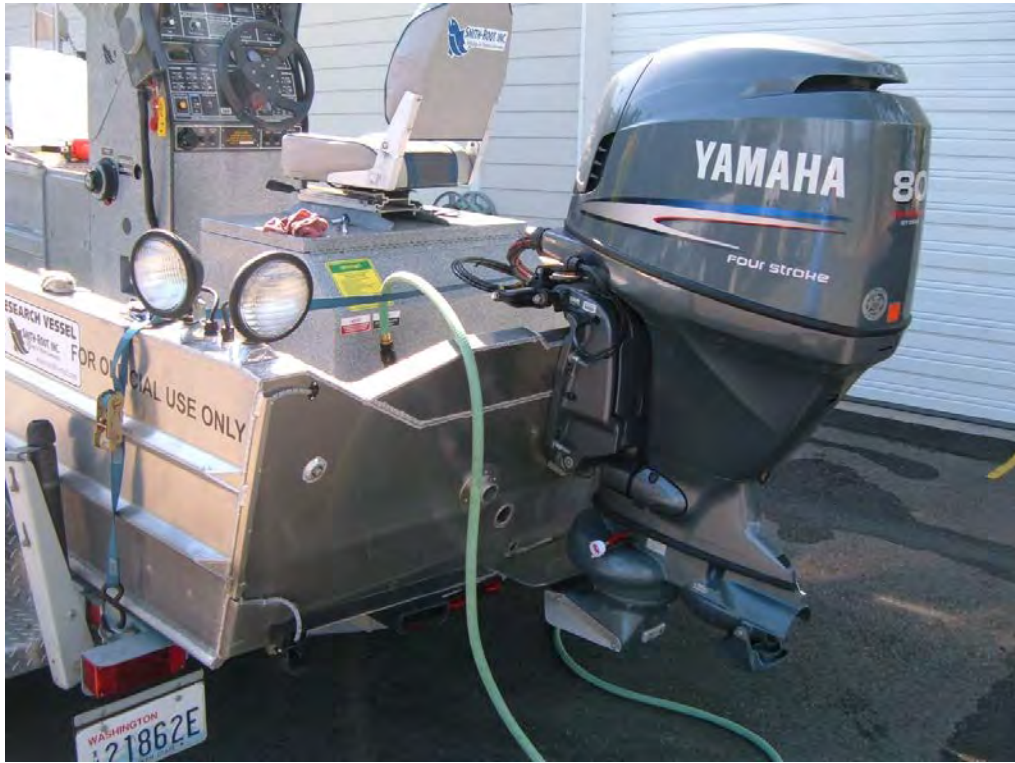
**3D.** Generator flushing adapter is attached. Ready to turn on water supply and flush generator and washdown pump systems.

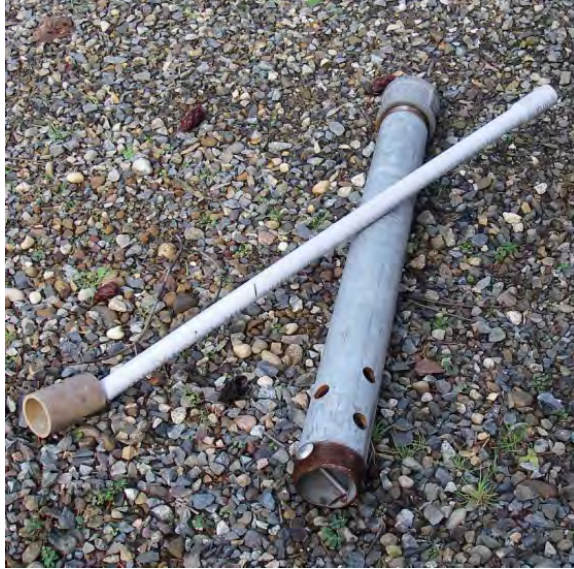
**Figure 3. Deployment method using a length of PVC pipe**
