# LAUGHING JACOBS BASIN PLAN

**City of Sammamish**  
801 228th Ave. SE  
Sammamish, Washington 98075

Geosyntec Consultants, Inc  
520 Pike Street, Suite 2600  
Seattle, Washington 98101

May 10, 2022

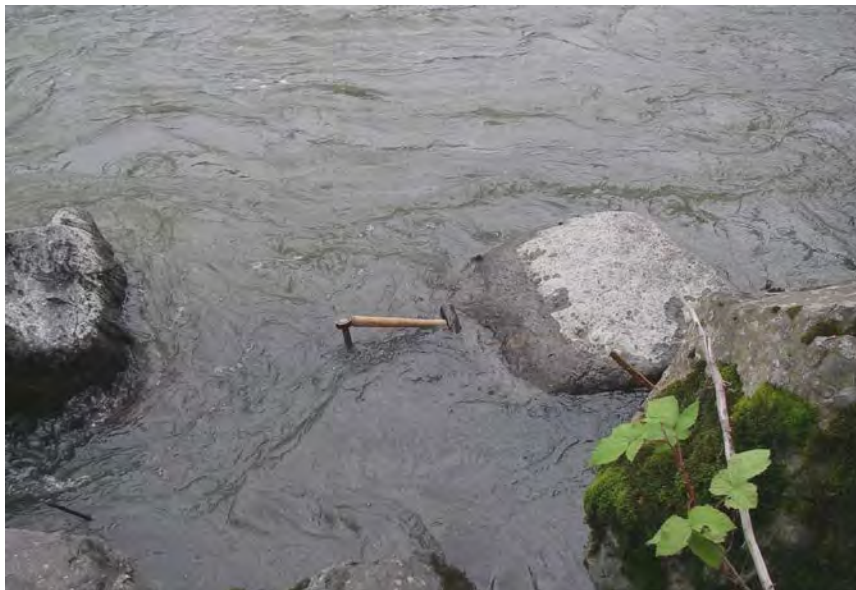
**Figure 4. Photo showing the water-temperature-logger deployment location.**

- 6.5.4 Take upstream and downstream photographs of the water-temperature-logger location that includes useful and easily identifiable landmark tree(s), flagging, or boulder. It is also important that the photographs include some visual marker (such as the rebar pounder, hammer handle, or pointing with a finger) to use along with the information on the survey form to help relocate and retrieve it in the future (See Fig 4 below).

- 6.5.5 Measure and record: the total water depth (water depth), distance from the logger to the streambed (height), distance from water surface to the logger (deployment depth), and the stream temperature on the survey form.

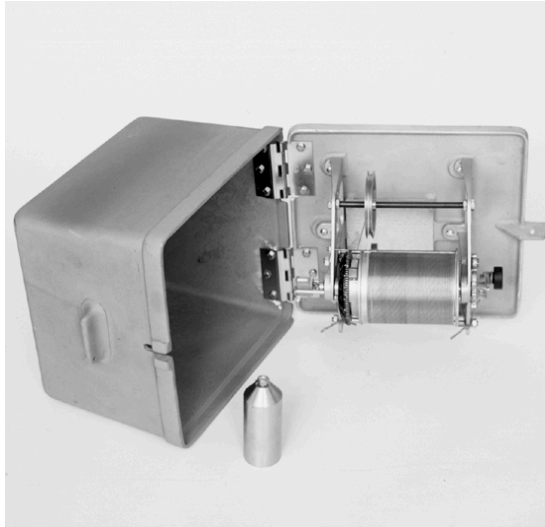
Figure 2. Wire Weight Gage (photo courtesy Rickly Hydrological Company)

6.4.1 The basic parts of a wire-weight gage include a drum wrapped with a single layer of cable and a weight attached to the end of the cable. A readable disc, graduated in tenths and hundredths of a foot is attached to the side of the drum. A Veeder counter, reading in whole feet is also included.

6.4 Determining Stage Height Using a Wire Weight Gage — Wire-weight gages are stage-height-measuring instruments typically attached to a bridge railing or parapet over a stream. The gage is housed in a locked protective covering.

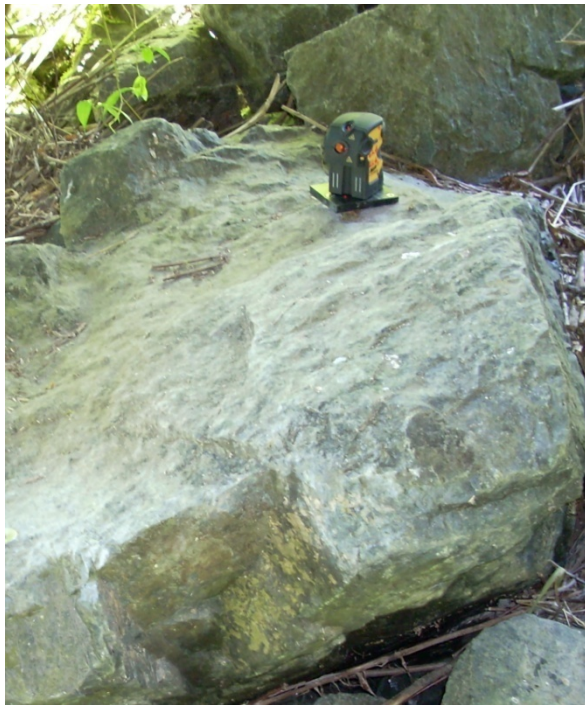
- 6.5.1 Laser levels are useful instruments to determine stage height, particularly in areas where staff gages are not practical. The laser level, a portable device mounted on a permanently installed structure or pad of known elevation emits a laser beam on a level plane.

Figure 4. Laser level mounted on laser level pad. (Photo by Washington Dept. of Ecology)

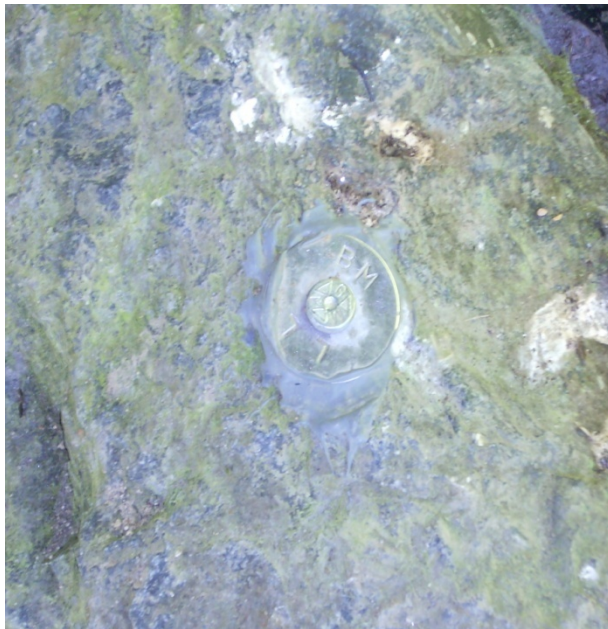
- 6.5.2 Determine stage height by measuring the difference between the known laser beam elevation and the water-surface elevation. Confirm the elevation of the laser level with the use of reference marks placed near the laser level pad.

Figure 5. Reference mark placed near laser level is used to confirm elevation of laser level beam. (Photo by Washington Dept. of Ecology)

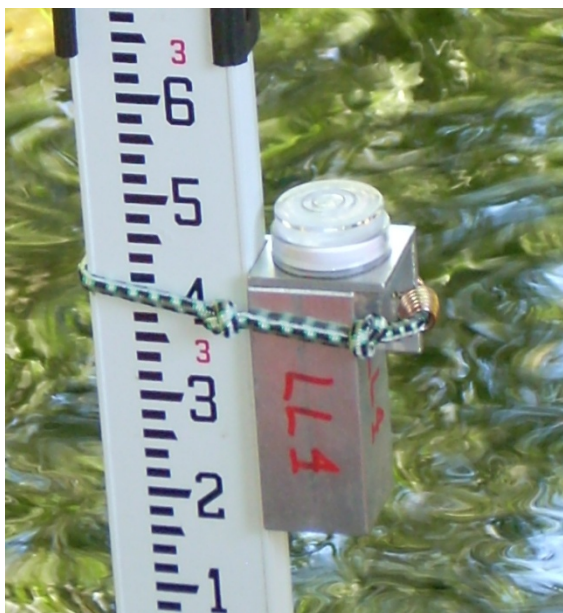
- 6.5.8 Place the stadia rod on one of the reference marks. Using a circular bubble level as a guide, hold the rod as vertical as possible.

Figure 6. A circular bubble level is used to vertical the stadia rod. (Photo by Washington Dept. of Ecology)

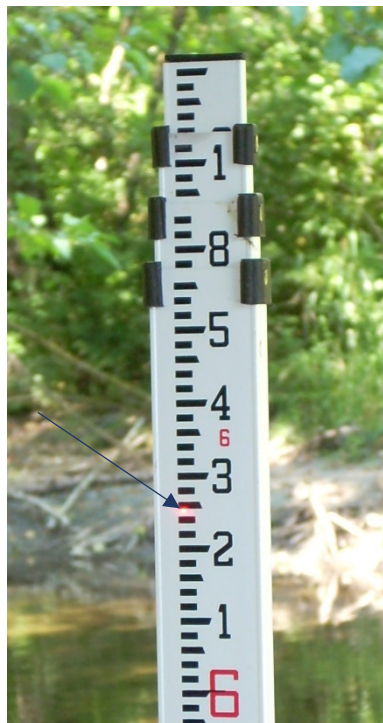
Figure 7. The center of the bright red laser light dot projected on the rod is the point at which the stadia rod is read. (Photo by Washington Dept. of Ecology)

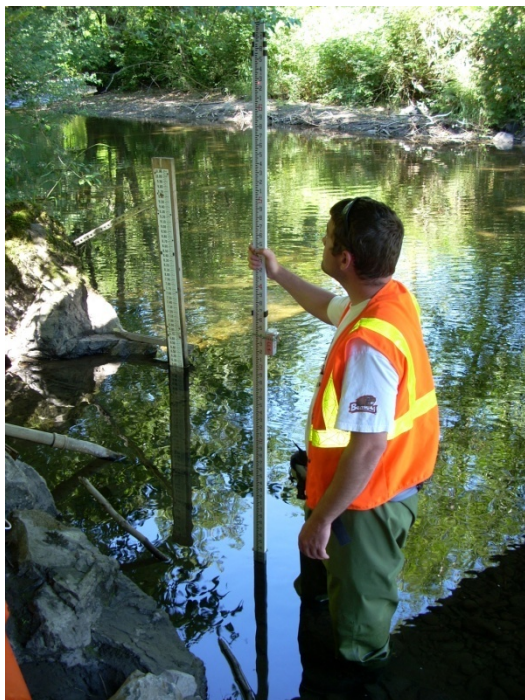
- 6.5.17 *Measuring Water Surface Elevation with Laser Level* — After confirming the laser level beam elevation, measure the water surface elevation.
- 6.5.18 The stadia rod handler stands the rod vertically on a solid, steady section of substrate in the calmest water practical in the gage pool subject to the station control. Place the rod as close to the primary and recording gage as possible.

Figure 8. Hold the rod perpendicular on solid substrate in calm water. (Photo by Washington Dept. of Ecology)

- 6.5.19 The instrument person rotates the laser level toward the stadia rod until the laser beam illuminates on the rod. Read the illuminated point on the rod and record in the Stream Gage Logger notes under LASER: STADIA ROD READING. Note any uncertainty in reading the laser illumination on the stadia rod (i.e. rod reading +/- n ft.)

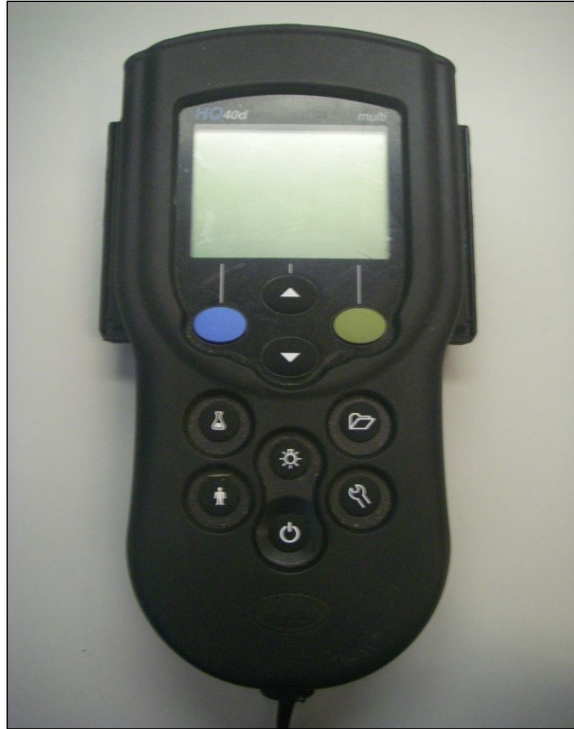
Figure 1. HQ40d Multi-Parameter Meter

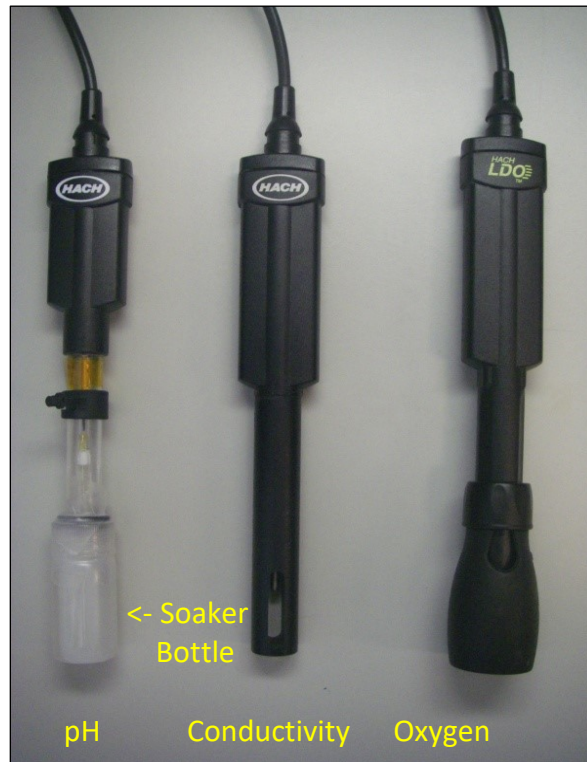
Figure 2. PHC28101 IntelliCAL pH Ultra Electrode, CDC401 IntelliCAL Standard Conductivity Probe, and LDO101 IntelliCAL Standard Dissolved Oxygen Probe.

- 6.1.1.2 Before removing the electrode from the soaker bottle (Figure 2), unscrew the bottle base from the bottle cap. This will ensure that electrolyte is not suctioned out of the probe. Remove the bottle cap and put the bottle aside where it will not spill or become contaminated.

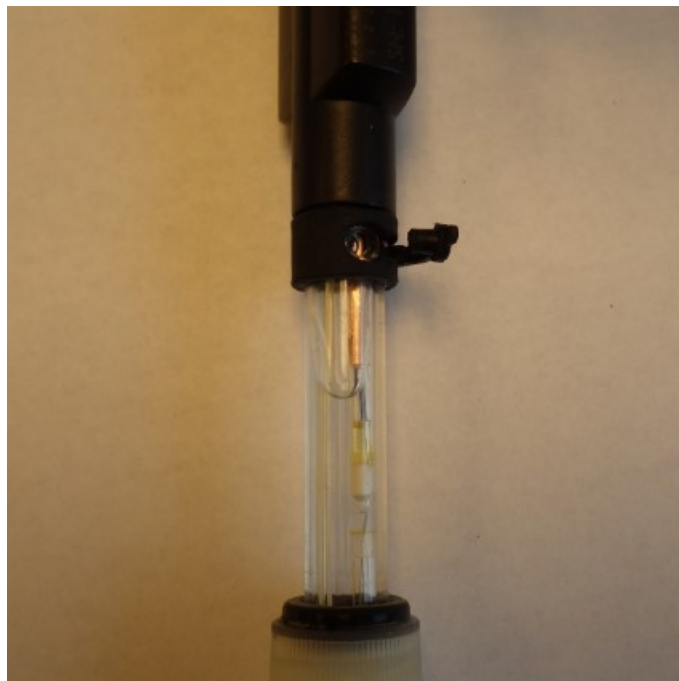
6.1.1.1 Ensure that the pH electrode is full of IntelliCAL™ 2.44M KCl PHC281 solution. If needed, top off the probe fill chamber with filling solution (Figure 3).

Figure 3. Close-up of electrolyte filling hole on pH probe

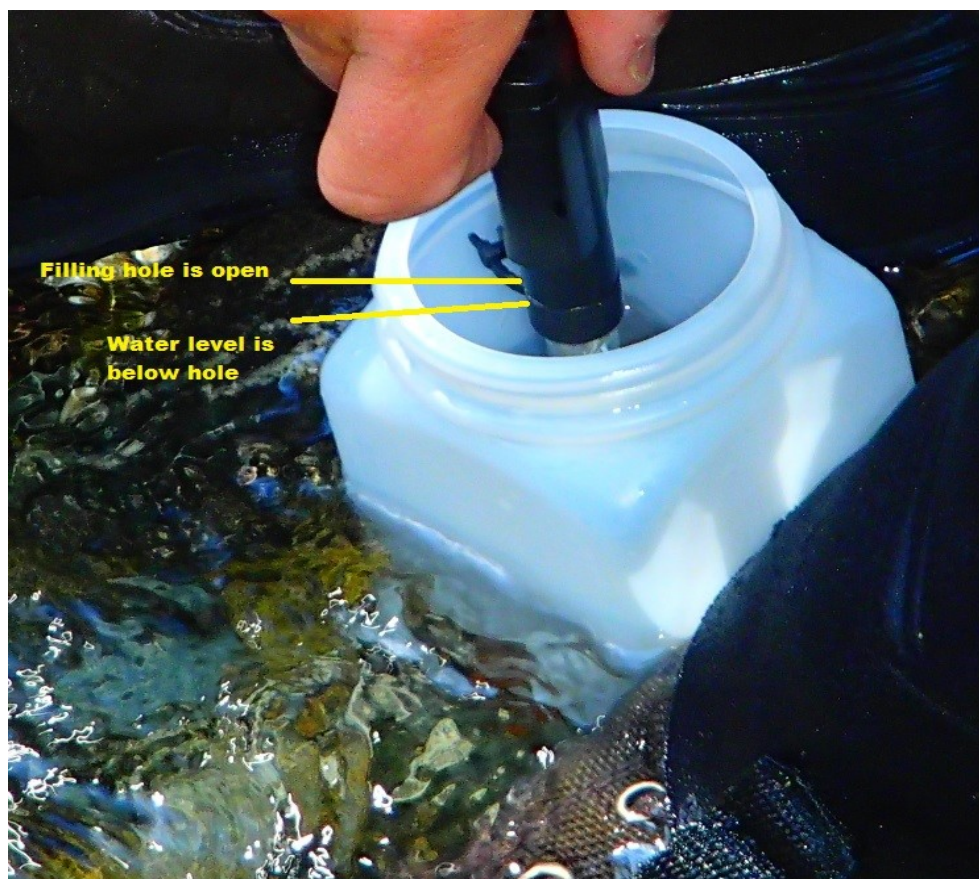
- 6.3.1.1 Thermally equilibrate the pH electrode. Collect a sample of stream water with the 500 mL beaker (Figure 4) and place it in a shallow, calm, edge section of the stream. Unplug the pH electrode fill hole and carefully remove the pH electrode soaker bottle. Place the pH electrode upright in the beaker and let it sit for 3-5 minutes. Be sure that you do not submerge the pH electrode past the electrode filling solution hole.

Figure 4. Measuring pH at equilibrated temperature and outside of streamflow.

- 6.3.1.2 Protect the pH electrode from flow-induced error. Measuring pH in flowing water can be problematic so do not place the electrode directly into the stream. Instead, re-fill the beaker with fresh, well-mixed stream water and measure from that (Figure 4). Keep the filled beaker partly submerged in stream water while taking the measurement in order to measure close to ambient stream temperature.

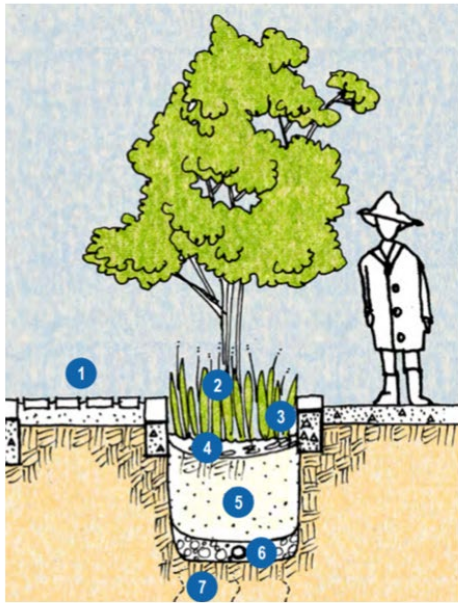
- 1 Sidewalk or trail
- 2 Vegetation
- 3 Intermittent ponding
- 4 Plant roots help maintain infiltration
- 5 Specialized bioretention mix
- 6 Optional underdrain where needed
- 7 Infiltration where feasible

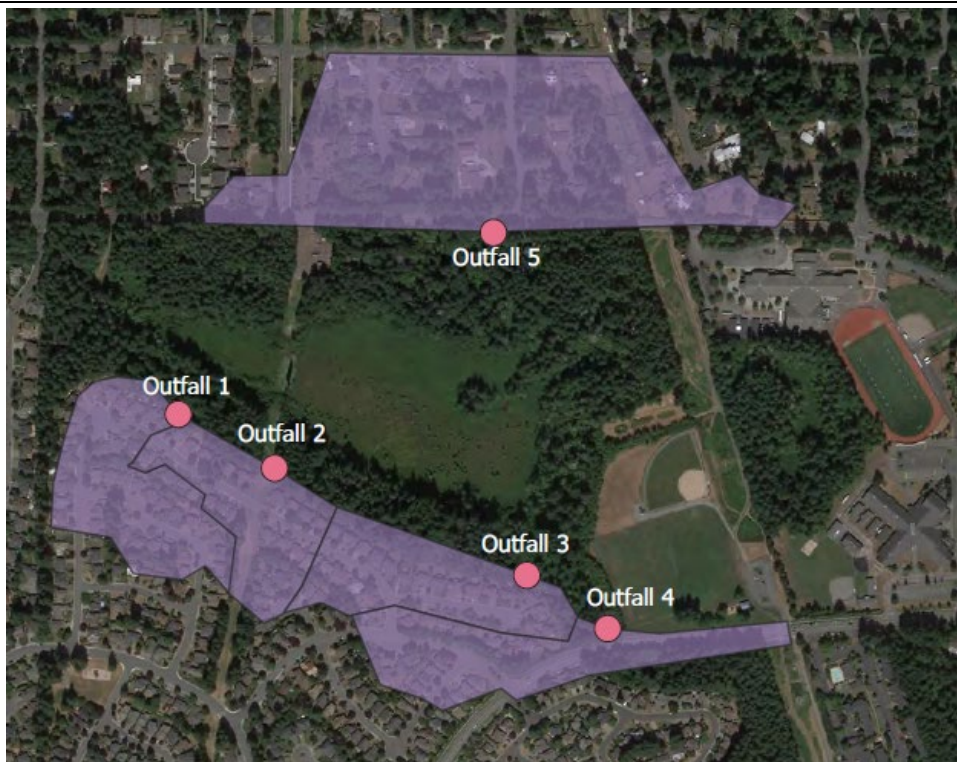
**Conceptual Design: Queen’s Bog Stormwater Treatment, Cont.**

Queen’s Bog is one of Sammamish’s most valued Sphagnum Bogs. It is an example of a unique habitat type rarely found in the region. A portion of the Klahanie neighborhood discharges stormwater runoff directly to the bog, altering the natural hydrology and water chemistry of the bog. Sphagnum bogs, like Queens Bog, are typically ombrotrophic (rainfall dominated) and contain vegetation that needs acidic conditions to survive. Preliminary evidence suggests that the bog vegetation may be changing due to untreated stormwater and the altered hydrology of the system. Up to five systems of bioretention cells would be installed to reduce harmful constituents in stormwater runoff tributary to the bog. Specific locations would be identified during design. Initial analysis shows the surface area of each bioretention systems would range from 1,000 to 2,500 square feet.

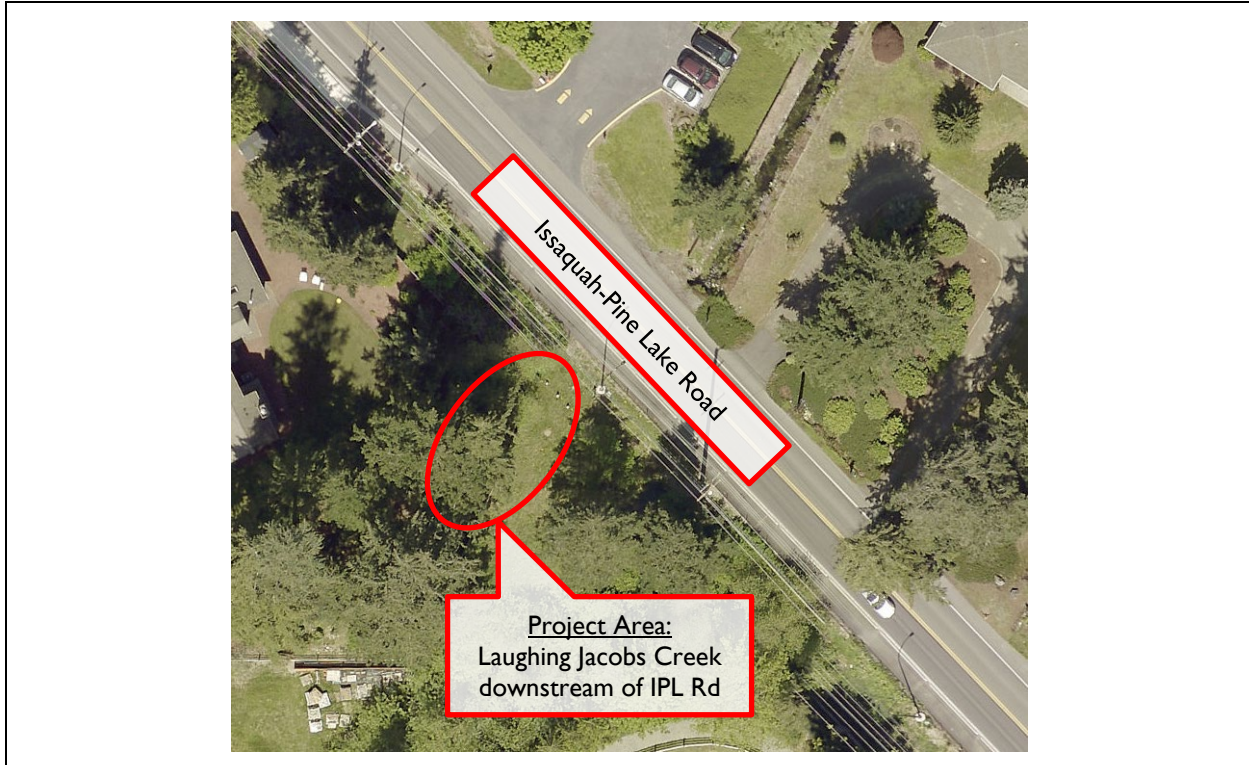
## Conceptual Design: Issaquah-Pine Lake Road Crossing Engineered Hyporheic Zone Augmentation, Cont.

This project would take advantage of proposed stream improvements related to the widening of Issaquah-Pine Lake (IPL) Road. Engineered hyporheic zones would be added using proposed engineered wood structures to provide instream water quality improvements. This project would add engineered media and controls that would direct a portion of the flow through the hyporheic zone of the stream channel. This project would utilize lessons learned from pilot studies by Seattle Public Utilities and others in Thornton Creek, where the concept has been successfully demonstrated. Studies suggest that engineered hyporheic zones can provide reduction of contaminants typically present in roadway runoff, while helping to lower stream temperature.

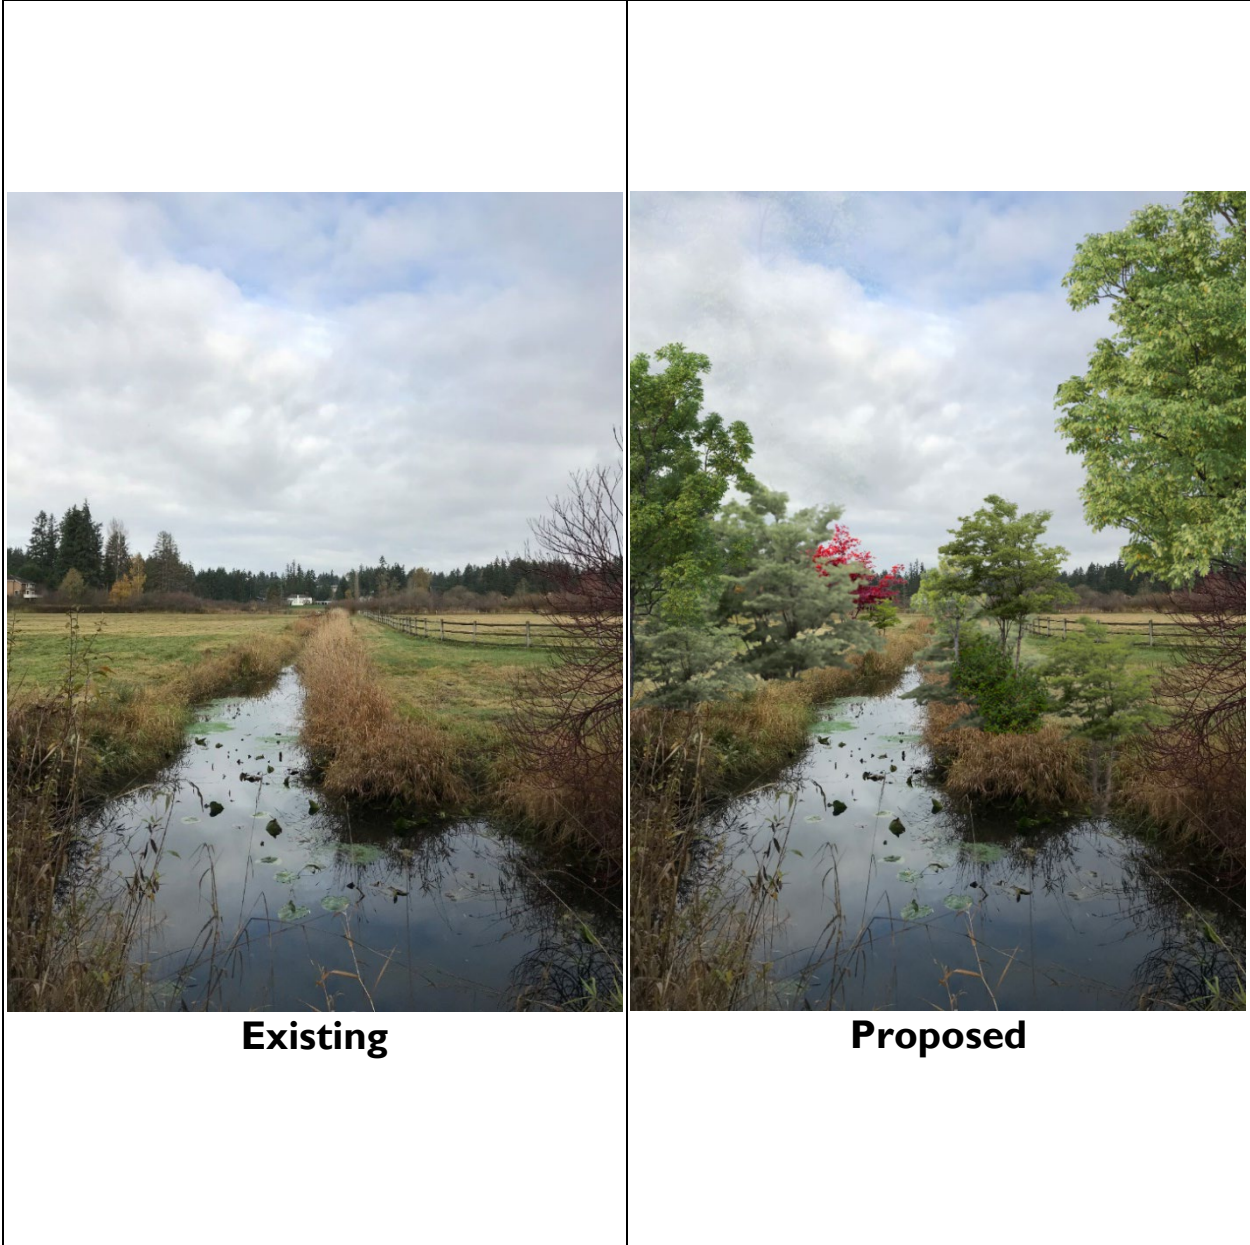
**Conceptual Design: Laughing Jacobs Lake Downstream Channel  
Native Vegetation Restoration**

**Existing**

**Proposed**

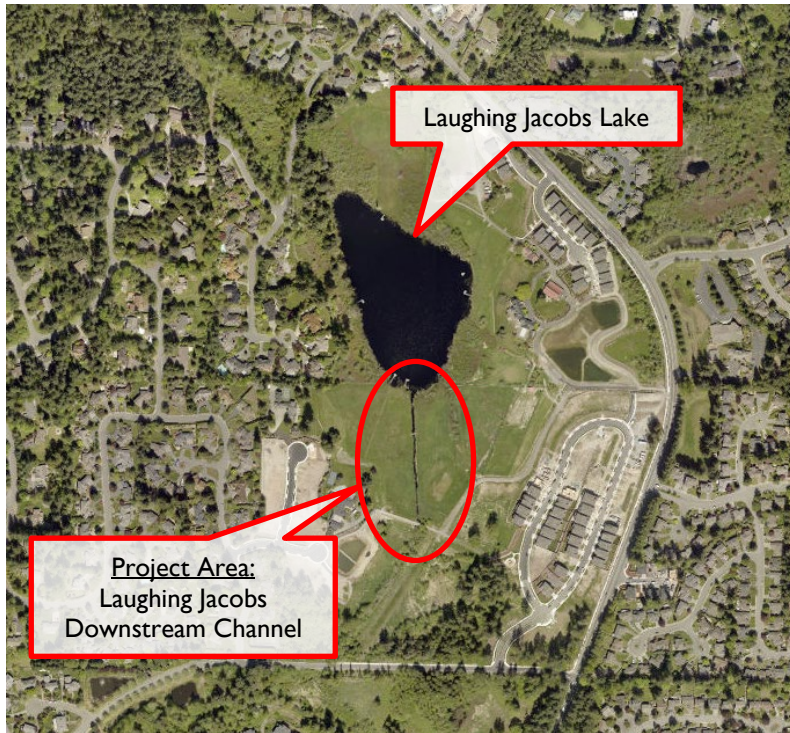
## Conceptual Design: Laughing Jacobs Lake Downstream Channel Native Vegetation Restoration, Cont.

The downstream channel at Laughing Jacobs Lake is shallow and not shaded by riparian cover. Small channels, such as this reach, are most susceptible to temperature changes, which will likely be exacerbated by climate change. Temperature data collected at this reach from August 2019 to August 2021 indicate an exceedance of the Washington Water Quality Temperature Standard of 16.0°C during summer months by 0.7°C to 2.5°C. This stream is considered by Ecology to provide core summer salmonid habitat.
