## *Technical Memorandum*

Project: Zaccuse Creek Restoration

Subject: Initial Planning Study

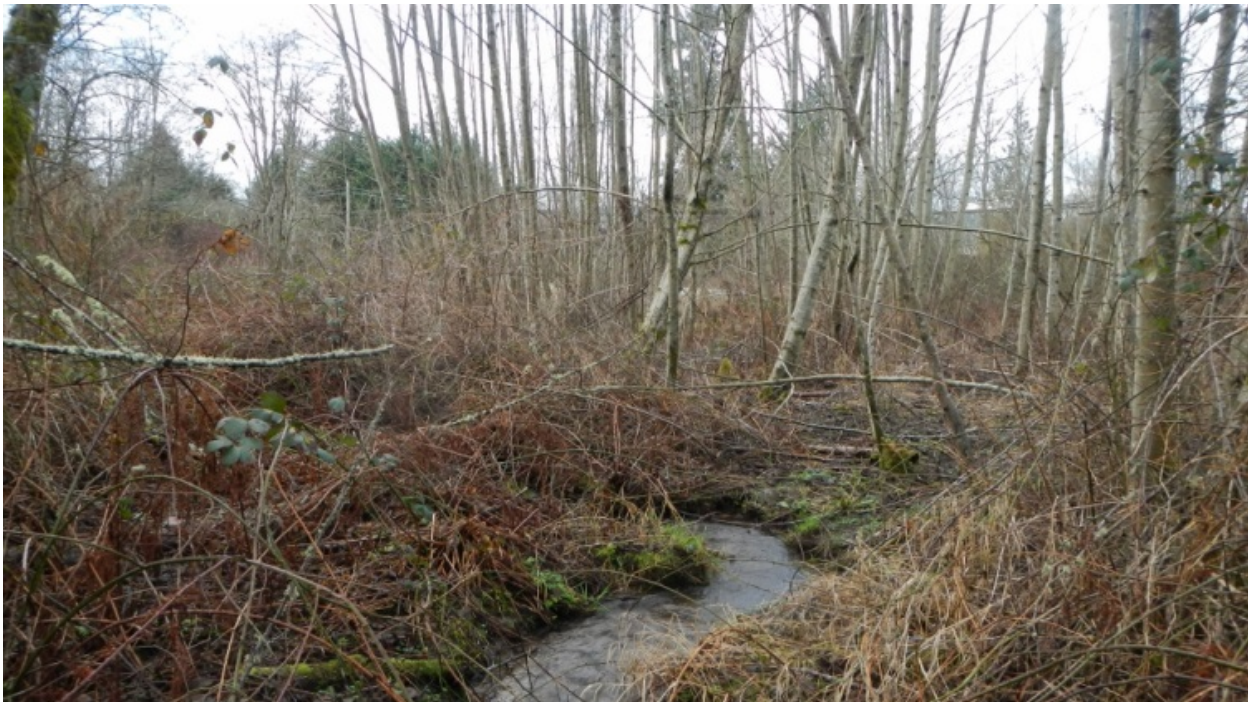
Photo 1. Looking downstream in Reach 3 towards the Parkway. Red alder, blackberry and other vine species dominate the vegetation in this reach.

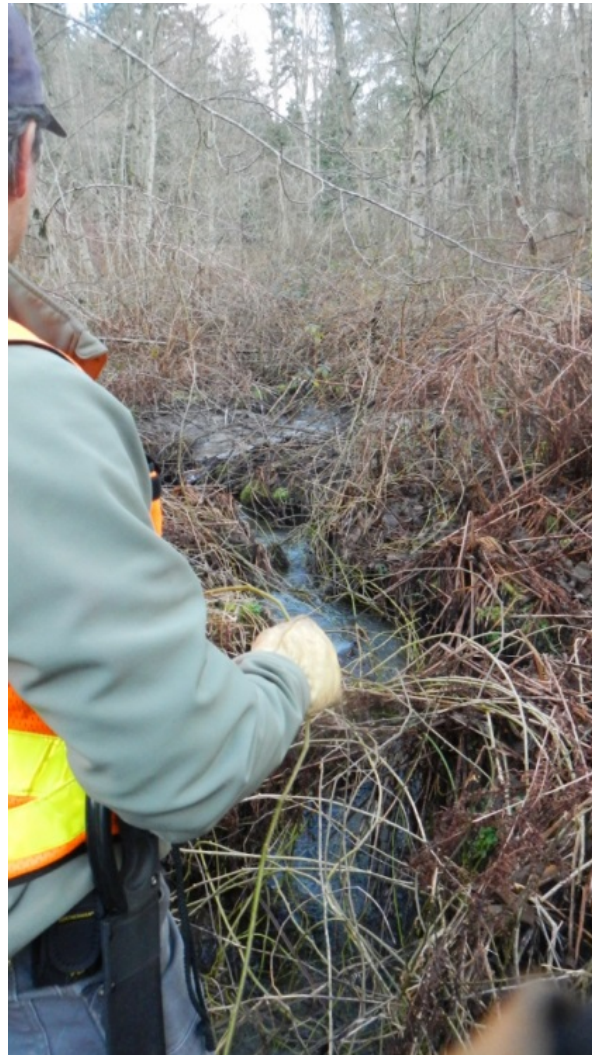
Reach names used in this trip report are those identified in R2 2012 and shown on Drawing 1 (attached). The vegetation in Reach 3 is dominated by red alder trees and blackberries, and other low lying unidentified vines (See Drawing 2 and 3). At some locations the channel is choked by vegetation which results in sediment deposition and channel movement. Photos 1 and 2 show the dominant vegetation and Photo 2 shows an area where the channel is choked and significant deposition has occurred.

Photo 2. Looking upstream in Reach 3 at an area where vegetation has choked the channel and caused significant sediment deposition.

In Reach 3 we recommend construction of a new channel connecting the downstream end of Reach 4 with the upstream end of the Parkway culvert. Drawing 6 shows a sketch of a proposed channel, including a six foot wide pilot channel, and a low floodplain with wood roughness elements. These wood structures would also function to slow channel velocity and to keep the channel from jumping into a new alignment. The roughness elements would act to slow down flow and allow deposition and sediment sorting to take place on the floodplain. Overflow notches to allow flood flows to spread out and deposit sediment during large floods could also be elements of the design. The details for these elements will require further hydrology, hydraulics, and sediment transport analysis to be conducted as part of any channel design which would be described in a design report.

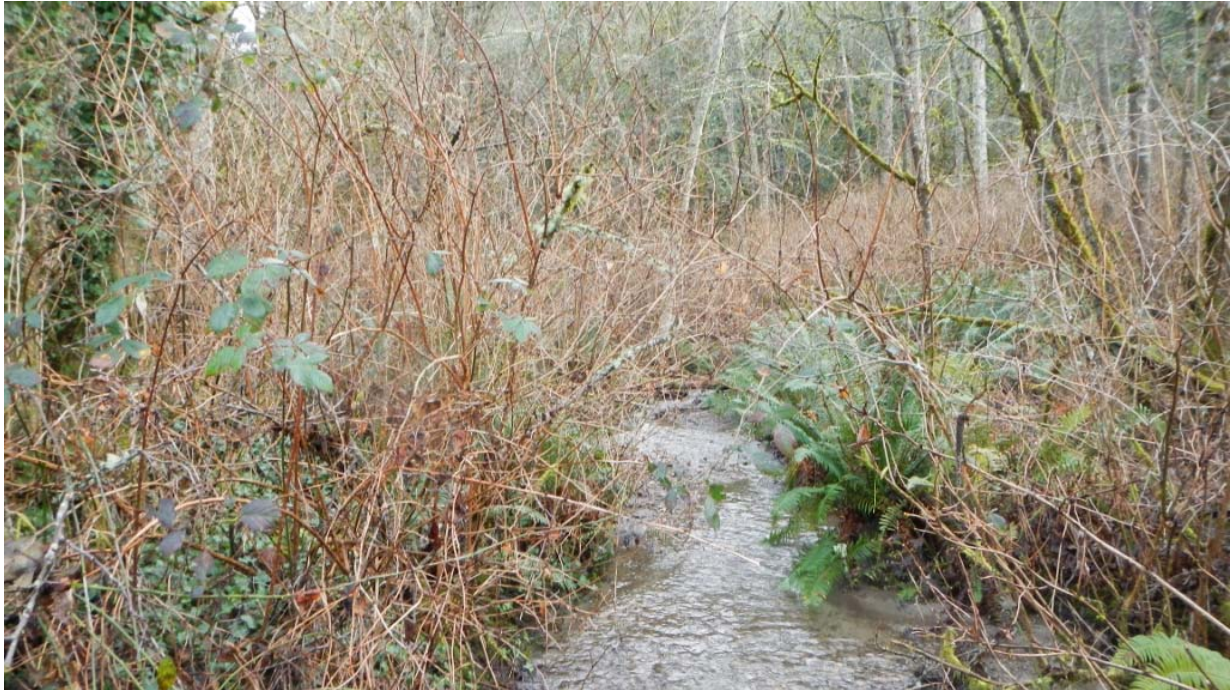
Reach 4 vegetation is dominated by a salmonberry understory with red alder still the dominant tree, some cedar are also present in this reach (See Drawing 2 and 4). Photo 3 shows the straight gravel bed stream and a riparian with salmonberry, fern, blackberry and red alder visible.

Photo 3. Looking upstream in Reach 4 with salmonberry, fern, red alder and some blackberry visible.

In Reach 4 we are proposing the addition of roughness elements to the creek for at least 400 ft of the channel, ending at the Pereyra property line. However, these roughness elements could be added in the channel up to the head-cut location if desired. The recommend roughness elements will slow the flow, encourage local deposition, and thereby increase channel diversity and Kokanee habitat. Roughness elements could be a combination of wood and/or large boulders. We also recommend blocking the ditch that acts as a distributary to the south (approximate station 7+90). This ditch is connected to the primary channel at high water and holds standing water most (or all of the year), and could strand fish.

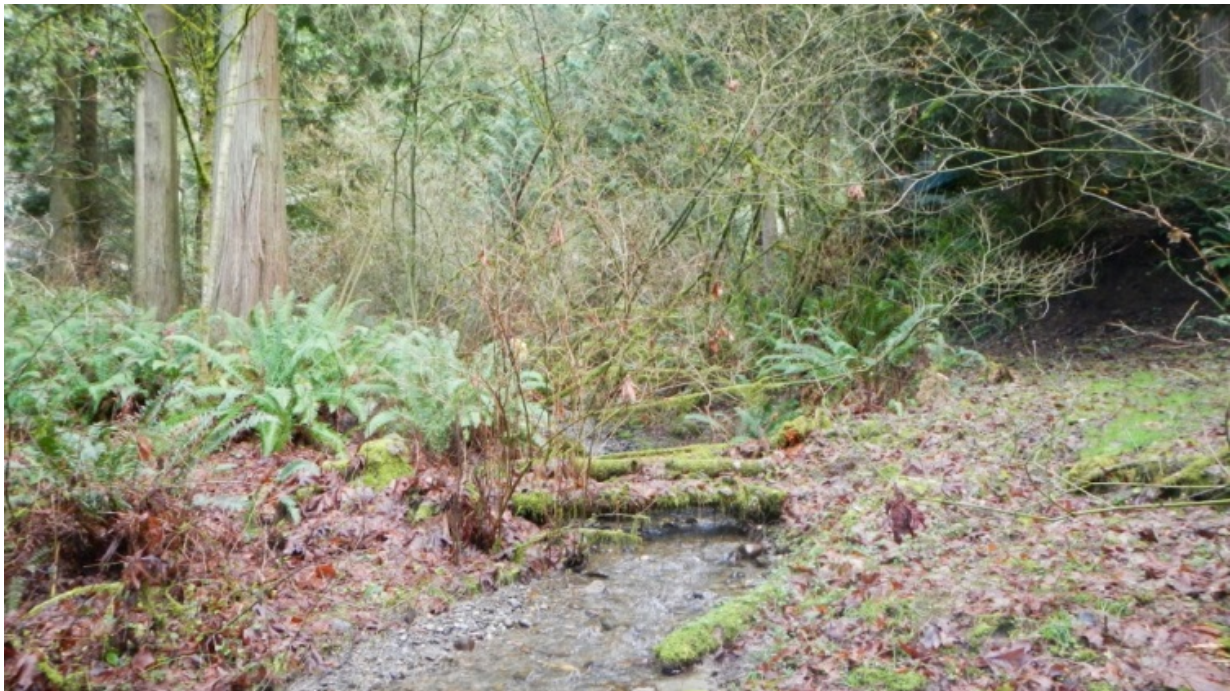
In Reach 5 and 6 the vegetation transitions into a mature forest with cedar, cottonwood, vine maple, and fern dominant. Photo 4 shows Reach 6 (by the footbridge), which will be used as a reference reach to show the goal for riparian rehabilitation in Reaches 3 and 4 (See Drawing 2 and 5).

Photo 4. Looking upstream in Reach 6 at the footbridge. This area is used as a reference reach for vegetation rehabilitation goals in Reaches 3 and 4 downstream. Cedar, fern, salmonberry, and vine maple are dominant in this area.

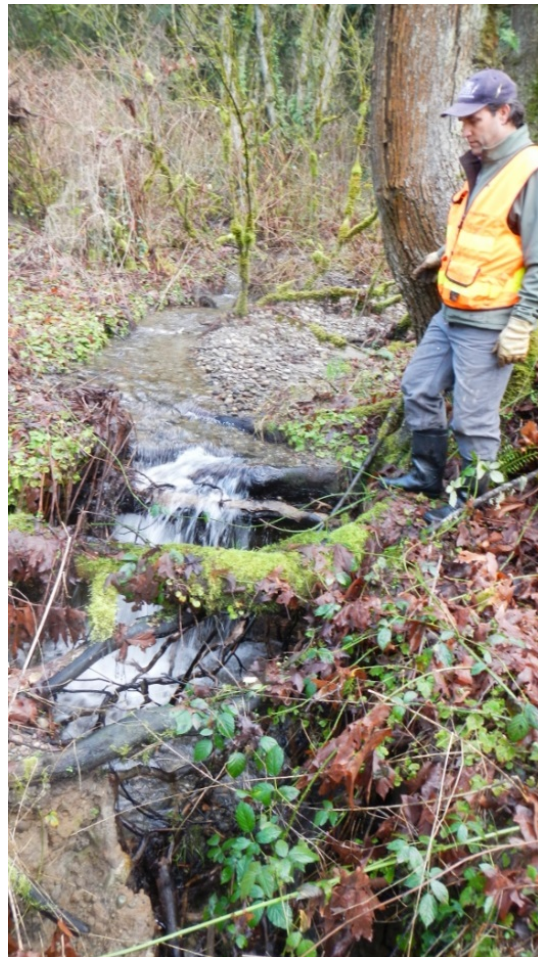
Deep head-cutting looks to be a new process in this reach of Zaccuse Creek. The head-cutting is likely caused by changes in the capacity of the creek to move material, potentially caused by higher peak flows or increased channelization. Photos 5 and 6 show the current head-cut location and the channel scoured since 2012. Development in the upper basin may be the cause of these higher peak flows. The deposits in the floodplain (alluvial fan) indicate that previously the flow spread out and deposited material in reach 6, and that the creek was unable to carry the larger material any further. Inspection of the layers in the recent cut banks indicates only one or in some locations two visible lenses with gravel deposits separated by one to two feet of soil deposited between. We believe that for many years the creek channel had meandered on the alluvial fan, depositing gravel in the channel, and contributing to soil building in the area for long periods in between subsequent gravel deposition. Another indication that the creek bed has moved over the years in Reach 6 is shown on the older maps of the area, which still show Zaccuse Creek further to the north running along the base of the slope. We followed the route shown on the older maps in the field. There are signs that the creek once took the more northern course, but there is no indication that deep head-cutting had occurred in that channel. Based on our observations, it appears that this incision and head-cutting may be a new phenomenon at this location caused by recent changes to the creek.

Photo 5. View of the current location of the head-cut at the base of a large cottonwood tree. The channel is supported by the cottonwood roots, temporarily retarding the rate of movement upstream. This location is at least 150 ft upstream of the head-cut (called Reach 5, or "waterfall" in R2 2012) location in 2012.

If stabilization/fish passage work in this area is pursued, we would recommend installing grade control structures starting at approximately station 9+50, where the incision begins, and extending upstream approximately 250 ft at a six percent slope to the current head-cut location. Grade control steps would be six inches high and spaced approximately eight feet apart. The engineering for this feature would be relatively straight forward, but the permitting and construction could be much more costly.

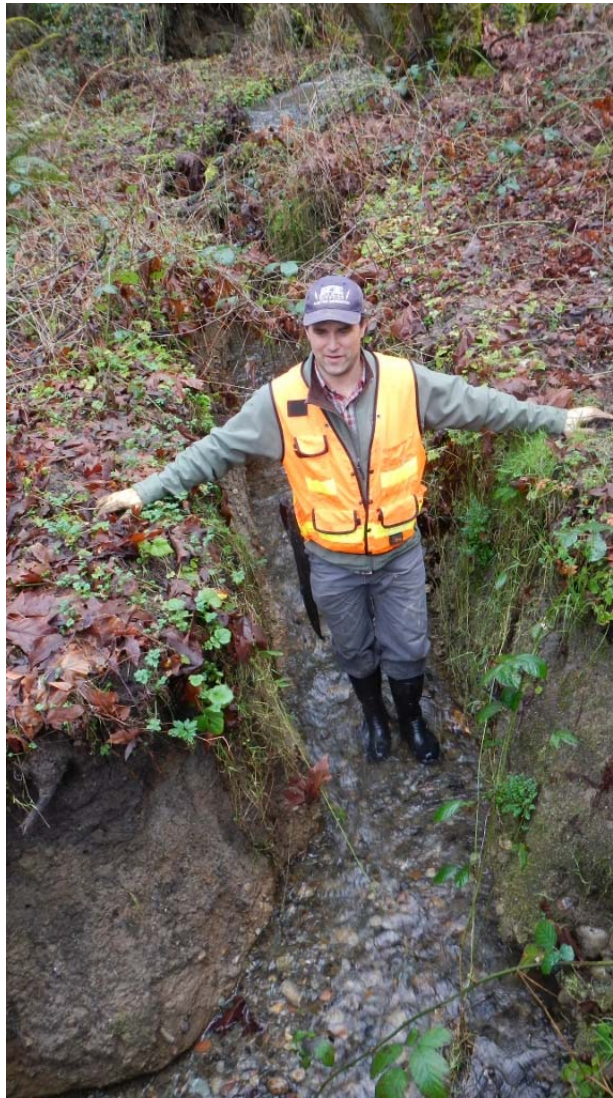
Photo 6. View looking upstream in Reach 6 at a channel roughly 4.5 ft deep by 4.5 ft wide which has formed since 2012. The head-cut location is approximately 50 ft upstream from this location.

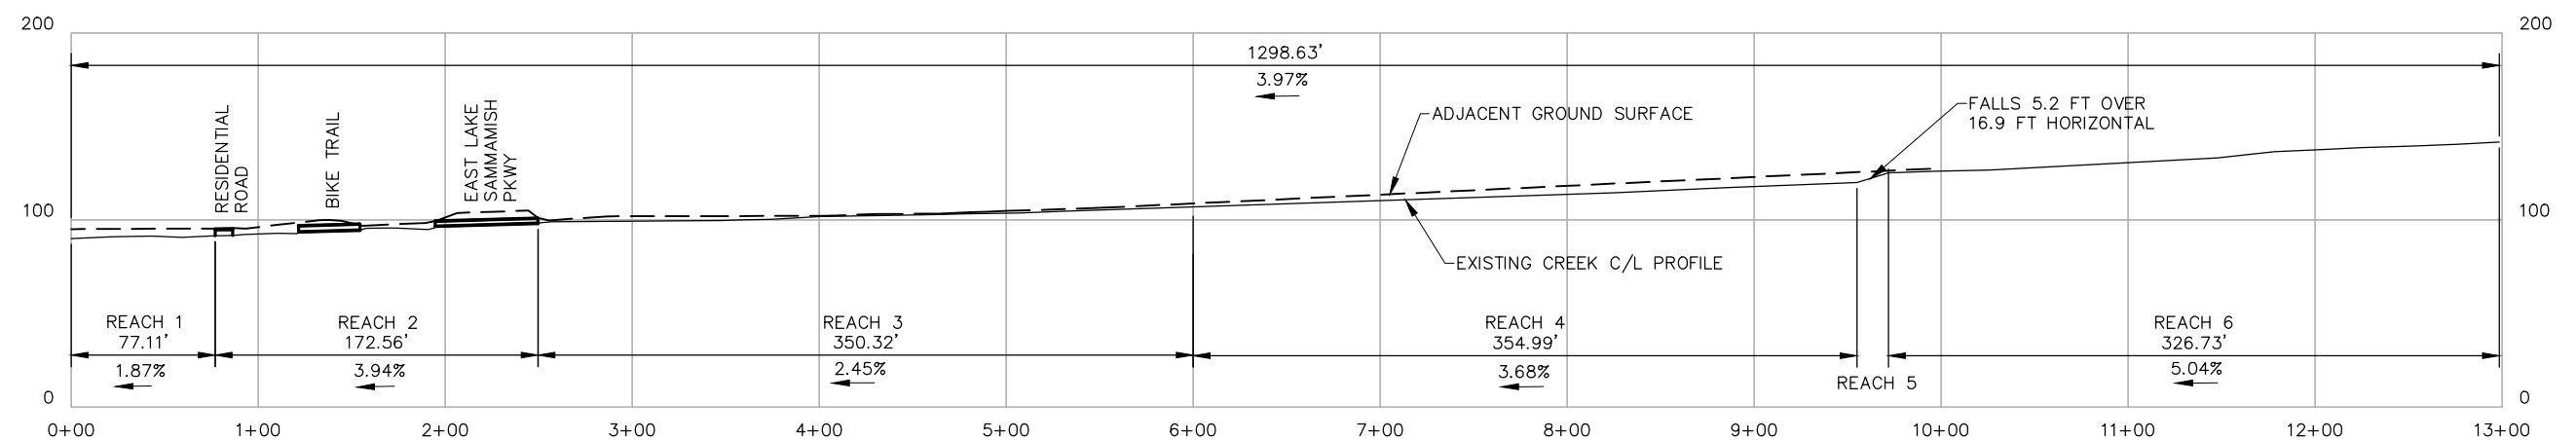
<p>Resource Consultants, Inc. REDMOND, WA.</p>	<p>PEREYRA ZACCUSE CREEK</p>
	<p>DRAWING 1 EXISTING PLAN AND PROFILE</p>

1. SURVEY APRIL 13TH, 2012. ZACCUSE CREEK FLOW = 1.0 CFS. HORIZONTAL LOCATION BASED ON BEST FIT TO AERIAL PHOTO. VERTICAL DATUM BASED ON SETUP #1 ON SAMMAMISH TRAIL ARBITRARILY SET TO 100.0'.

**SITE PLAN**

**EXISTING CHANNEL PROFILE**

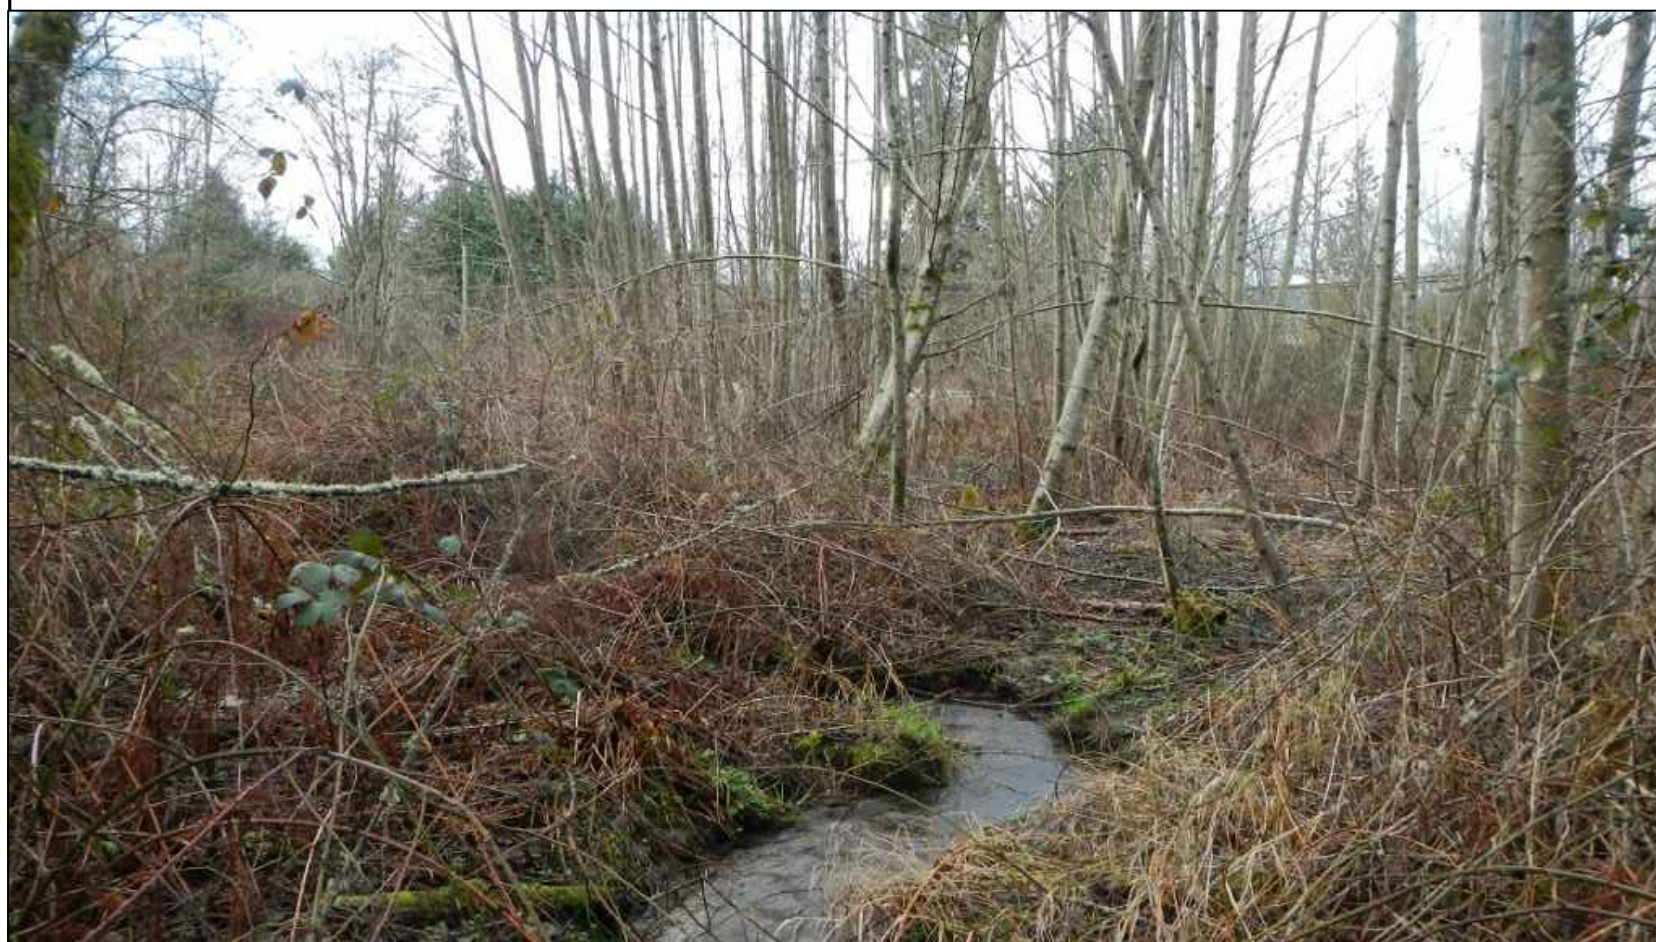
LOOKING DOWNSTREAM IN BLACKBERRY AND RED ALDER DOMINATED AREA

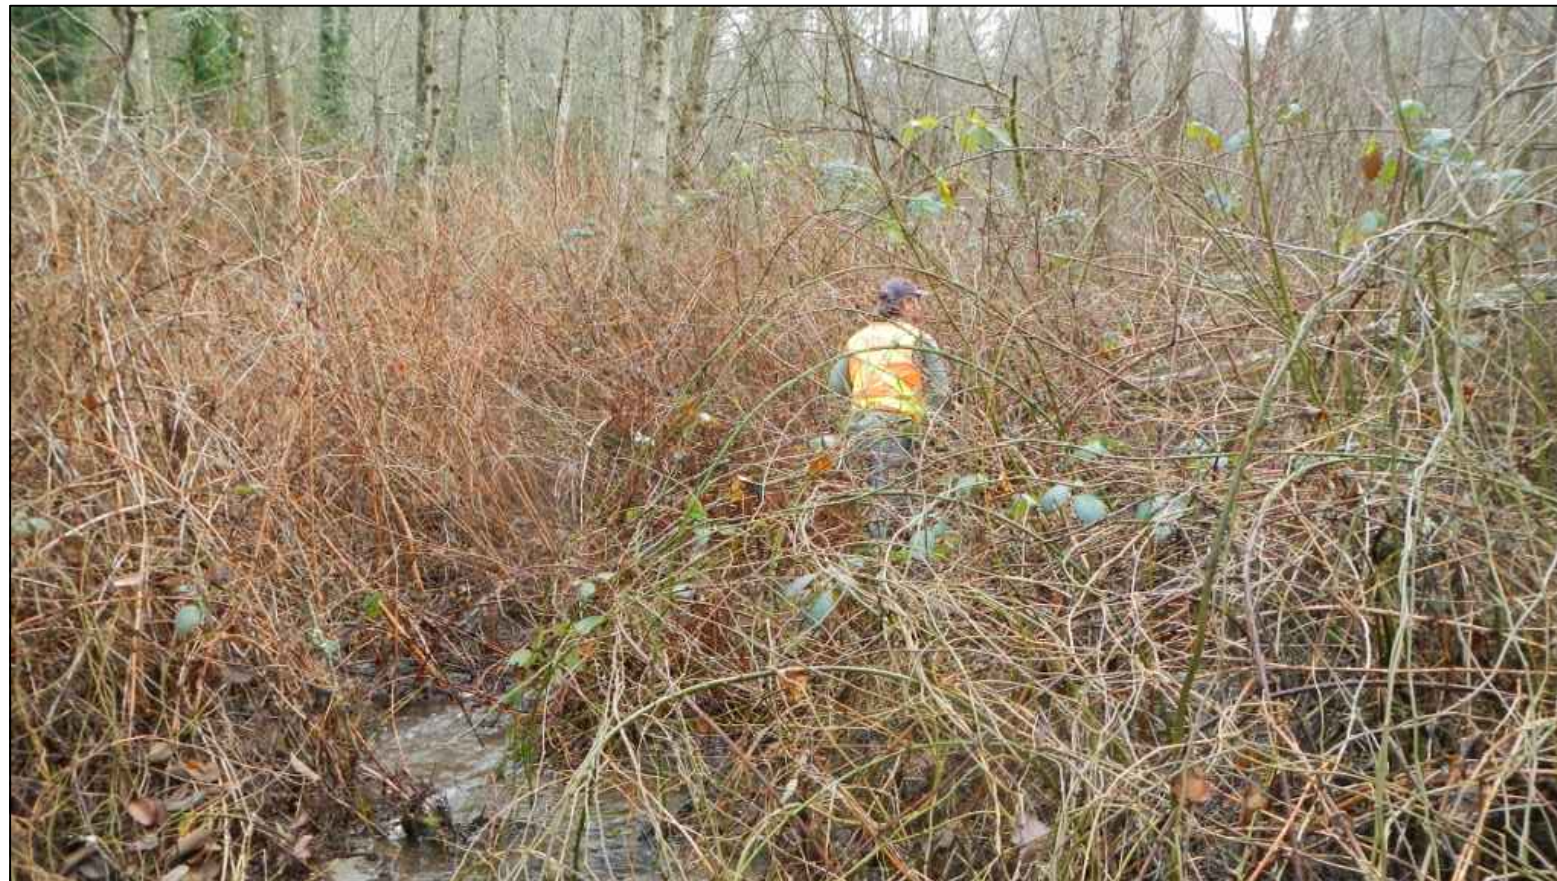
LOOKING UPSTREAM IN BLACKBERRY AND RED ALDER DOMINATED AREA

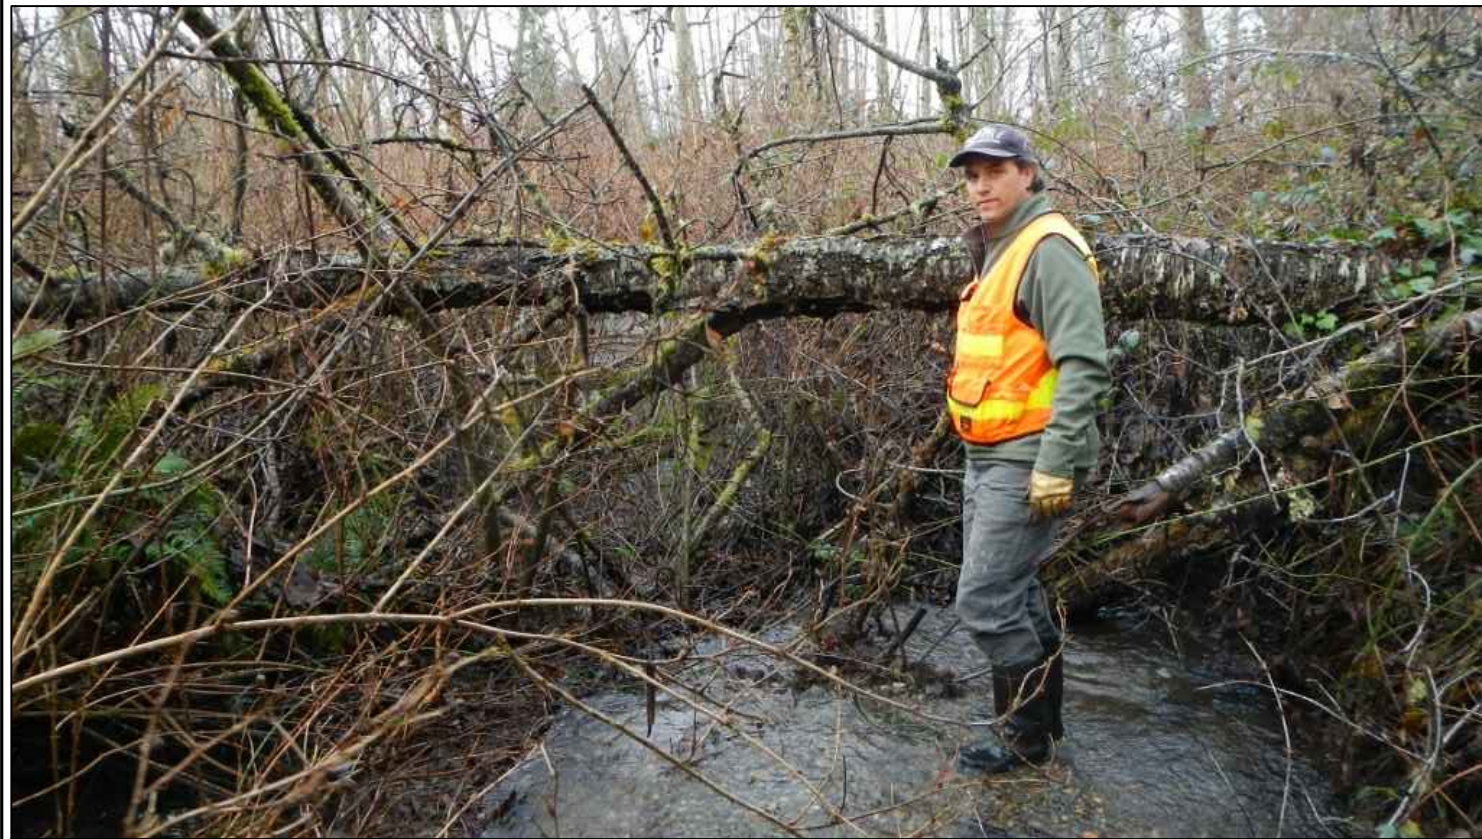
LOOKING DOWNSTREAM IN SALMONBERRY DOMINATED AREA LOOKING AT 1' HIGH DAM CAUSED BY WOOD, HOLDING BACK STREAM GRAVEL

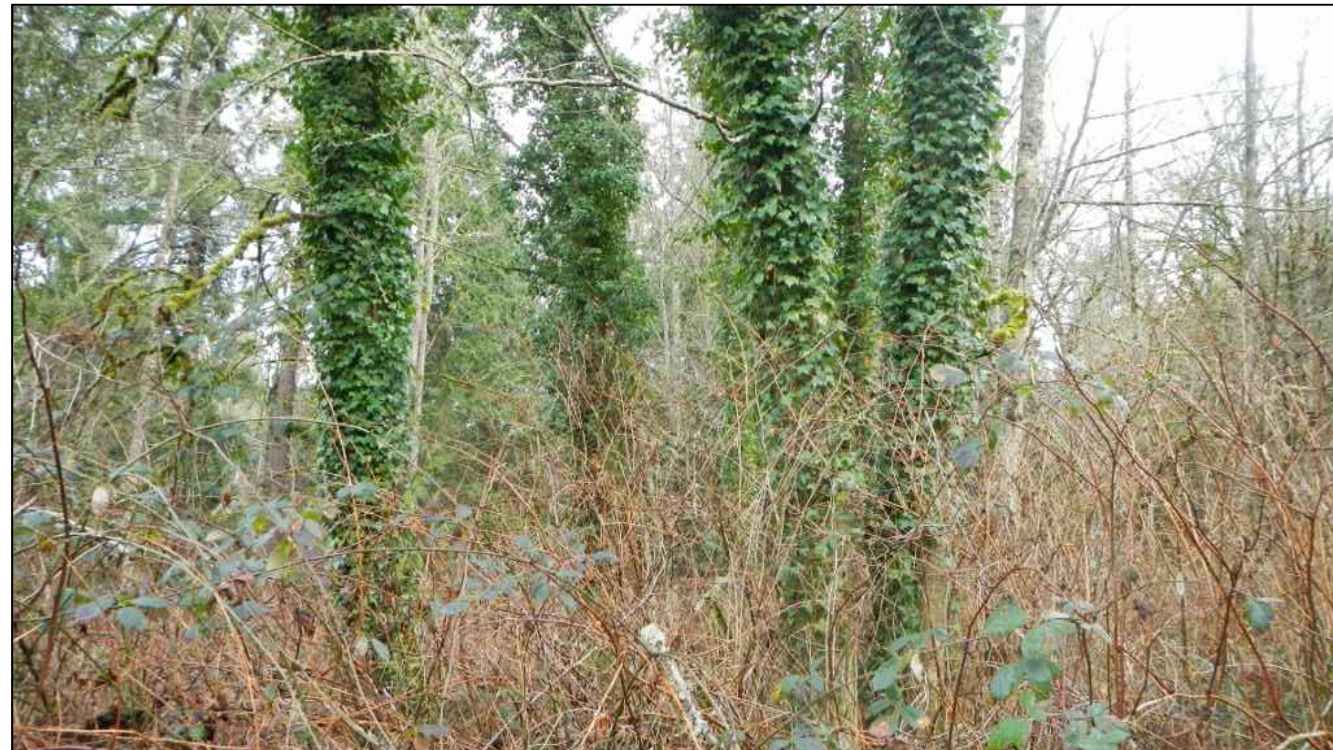
LOOKING ACROSS CHANNEL IN SALMONBERRY DOMINATED AREA AT TREES COVERED IN IVY

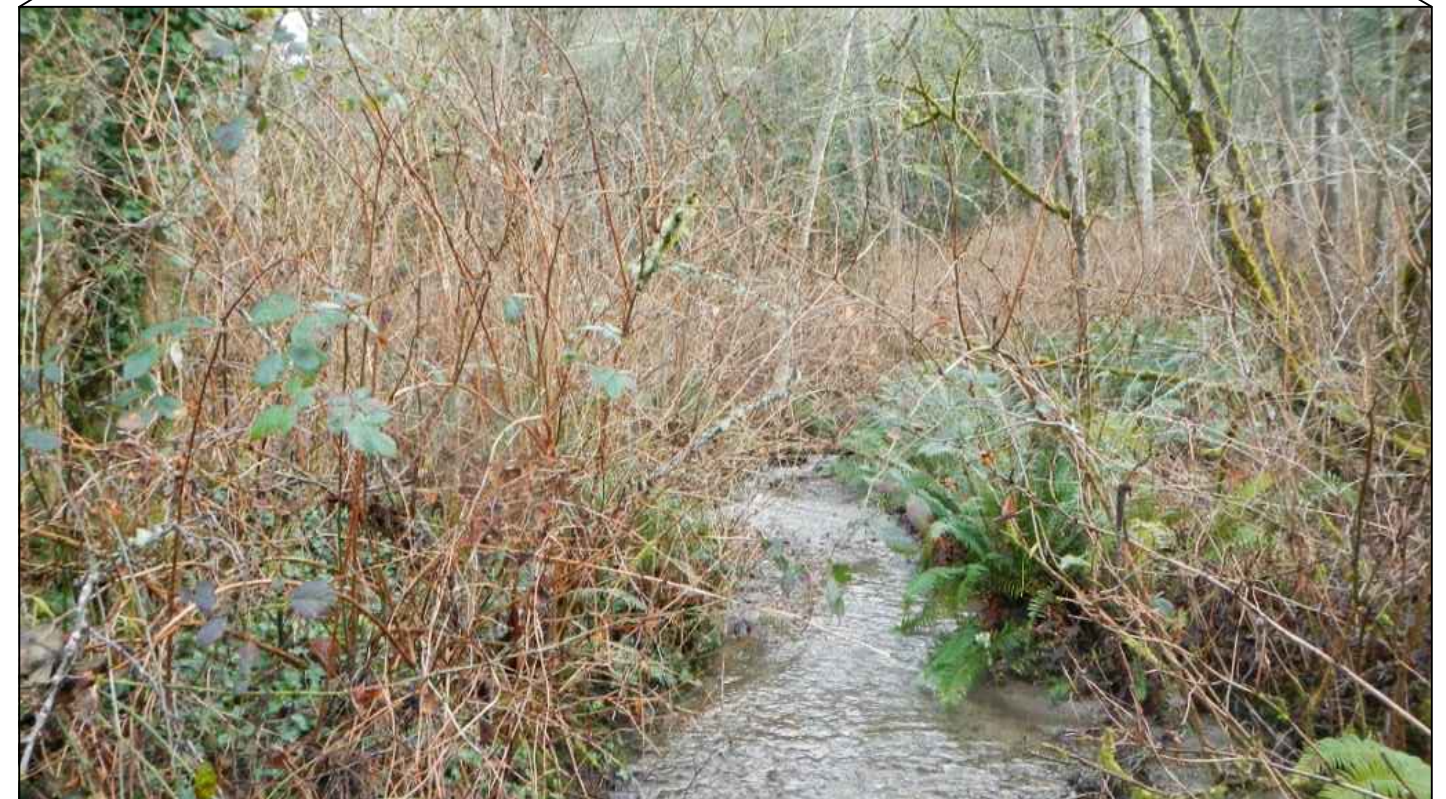
LOOKING UPSTREAM IN SALMONBERRY DOMINATED AREA

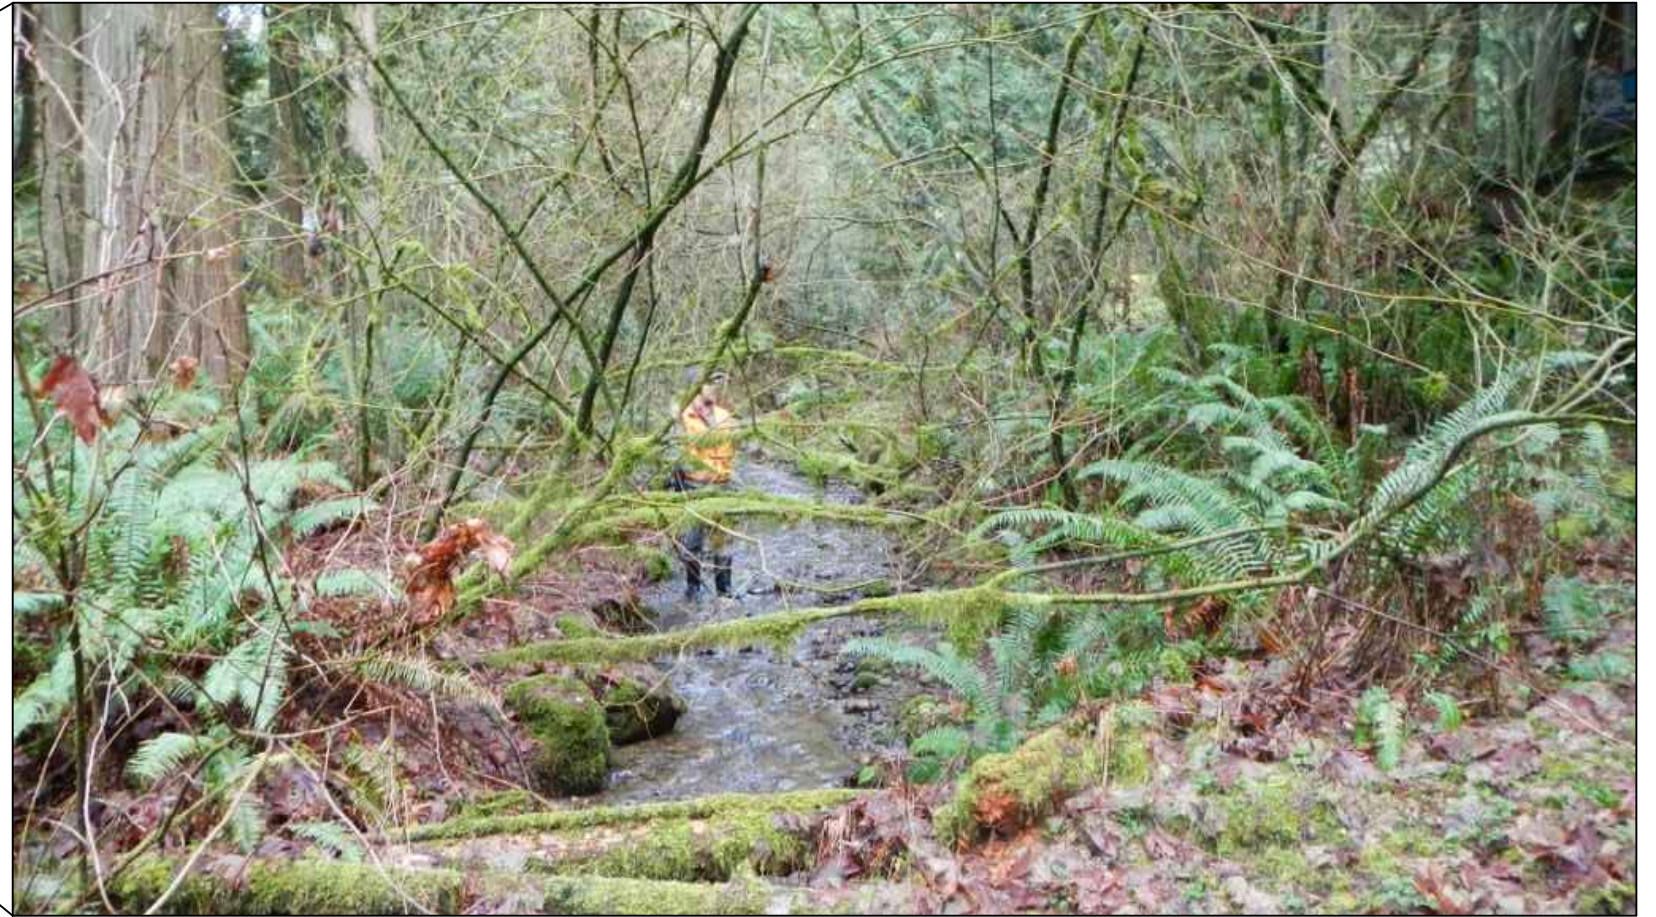
LOOKING UPSTREAM IN REFERENCE REACH BY WALKING BRIDGE – FOREST DOMINATED BY CEDAR, FERN, VINE MAPLE ETC.

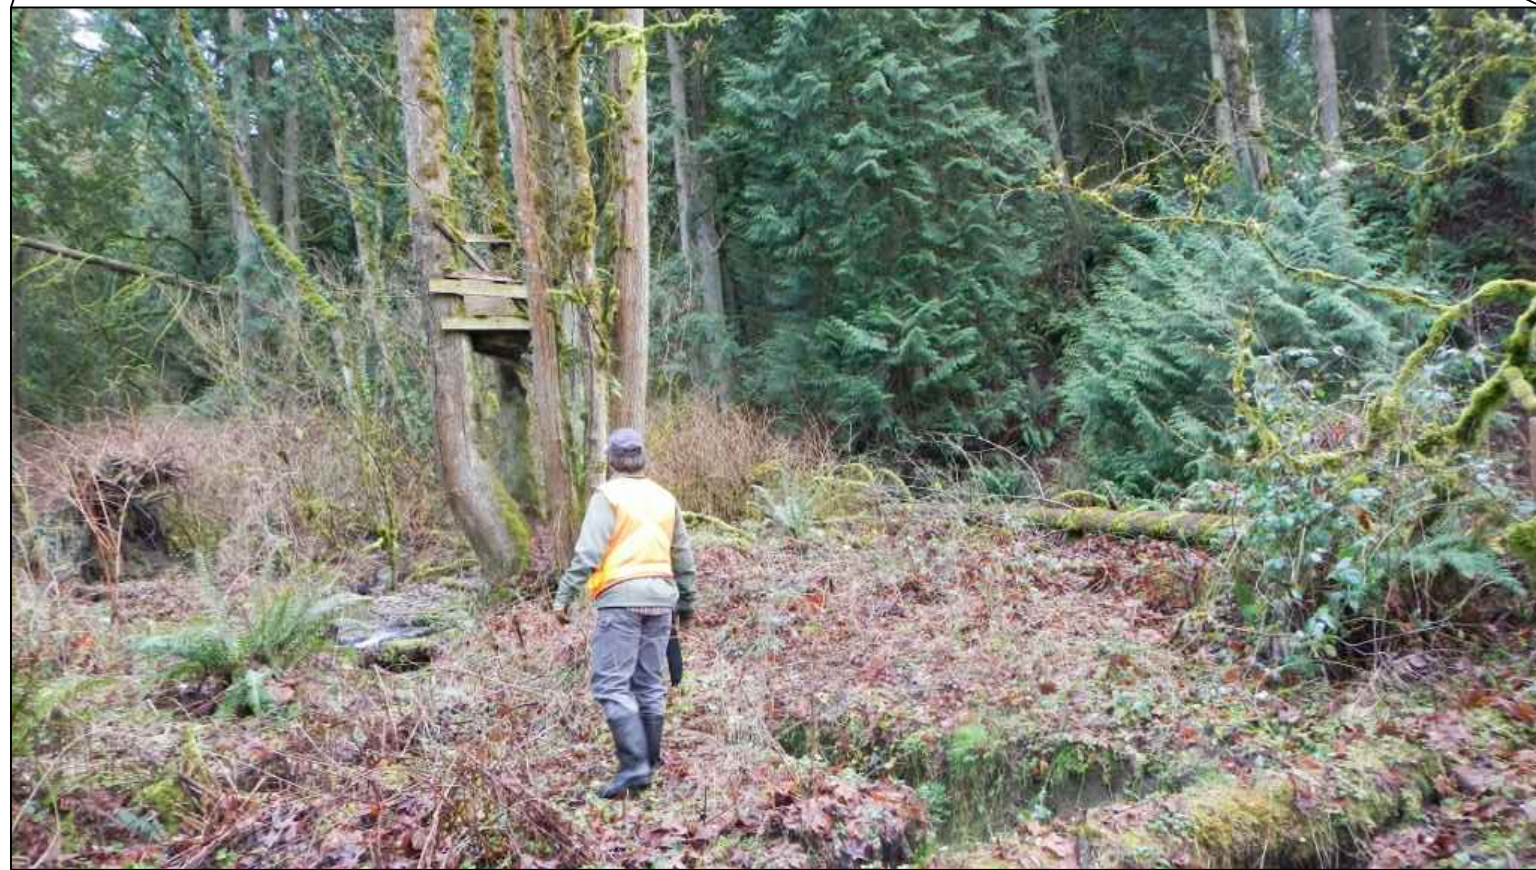
LOOKING UPSTREAM AT MATURE FOREST AREA WITH RECENTLY CUT INCISED CHANNEL IN THE FOREGROUND

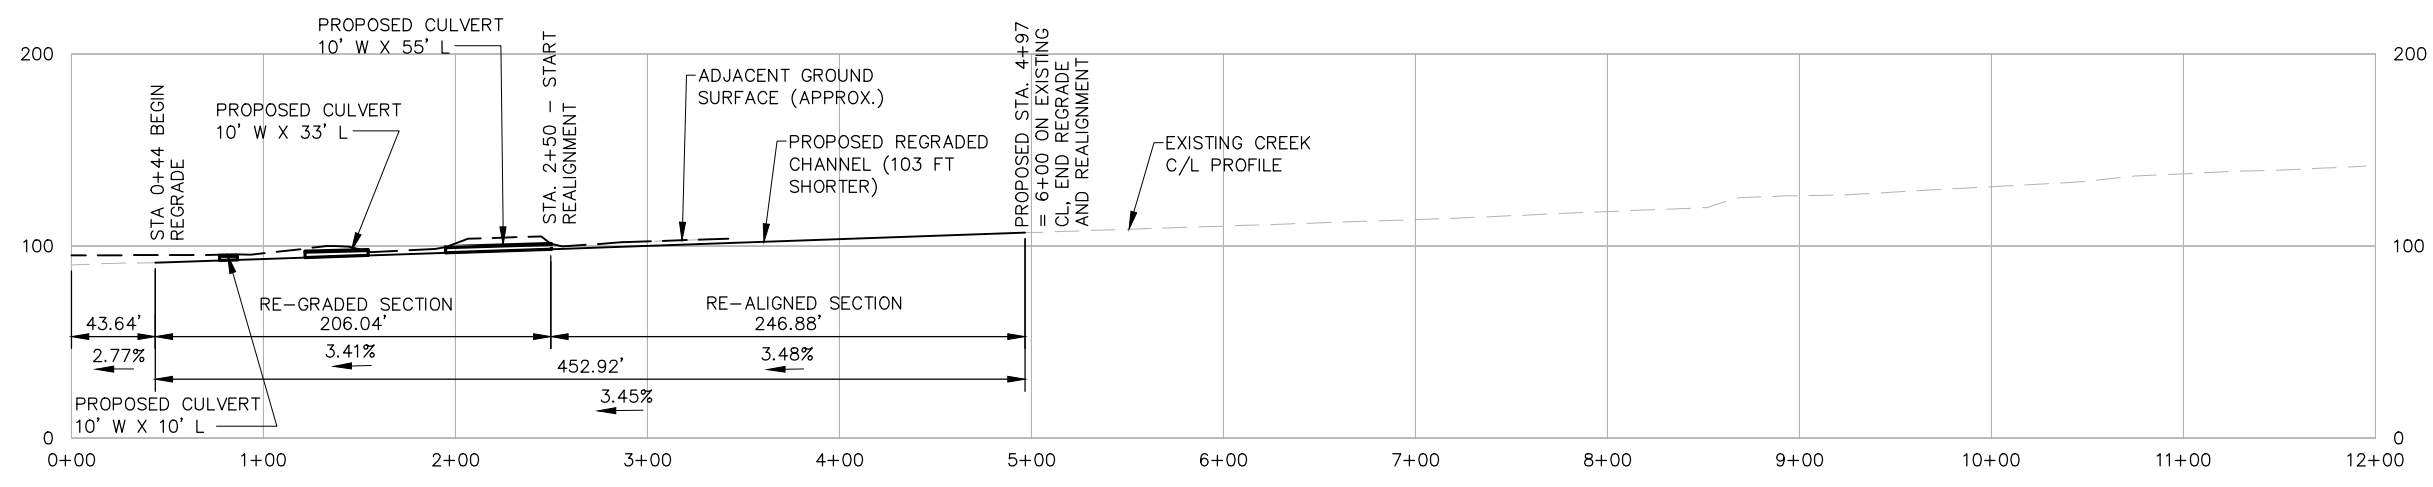
**SITE PLAN**  
SCALE: 1" = 100'

**PROPOSED CHANNEL PROFILE**  
SCALE: 1" = 100'
