East Lake Sammamish Trail Inglewood Hill Road Parking Lot Project

Tree Inventory/Assessment Report

**6/17/2017
Updated 7/7/17**

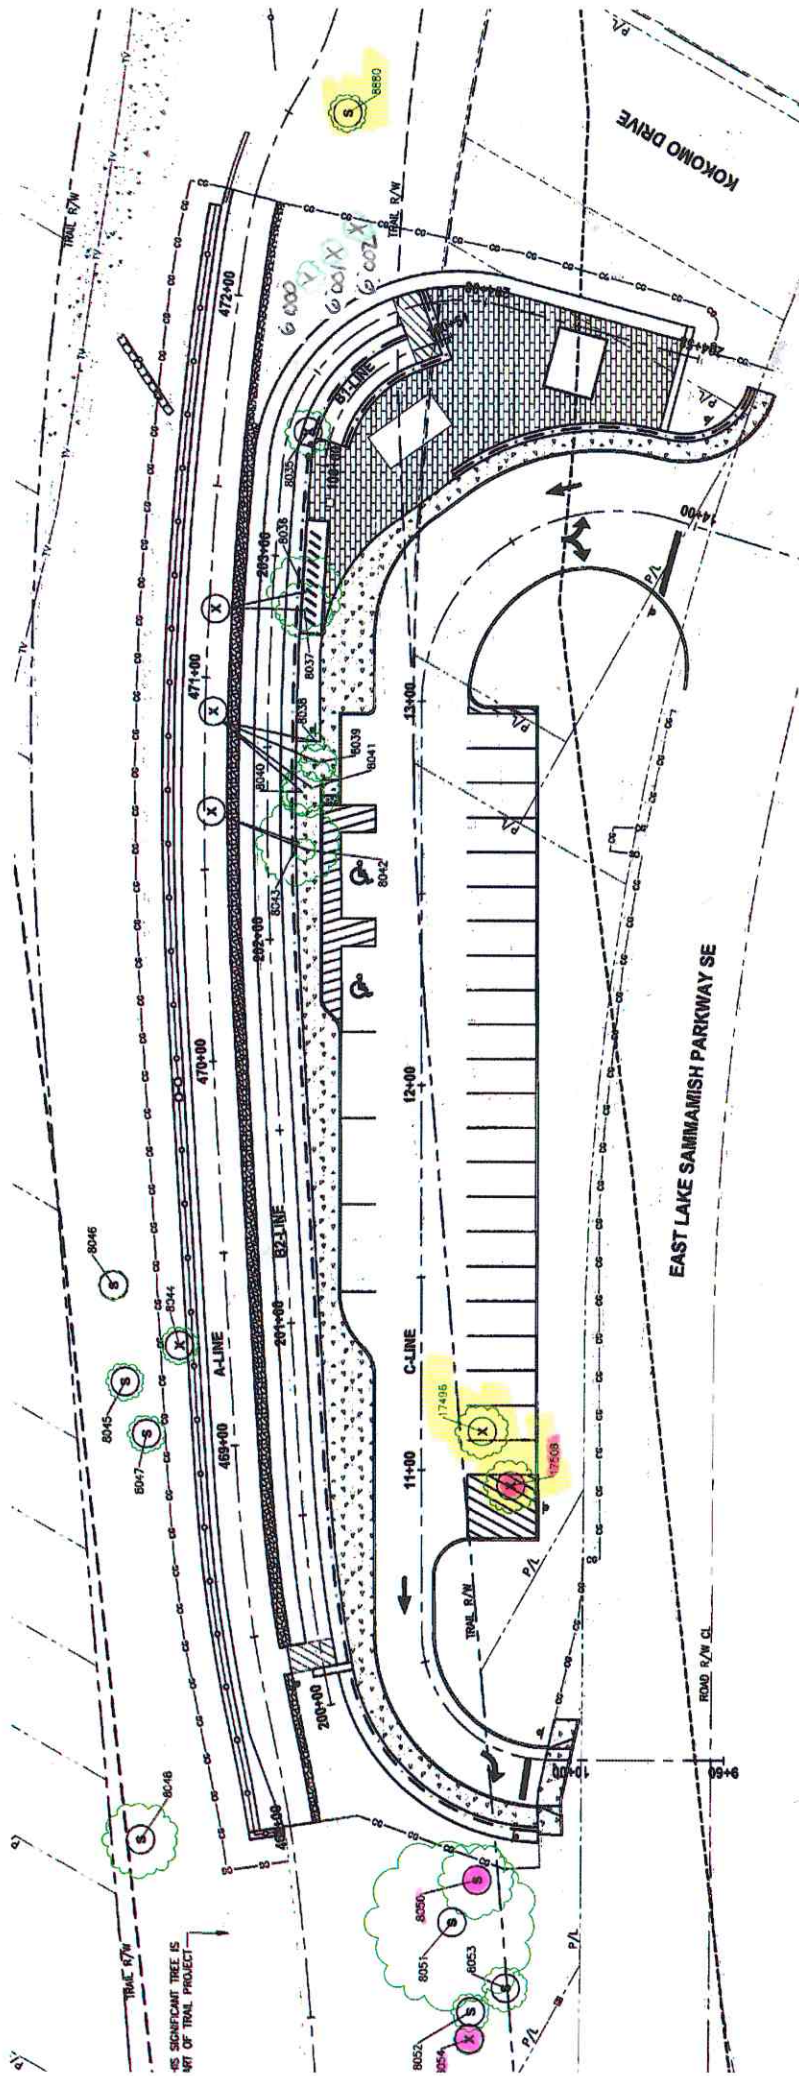
INGLEWOOD HILL ROAD - PARKING LOT PROTECT
 SIGNIFICANT TREE ASSESSMENT

- #6000, 6001, 6002, 8035, 8036, 8037, 8038, 8039, 8040, 8041, 8042, 8043 - ALL TOPPED IN RECENT PAST
- #8044 HAS BEEN REMOVED - NO LONGER EXISTS
- - INDICATES HAZARD TREE
