## TECHNICAL MEMORANDUM

**DATE:** February 26, 2015  
**TO:** King County  
**FROM:** Paul Fendt  
**SUBJECT:** Evaluation of Existing Drainage Structures for Replacement in the South Sammamish Segment  
**CC:** Craig Buitrago, Jenny Bailey  
**PROJECT NUMBER:** 554-1521-075 (20/05)  
**PROJECT NAME:** East Lake Sammamish Trail

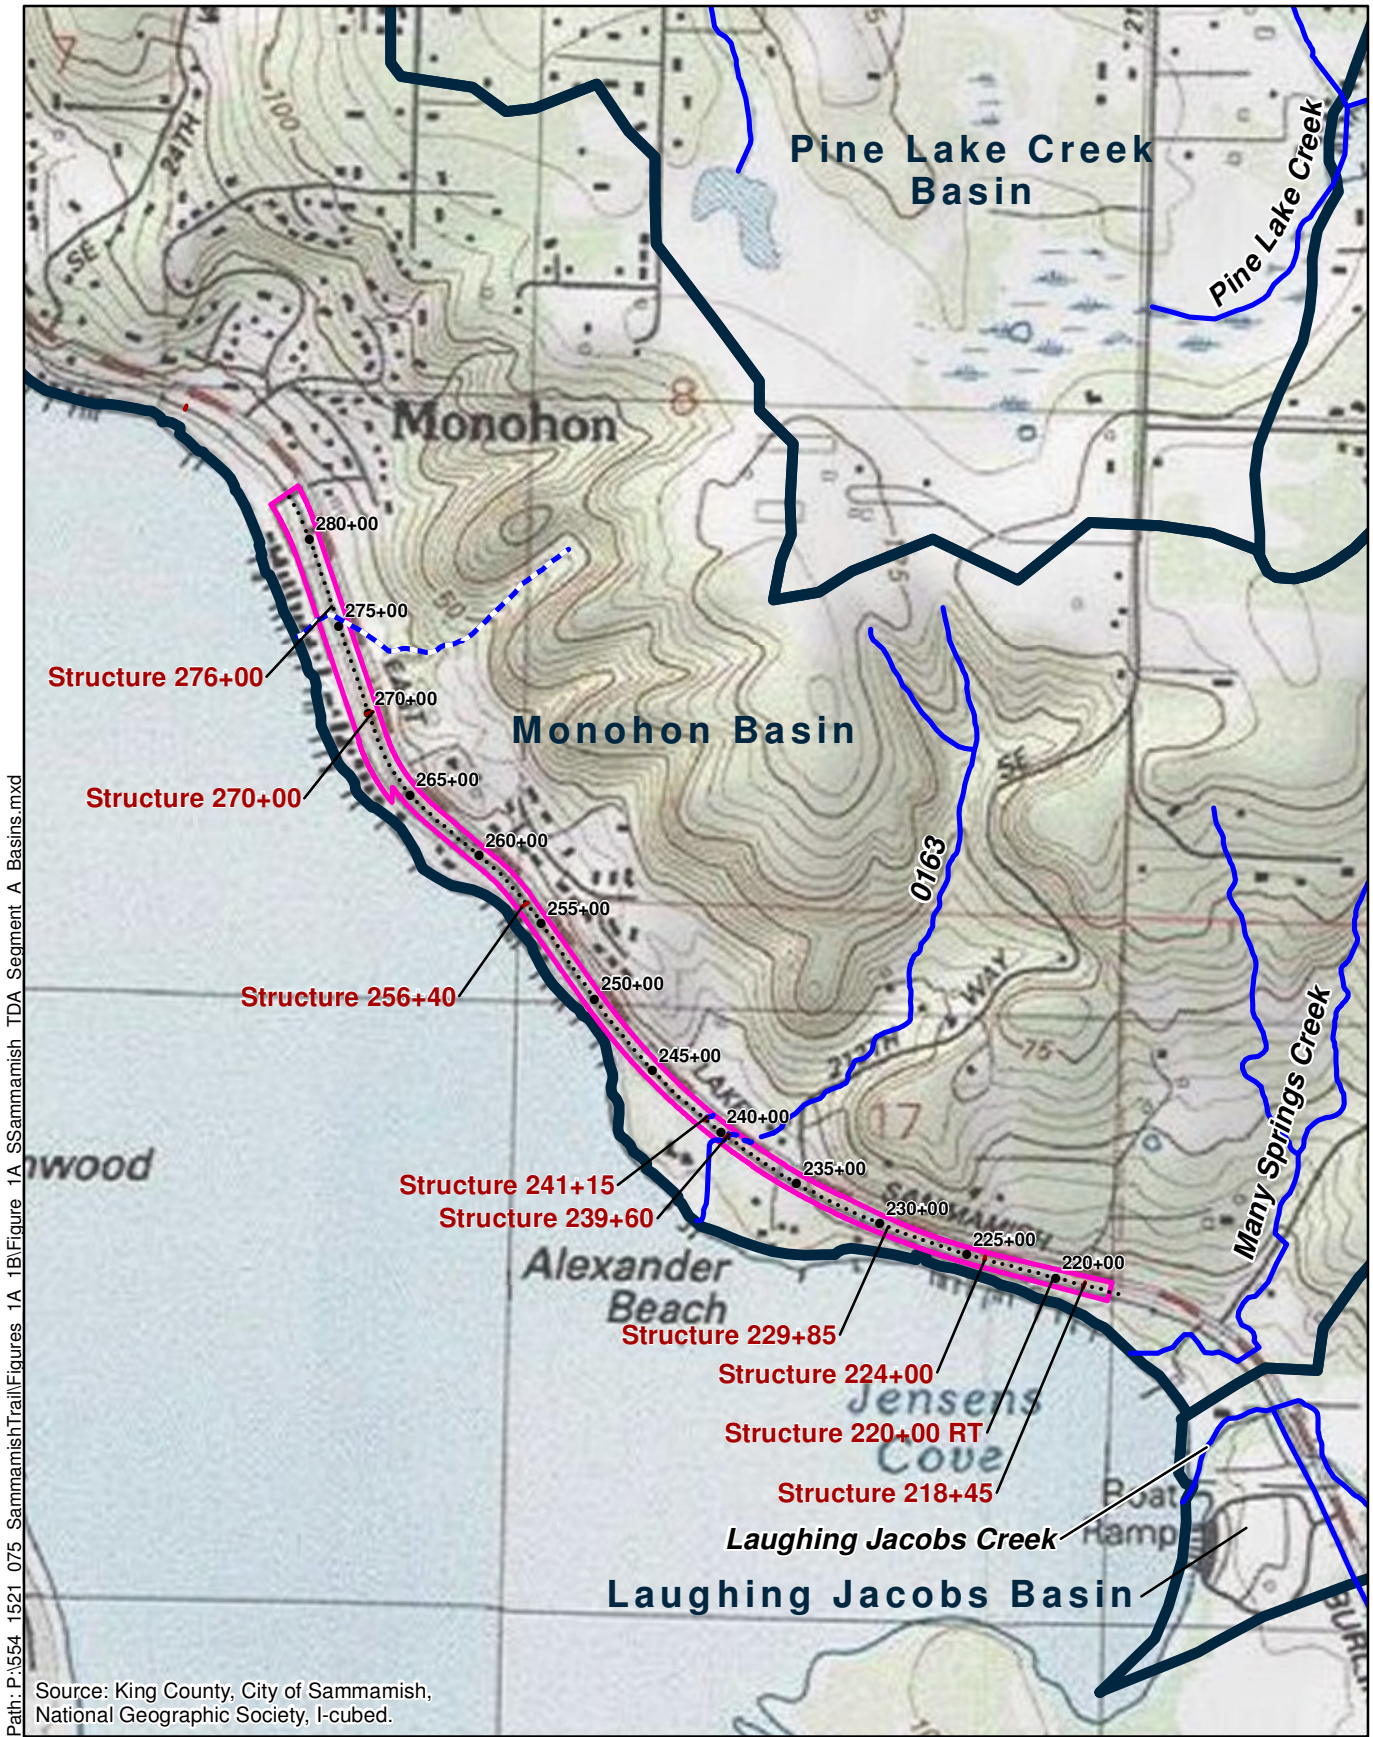
**Exhibit 57**  
**Figure 1A-00415**  
**Drainage Structure Locations**

- South Sammamish Segment A Project Location
- Stream Crossing Field-verified by Parametrix
- Stream Crossing Not Found within Trail Corridor
- City of Sammamish Drainage Basin

Each of the screening steps were performed on all 41 structures in the South Sammamish Segment (Figures 1A and 1B), which includes nine structures in South Sammamish Segment A, shown as the southern-most nine structures on Figure 1A (stations 218+45 through 276+00). Consequently, if additional data is found that may change a decision on a culvert for one screen, other screens may be reviewed to confirm the original decision. This analysis was a combination of desk top reviews of maps and plans, site photographs, and personal knowledge of the sites based on multiple field visits. Additional field verification may be needed to confirm findings in selected areas.

The 41 structures in South Sammamish have been identified by their station location along the corridor to provide a unique identifier for each drainage path. Figures 1A and 1B shows the trail stationing, location of the 41 structures, and general drainage catchment areas as defined in the King County GIS hydrography layer.

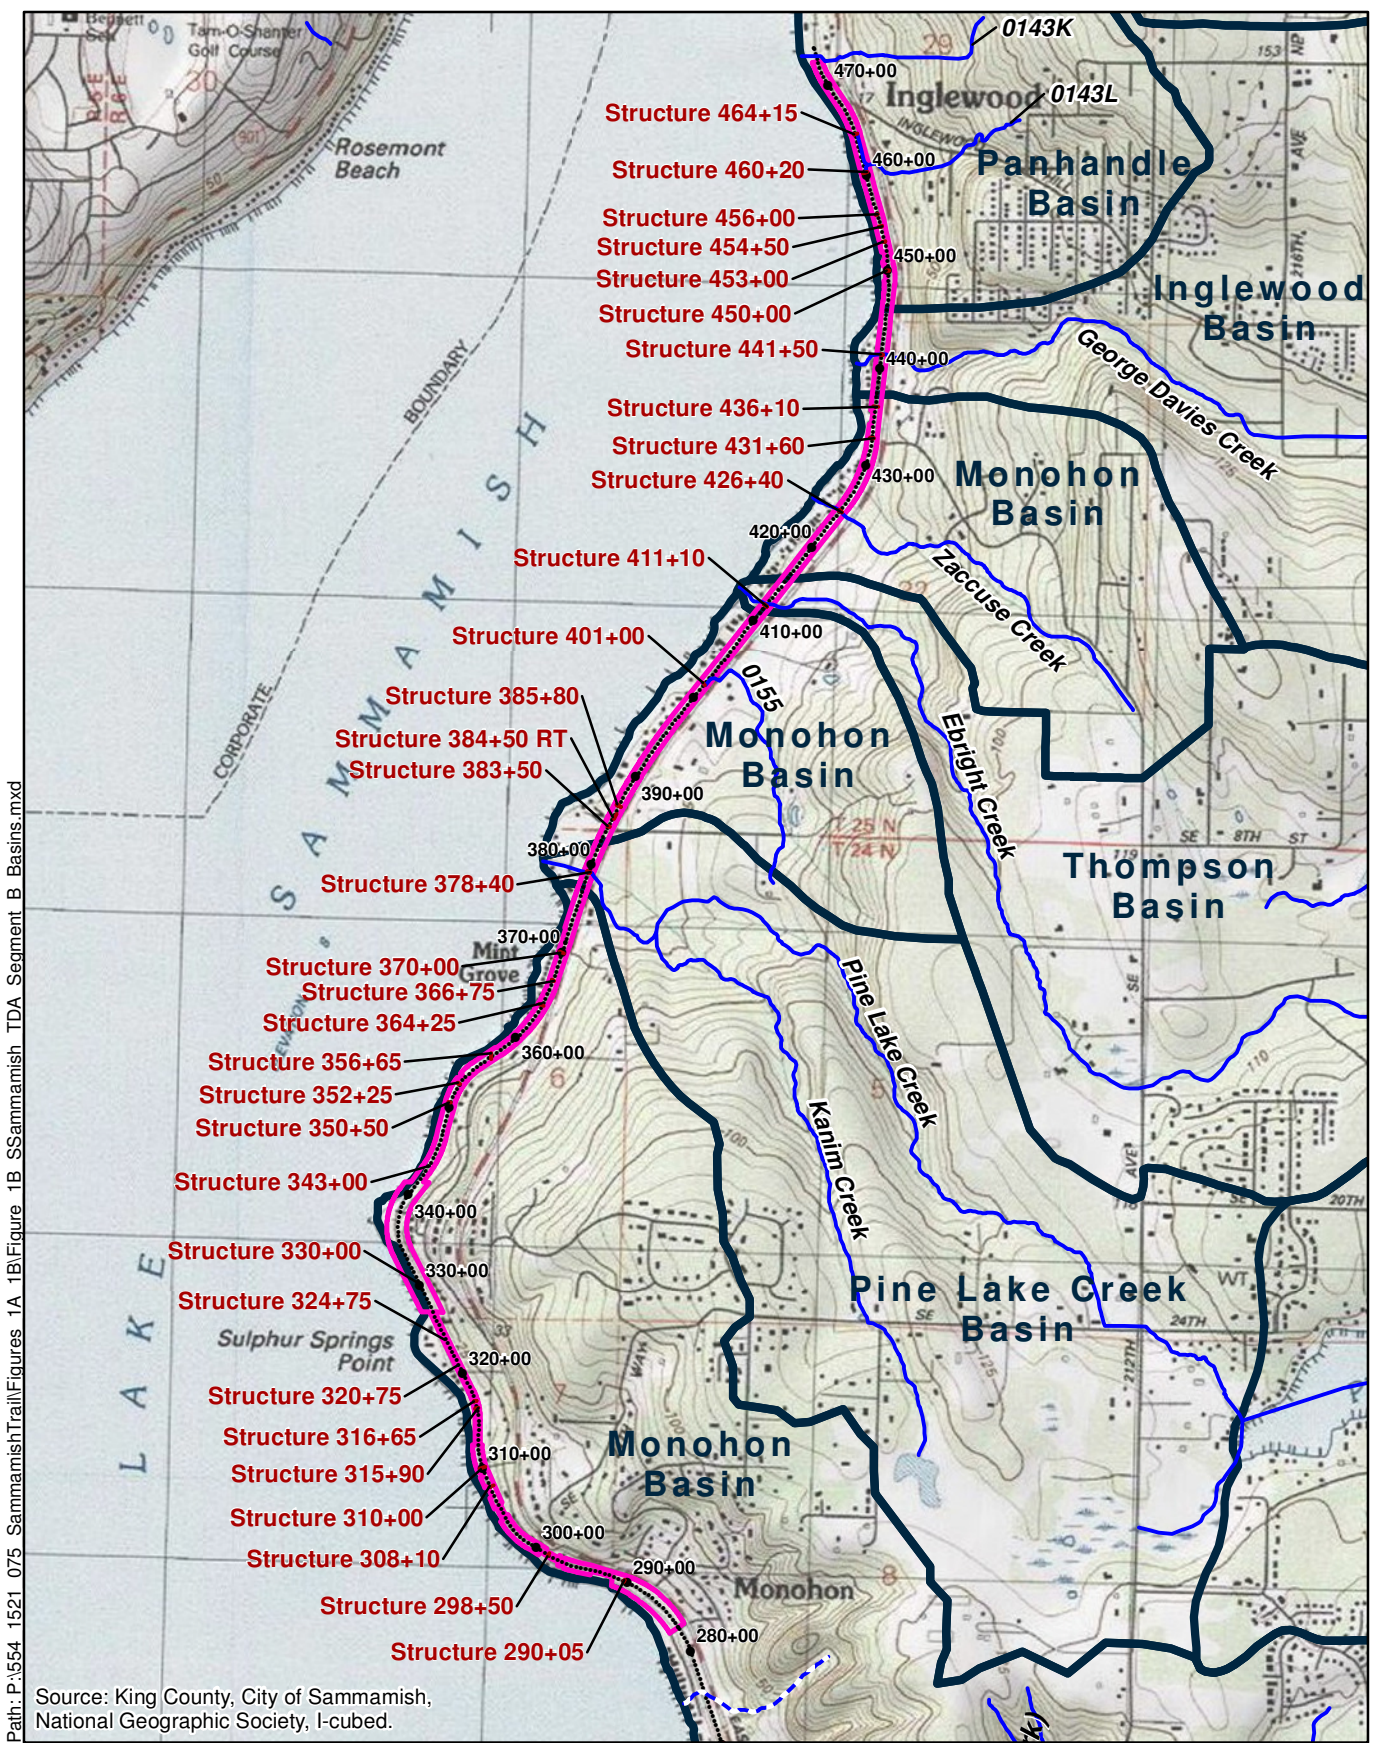
**Exhibit 57**  
**Figure 1B-00415**  
**Drainage Structure Locations**  
 05560

□ South Sammamish Segment B Project Location  
— Stream Crossing Field-verified by Parametrix  
- - - Stream Crossing Not Found within Trail Corridor  
 City of Sammamish Drainage Basin

● Proposed Trail Stationing
